2021년도 주요 해외 해양사고 교훈사례집

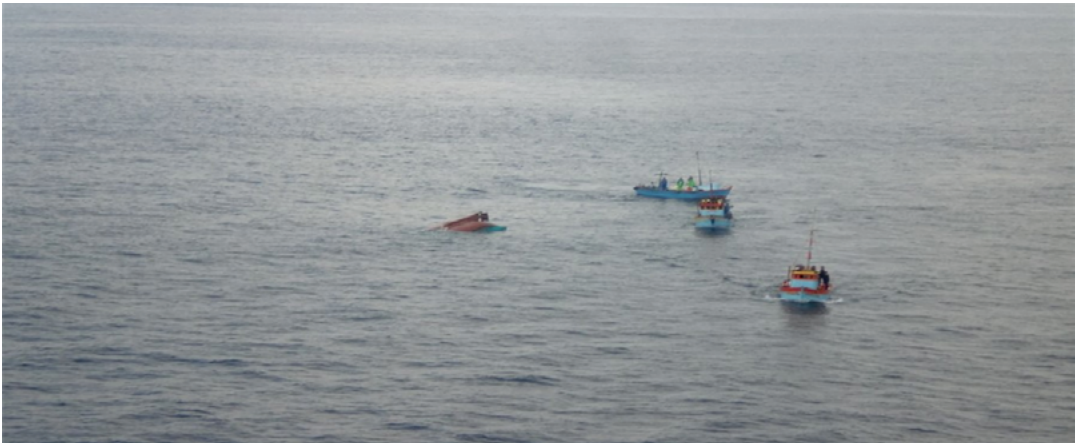
컨테이너선 A호는 조업 중인 다른 선박 무리를 통과하는 동안 어구를 서로 당기며 와이어로 연결된 상태로 조업 중인 어선 두척을 피하지 못하고 충돌하였다. 이번 충돌사고로 두척의 어선은 침몰되었고 이로 인해 선원 두 명이 익사하였으며, 컨테이너선 A호는 선체 표면이 손상되었다.

Figure 1.3 충돌 후 사진 출처 Investigation Report (LIBERIA MARITIME AUTHORITY)

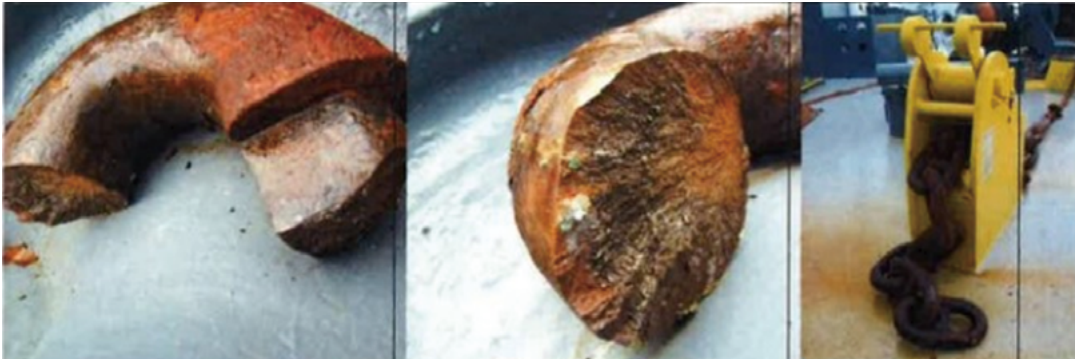
- 사고 예방을 위해서는 장비가 적절하게 활용되어야 한다.
 - 사고당시 유조선 선미에서 근무 중이던 선원 한 명은 예인패넌트가 예인선 와이어에서 예인원치로 직접 연결되어 있었으며 곱 와이어나 예인핀 모두 사용되지 않은 것으로 증언하였다.
 - 또 다른 선원은 예인선에 연결된 와이어가 거널에서 갑판실로 미끄러졌으며 예인선은 첫 번째 파도를 맞았을 때 우현으로 기울어졌다고 증언하였다. 예인핀(장치된 경우)과 곱 와이어가 사용되었더라면 와이어는 거널에서 미끄러지지 않았을 것이다.
 - 이번 사고에서 1열 마모방지 체인(single length chafing chain)이 끊어졌으며, 원인 조사결과, 이 체인의 안전하중(SWL, 230~458톤)은 권장 안전하중 보다 낮았다. 체인의 권장 안전하중과 최대파괴하중은 각각 482톤과 612톤이다.

Figure 2.2 Defective chafe chain 출처 Investigation Report (LIBERIA MARITIME AUTHORITY)

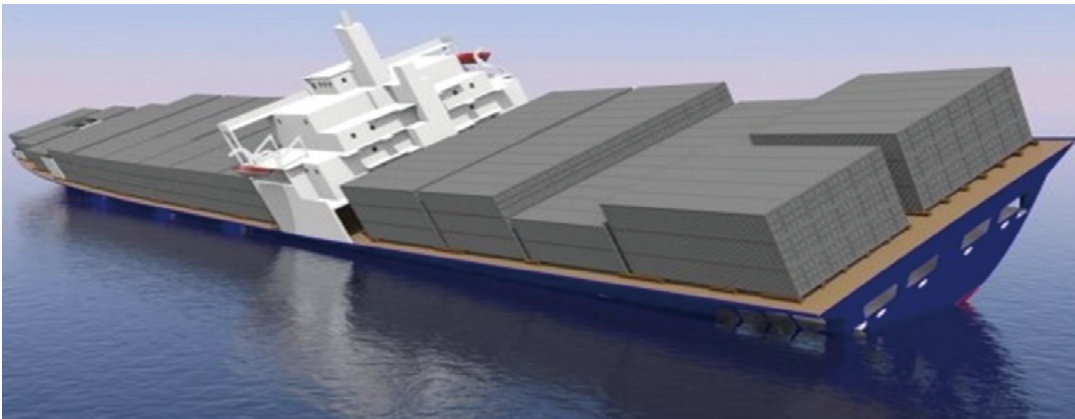
- 유지보수가 잘 되지 않은 선내구조와 통풍 댐퍼(ventilation damper)는 선박의 수밀성을 약화시켰다. 선박개조로 인해 만재흘수선(load line draft)이 높아 복원성이 낮아지고 악천후에 대해서는 취약해 졌다.
- 하역인부에 대한 관리감독 부족으로 선내 화물은 화물고박매뉴얼에 따라 튼튼하게 고박되지 않아 외력을 받을 때 화물이 이동하며 흘수선 아래의 선체 일부가 손상되었다.
- 기관사들에게 횡경사로 인한 엔진의 운영한계 및 악천후를 대비 필수 준비사항에대하여 충분히 알려주지 않았다. 그 결과 선박은 섬프탱크 내 윤활유 수위가 권장 수위보다 더 낮은 상태에서 출항하였고, 그 결과 주기관 추진장치 작동을 위한 윤활유 석션(suction)을 할 수 없었다.
- 선박의 복원성 소프트웨어로는 침수부위를 파악할 수 없었으며, 그 결과 침수지점을 파악할 수 없었던 선원들은 통풍구 입구를 닫을 수 없었다. 또한 승인받은 손상제어계획(damage control plan)이 있었다면 선원들은 선박 상태의 심각성을 인지하고 비상상황에 대응할 수 있었을 것이다. 그러나 이 역시 필수요건이 아니었기 때문에 본선에는 구비되어 있지 않았다.
- 선사 또한 안전한 항해, 수밀성, 악천후 대비, 악천후 상황 속 비상대응, 항해사의 수행실적을 평가하는 절차와 관련한 안전관리체제(SMS)의 효과에 대해 적절히 관리 감독하지 않았다.
- 선원훈련에 손상제어, 복원성 회복 수단, 기상학 및 선박조종은 포함되지 않았으며 RRDA(Rapid Risk Damage Assessment) 서비스에 가입했음에도 불구하고 해당 서비스에 대한 훈련도 없었다.
- 선박에 있는 개방형 구멍정이나 구멍뿔목을 적시에 사용했다 가정하더라도, 극심한 악천후 속에서 선원들을 제대로 보호할 수 없었을 것이다.

Figure 3.2 Simulation before sinking 출처 Investigation Report (UNITED STATES COAST GUARD)

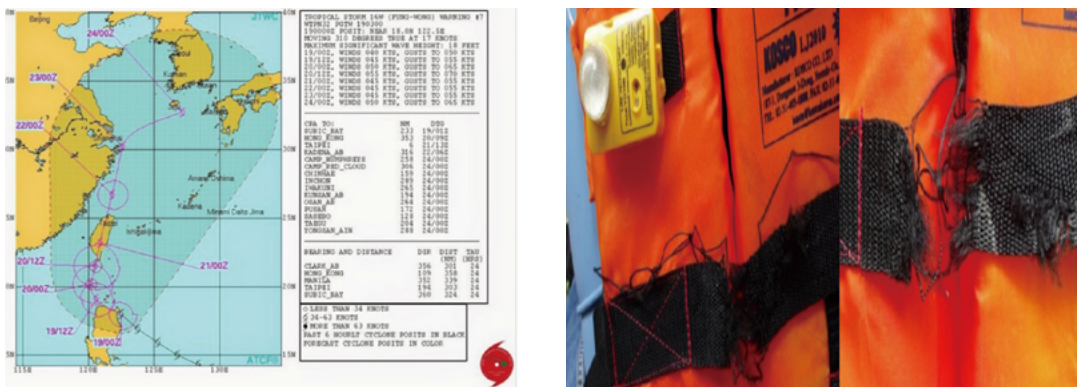
- 선원은 큰 파도가 선수루를 덮쳤을 때, 파도에 바로 노출되는 위치에 있었다.
- 위험평가는 기후조건에 적합하지 않게 실시되었으며, 이로 인해 갑판에 있던 선장과 선원은 안전문제에 있어서 잘못된 판단을 하였다.
- 선박의 충분히 크게 변침하지 않았고, 안전장비 및 벨트를 사용하지 않는 등 주의사항을 적절하게 지키지 않았다.
- 점검 시 추가 문제가 발견되었을 경우에 대한 대비책이 없었다.
- 열대성 태풍이 발생하는 악천후 예방대책은 부적절했다.

Figure 5.3 5.4 사고당시 기상도 · 익수자 구명동의 출처 Investigation Report(Republic of the Marshall Islands Maritime Administrator)

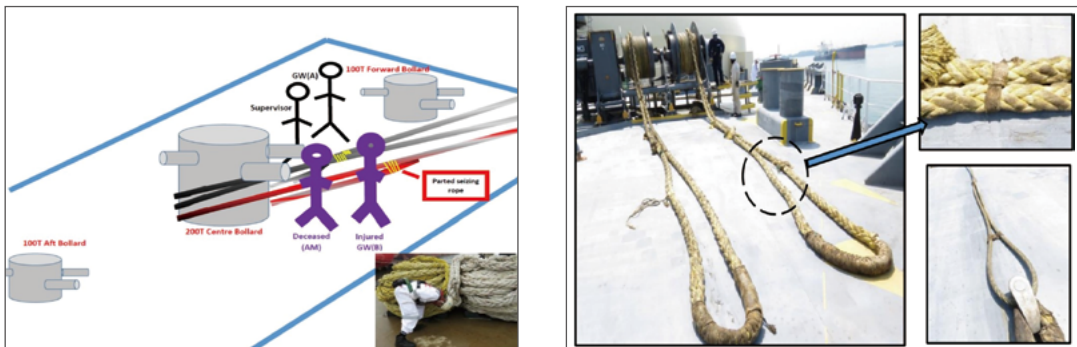
- 테일로프는 보관되기 전(2개월전)에는 상태가 좋았던 것으로 기록되었다. 보관되는 동안 상태가 악화되었을 수 있다.
- 계선작업에 참여한 조선소 근로자들에게 선박의 접·이안 관련 직무능력표준에 따라 구조화된 훈련 프로그램을 이수하는 것이 의무사항이 아니었다.
- 계선줄에 대한 점검 및 평가기준에 특히 메인로프와 유사한 운항 및 환경조건에 있는 시징 트와인(seizing twine)에 대한 점검은 포함되지 않았다.

Figure 6.2 Worker's Position · Mooring Line 출처 Investigation Report (Transport Safety Investigation Bureau (TSIB) Ministry of Transport Singapore)

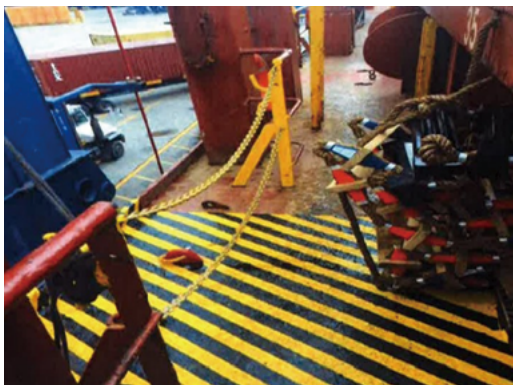
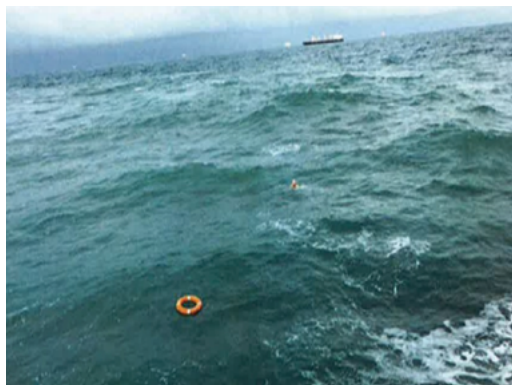
- 갑판장은 선측 가까이에서 작업할 당시 선박에 고정되어 있지 않은 상태였다. PPE(구명조끼와 안전장비)를 착용하지 않았다.
- 선박 SMS 상에는 해당 작업에 대한 공식 절차가 없었다. 안전장비를 착용하는 관행은 있었지만 이번 사건의 경우, 갑판장은 착용하지 않았다.
- 사고발생 당시 그는 혼자 작업하고 있었다.

Figure 7.2 7.3 Pilot ladder · Man overboard 출처 Investigation Report(LIBERIA MARITIME AUTHORITY)

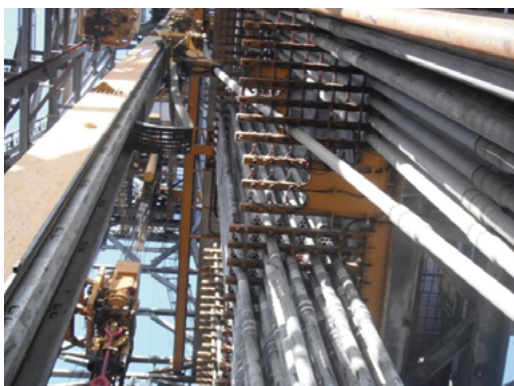
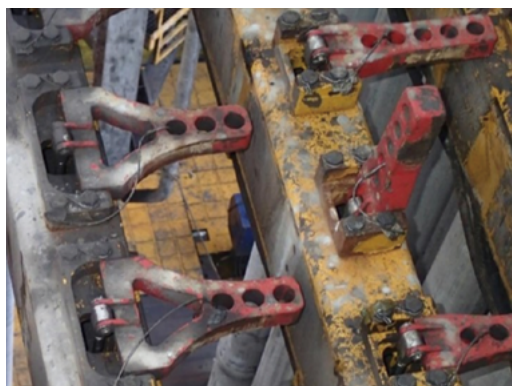
- 해당 인부는 관련 위험성에 대한 훈련을 충분히 받지 못했다.
- 배관관리 담당자 및 그 안에서 작업하던 사람들은 배관 보관구역을 보지 못했고 시야가 좁았다.
- 직무 첫 날이었던 채굴인부를 적절하게 관리감독하지 않았다.
- 사고는 해당 작업이 32번째 완료되었을 때 발생되었다. 즉, 여러 차례 작업으로 작업의 위험성에 대한 인식이 부족했거나 둔감해져 출입금지 구역에 들어간 것으로 추정된다.

Figure 8.2 Drill Pipes · Latches 출처 Investigation Report (LIBERIA MARITIME AUTHORITY)

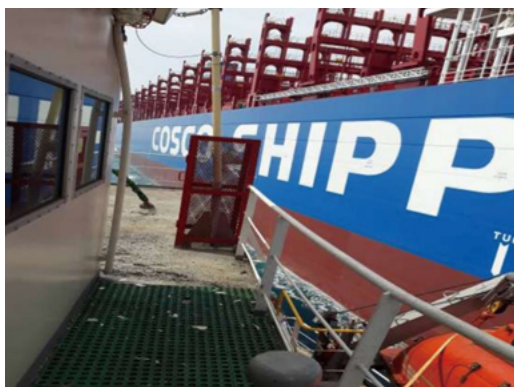
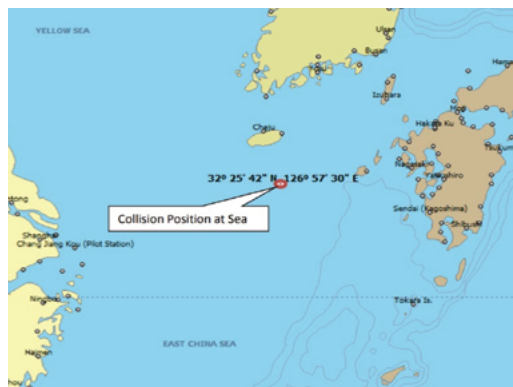
- 두 선박의 선교팀 모두 효과적인 견시를 하지 않았다.
- 통항상황을 고려한 안전속도가 유지되지 않았다.
- 충돌을 피할 수 있는 가능한 모든 수단을 사용하지 않았다.

Figure 9.2 9.3 Collision · Position 출처 Investigation Report (PANAMA MARITIME AUTHORITY)

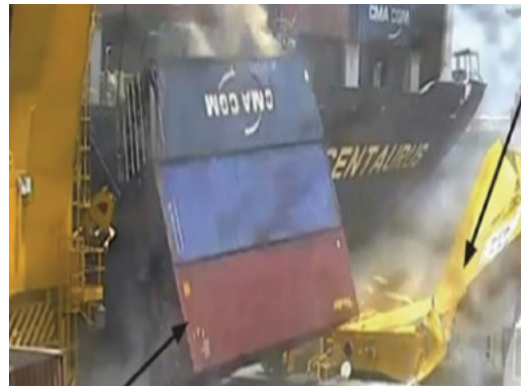
선장은 도선사에게 선박이 너무 빠르게(2.4kn) 움직이고 있다고 알리며, 반속 후진과 전속 후진 명령을 내리며 감속을 시도했지만 선박의 속력은 줄지 않았고, 3분 뒤 선박은 부두와 강하게 접촉하였다.

Figure 10.1 10.2 Heavy contact with quay 출처 www.porttechnology.org/news

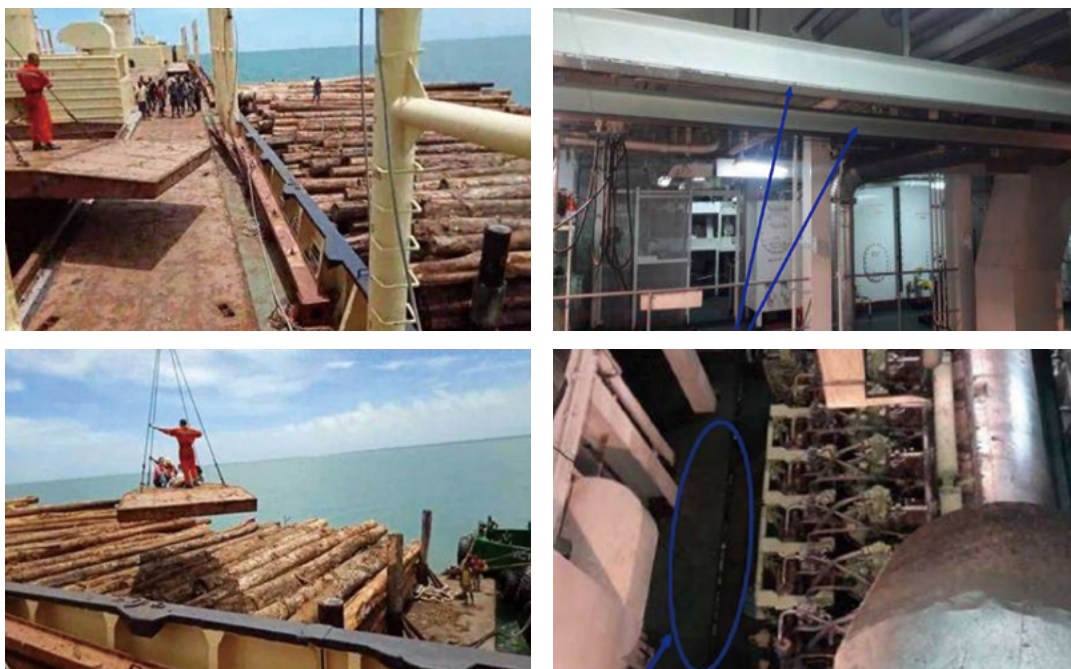
하지만 그 순간, 하역작업 중인 화물 바지선이 본선과 심하게 부딪히며 선박 전체에 큰 진동이 일어났다. 충돌로 발생된 갑작스러운 선박의 움직임으로 피스톤 리프팅 장비 속 고정볼트가 풀리며 피스톤로드 등 부속품이 기관실 바닥으로 떨어졌다. 일기사는 피스톤로드 푸트(piston rod foot)와 크로스헤드 어셈블리 사이에 끼이게 되었다.

Figure 12.2 갑판작업 중 · 기관실 추락현장 출처 Investigation Report (PANAMA MARITIME AUTHORITY)

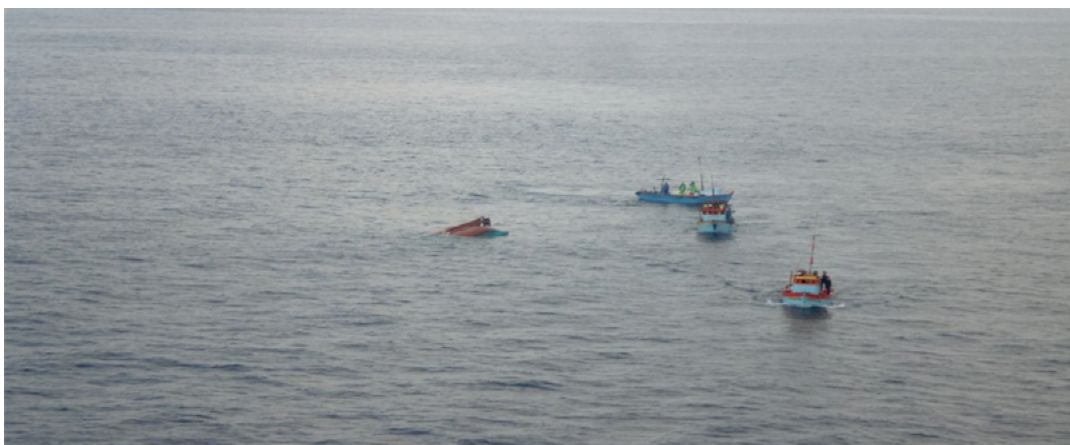
Figure 1.3 Post-collision photographs SOURCES Investigation Report (LIBERIA MARITIME AUTHORITY)

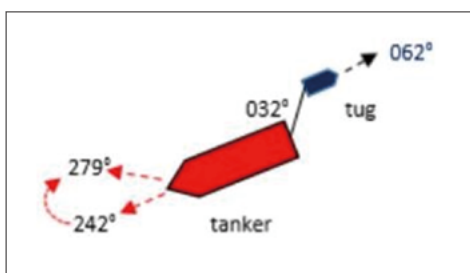
To mitigate the risk of damaging the cargo hoses and to keep the tanker in position and from drifting away from the SBM, the tanker had put its rudder hard to starboard, its bow thruster to starboard, and progressively increased its speed to slow and half ahead. The tug had its tow pennant fastened at the stern of the tanker. The tow pennant was directly shackled to the tug's tow line to the tug's towing winch. Neither gob wire nor towing pins to prevent girting were used. The tug wire had slipped on the gunwale to the deck house when the tug listed to starboard when it took two successive large waves on her beam before capsizing.

Figure 1. Tug-line was leading 032° (5 o'clock relative to the tanker's heading). Tug's centreline was parallel with tanker's centreline. Tug-wire slipped on gunwale to the deckhouse and the tug listed to starboard when the first wave hit her.

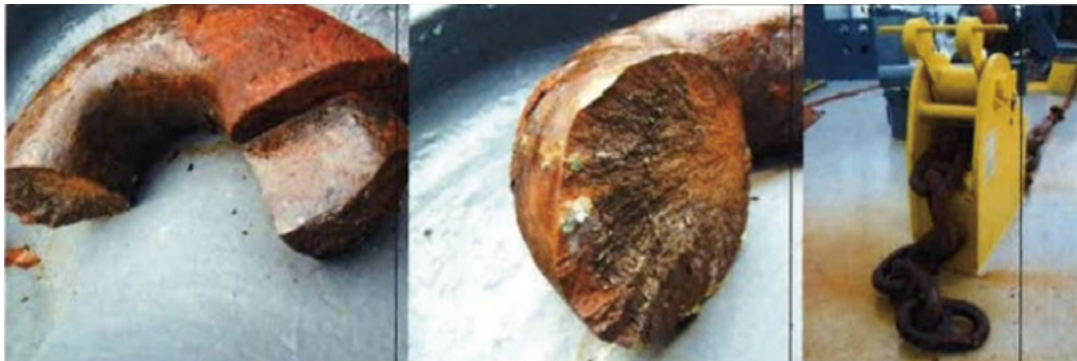
- One crew member, stationed aft of the tanker, reported that the towing pennant was connected directly to the tug's tow wire to the towing winch, neither gob wire nor towing pins were deployed. Another crew recalled that the wire to the tug was slipping on the gunwale to the deckhouse and the tug listed to starboard side when the first wave hit her. Had the tow pins (if fitted) and the gob wire been used, the tow wire would not have slipped on the gunwale.
- The single length chafing chain parted. The investigation shows that the chain had a Safe Working Load (SWL) of between 230–458 tonnes.
Recommendations for such chains is a proof load of 482 tonnes and a maximum breaking load of 612 tonnes.

Figure 2.2 Defective chafe chain SOURCES Investigation Report (LIBERIA MARITIME AUTHORITY)

The material of the chafe chains should be selected to match the required MBL of the mooring system. The rated strength should be at least equal to the 76 millimetre diameter IACS W22 Grade R3 or R4 (as a minimum), or equivalent stud link chain manufactured to the Society of anti-abrasive wear characteristics. Certificates for the material forming the links should be obtained from recognized proving houses.

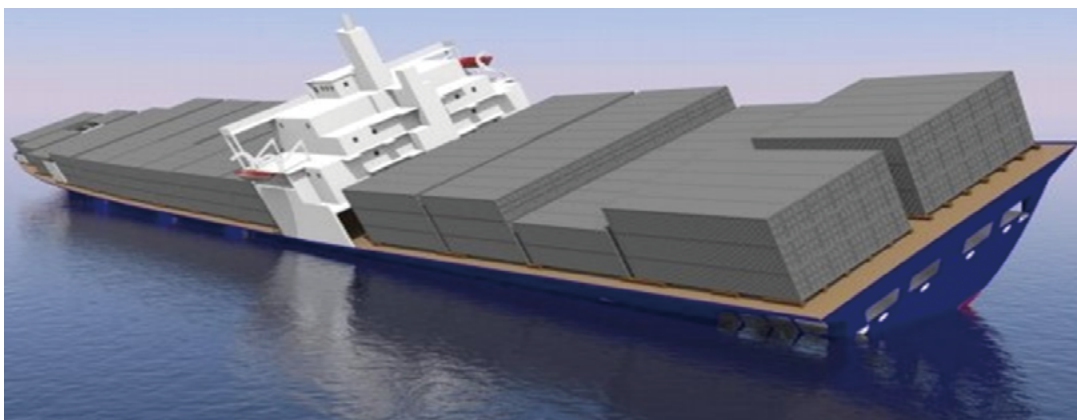
- The vessel's stability software did not identify the vessel's downflooding points which could have alerted the crew to close the ventilation openings. An approved damage control plan that would have assisted the crew in recognizing the severity of the vessel's condition and in responding to the emergency was not a requirement and thus not available.

Figure 3.2 Simulation before sinking SOURCES Investigation Report (UNITED STATES COAST GUARD)

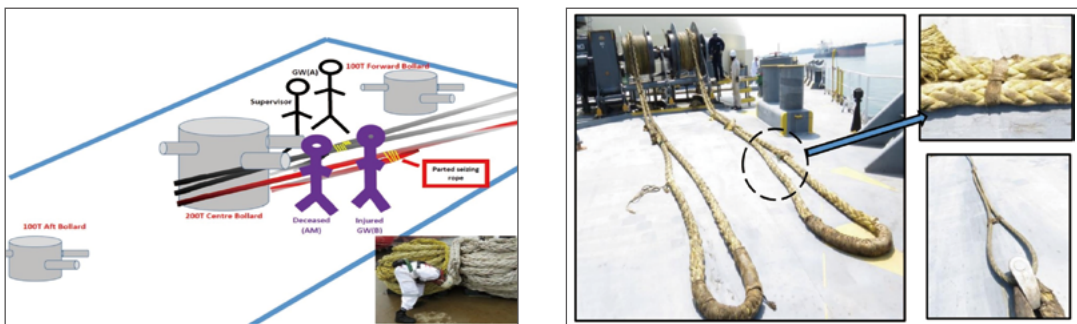
- The set of tail ropes used was recorded to be in good condition prior to being stored for 2 months. This could possibly have affected their condition.
- Shipyard personnel involved with mooring operations was not required to undergo a structured training programme as per competency standards for mooring/unmooring of ships.
- The inspection and appraisal criteria for mooring ropes did not specially include the inspection of the seizing twine, which like the main rope are subjected to similar operational and environmental conditions

Figure 6.2 Worker's Position · Mooring Line SOURCES Investigation Report (Transport Safety Investigation Bureau (TSIB) Ministry of Transport Singapore)

- The shipyard reviewed its risk assessment and formulated new procedures (safe work procedures) for mooring/unmooring operations.
- When inspecting and appraising the condition of the tail rope, the condition of the seizing twine should be taken into account.

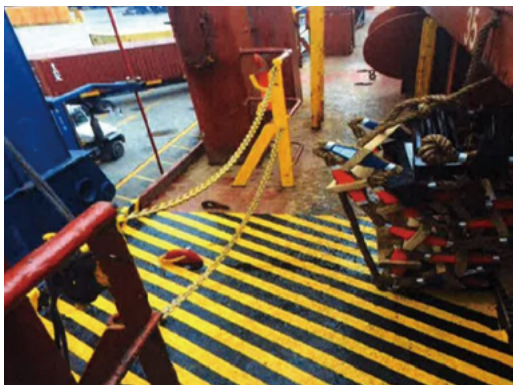
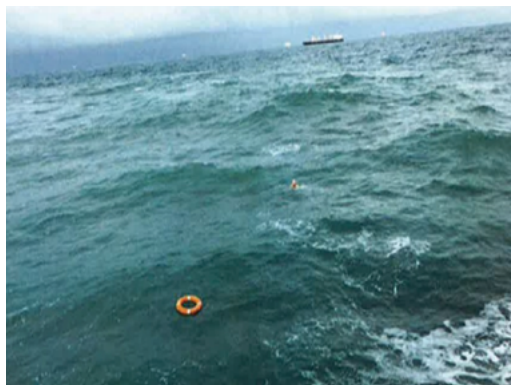
- Bosun was not secured to the vessel when working close to the side.
- PPE (lifejacket and safety harness) was not worn.
- Lack of formal procedures in vessel's SMS for this operation though it was established practice to wear a safety harness on this occasion the bosun did not.
- Solo working at the time of the accident.

Figure 7.2 7.3 Pilot ladder · Man overboard SOURCES Investigation Report(LIBERIA MARITIME AUTHORITY)

- Just because an operation is routine does not mean it is of low risk (and thus not being considered in the SMS). It is important to regularly review the SMS to ensure that all operations are correctly considered and appropriate risk mitigation is put in place.
- It is the responsibility of all crew members to look after their own and co-workers' safety.
- In this instance correct wearing and used of provided PPE may have prevented the fatality.
- When solo working, the risks are heightened.

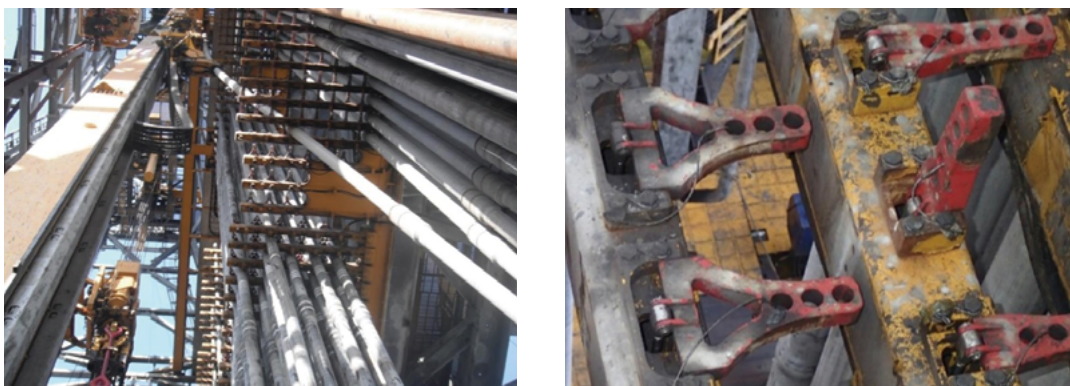
While removing the 32nd section of pipe, a pipe latch failed to open properly, causing the pipe to bend under load of the handling equipment. As the floor hand stepped into the setback area, the latch released. The end of the pipe sprang out and the floor hand was fatally struck on the head.

Figure 8.2 Drill Pipes · Latches SOURCES Investigation Report (LIBERIA MARITIME AUTHORITY)

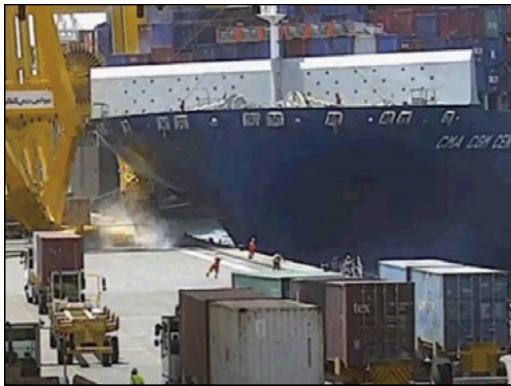
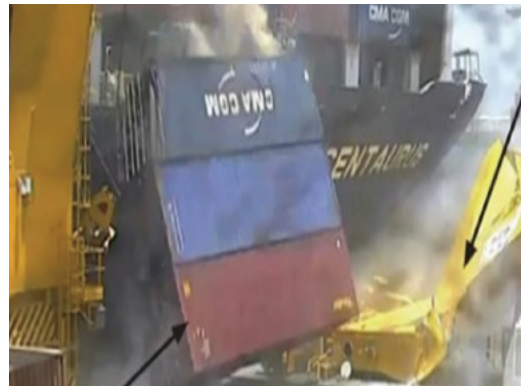
Figure 10.1 10.2 Heavy contact with quay SOURCES www.porttechnology.org/news

- A detailed and appropriate pilotage plan was not prepared beforehand and the chosen position for turning in basin did not take the conditions at scene fully into consideration.
- The two tugs were not connected, so they could not be used to help reduce the vessel's speed.
- The master was not able to fully fulfil his role of assistance and supervision, as a result of his over trust in pilot and the absence of a detailed, fully communicated pilotage plan.
- Precautionary measures identified from risk assessment about the berthing operation were not fully implemented and no sufficient emergency actions were taken, i.e. let go both anchors.
- The company's shore base did not provide sufficient instruction and support to ship regarding the pilotage operation.

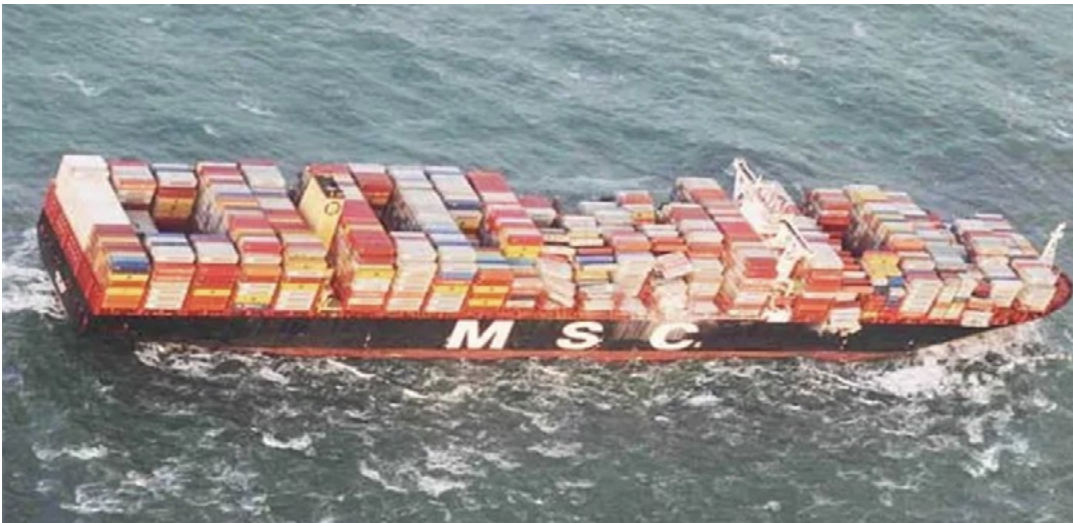
Figure 15 Loss of 342 container in storm SOURCES <http://maritimepost.com>
