2023년도 주요 해외 해양사고 교훈사례집

중앙해양안전심판원

**2023
LESSONS LEARNED
FROM MARINE SAFETY
INVESTIGATION
REPORTS**

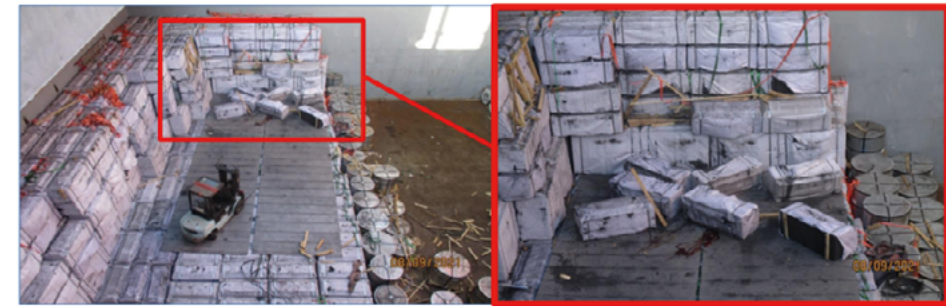
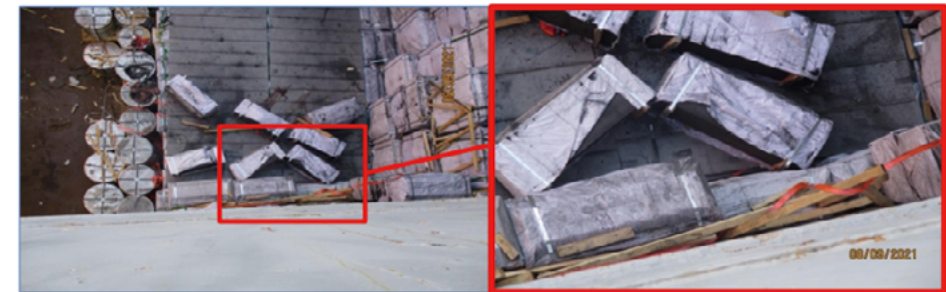
Image 10: Horizontal View of Fallen Cargo Block

허용적재
높이 초과

조사 결과 해당화물이 비표준 단위화물임에도 불구하고 하역 작업 중 허용 가능한 화물적재 높이를 초과하도록 내버려 둔 점과, 효과적인 모니터링 및 의사결정 메커니즘 없이 진행된 작업방식이 이번 사고발생의 원인으로 드러났다.

- 해운회사는 여러 업무에 포함된 위험요소를 분명하게 파악하기 위해 안전관리체계(Safety Management System, SMS) 절차를 검토하고 선대에 그에 따른 분명한 지침을 제공해야 한다.
- 선내 선적/하역작업에 참여한 터미널 운영사/하역회사는 작업에 앞서 위험평가를 효과적으로 수행해야 한다.

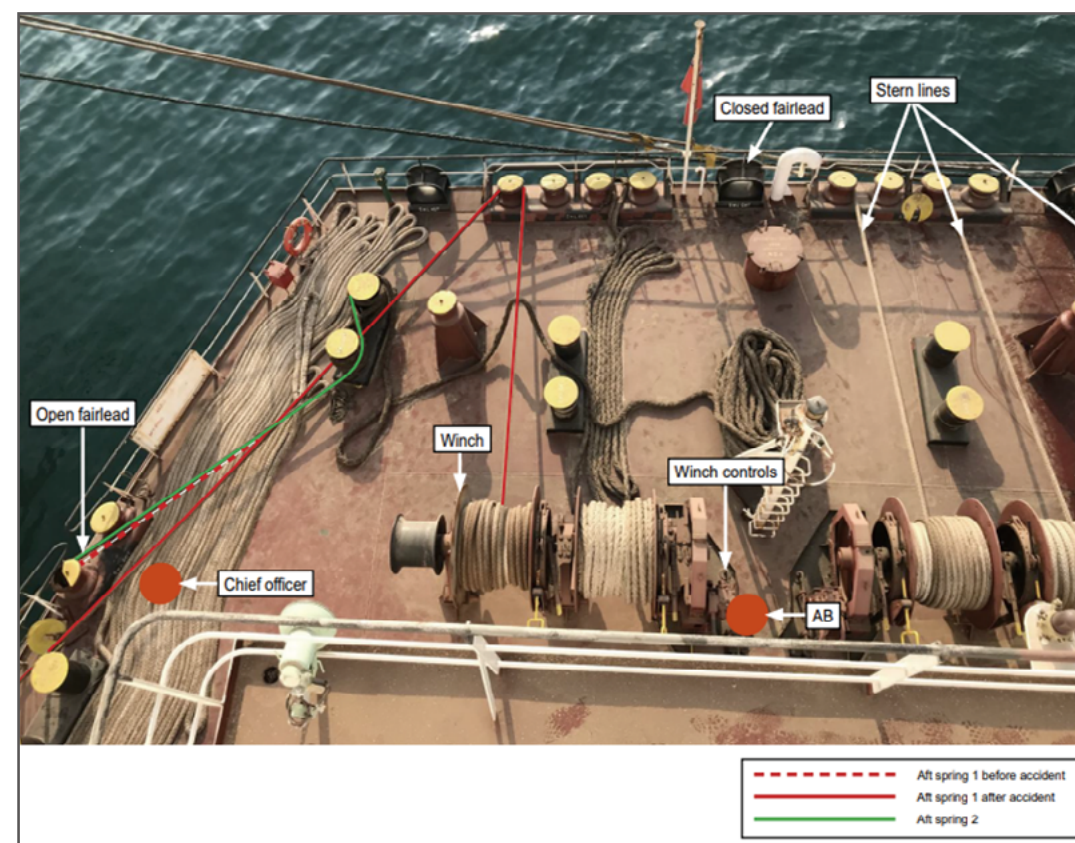
- 페어리드가 개방형이었기 때문에 계류작업 중 계선줄이 튀어 올랐고 두 선박의 높이 차이가 증가하여 계선줄이 화물작업을 하는 동안 위험하게 위쪽으로 향하였다.
- 두 개의 계선줄을 하나의 페어리드로 연결하여 공간이 부족해졌고, 이것이 계선줄을 페어리드로 부터 튀어 오르게 한 원인 중 하나로 추정된다.
- 계류작업을 시작했을 때 일등항해사는 팽팽해진 계류줄에 가까운 위험구역에 위치하던 중 심각하게 부상을 당했다.
- 당직이 끝난 선원들은 휴식중이었고, 선장은 그들의 휴식시간을 방해하지 않으려 계선작업에 불충분한 인원이 배치되었다.
- 시간적인 여유가 없고 선원이 STS 작업에 익숙하지 않았기 때문에 계류작업에 대한 계획이 불충분했다.
- 선원이 STS 작업에 익숙하지 않았고 SMS에 해당 작업에 대한 가이드가 없었다.

- 선내 작업에 충분한 수의 인원을 배치하는 것이 중요하다. 이 사고에서 선미 계류설비장소에 두명의 선원만 배치된 것은 안전하게 계류작업을 수행하는 데 불충분했고, 결국 일등항해사가 위험구역에 위치하게 되었다.
- 액체화물의 STS 작업에 대해서는 산업계에서 활용되는 문서화된 지침서가 충분하나, 산적 고체화물에 대해서는 제한적이다. 사고선박의 SMS에는 고체화물의 STS 작업에 대한 절차 또는 계선줄을 이용한 계류작업의 절차서가 없었다. SMS는 선박에서 발생할 수 있는 작업의 적절한 수행에 관한 지침을 포괄적으로 정하고 있어야 한다.
- 작업과 관련된 모든 위험을 식별하고 해당 위험의 통제 방안을 마련할 수 있도록 선내 작업은 적절한 계획에 따라 진행되어야 하고, 작업 전에 위험도 평가와 안전 정보 제공이 이루어져야 한다.
- 적절한 장비가 작업에 사용되어야 하고 선원은 해당 장비의 제약에 대해 충분히 이해하고 있어야 한다.

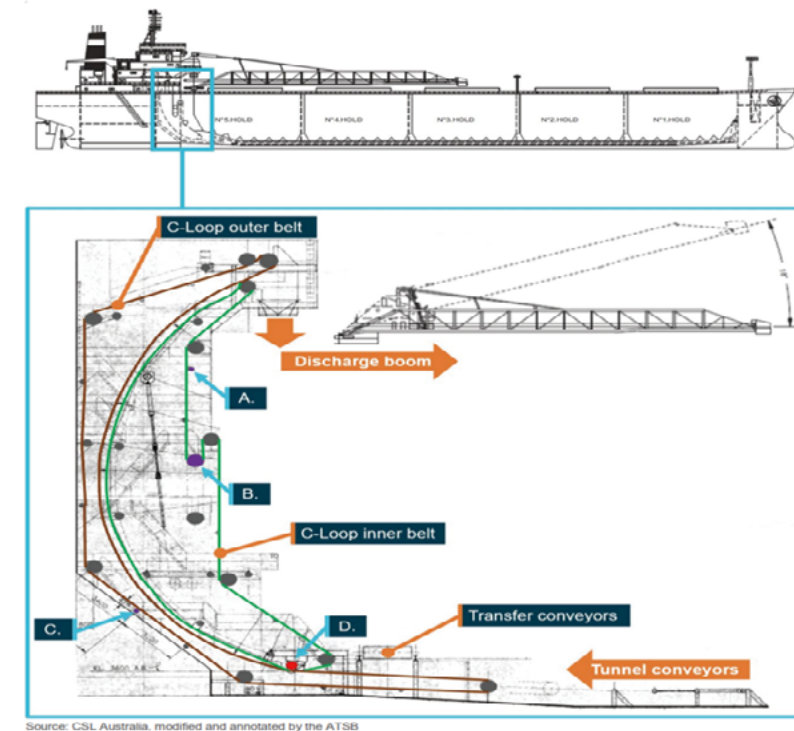
Figure 20: Location of idlers and pulleys of relevance to the fire investigation

조사에 따르면 화재는 선내 C-Loop 공간에서 시작되었고 선박의 컨베이어 장치에 있는 손상된 베어링으로 인한 발열로 고무 컨베이어 벨트에 발화되어 발생되었을 가능성이 있다. 또한, 선박에는 선내 SUL 공간에서 발생한 화재에 대한 비상대응계획이 없었으며 비상대응을 하는 동안 선박의 경보장치에 기술적 결함이 있었다는 점이 조사를 통해 밝혀졌다. 게다가 선박의 화재대응은 일부 화재의 확산에 기여하였고 또 다른 측면에서는 선내 화재진압 역량을 제거하여 화재위험을 높였다.

조사에서는 선박 C-Loop 공간에서 화재위험이 확인되었고 화재발생 약 5년 전 선사가 이를 허용불가한 수준인 것으로 기록했다는 사실이 밝혀졌다. 이 위험등급을 받은 것은 주로 SUL 공간에 화재탐지 및 화재진압을 위한 효과적인 수단이 없었기 때문이었다. 그러나 이를 해결하기 위해 취한 조치는 부적절하거나 비효과적이었다. 특히 SUL 선박의 화재 안전성과 관련된 적절한 규제요건이나 표준이 불충분한 점은 해당 선박을 포함하여 일부 화재발생 건의 요인이었다. 또한 선박의 안전관리체계는 이 조사에서 확인된 안전요소, 또는 선박에 내재된 높은 화재 위험성 및 해당 위험성 관리와 관련된 결함들을 확인하지 못한 것으로 이번 조사를 통해 밝혀졌다. 추가적으로, 조사에서는 육상 소방관의 해상화재 진압 역량과 관련된 안전사항뿐 아니라 선상 훈련 및 항만의 비상대응계획의 불규칙한 실시와 관련된 기타 안전사항이 확인되었다.

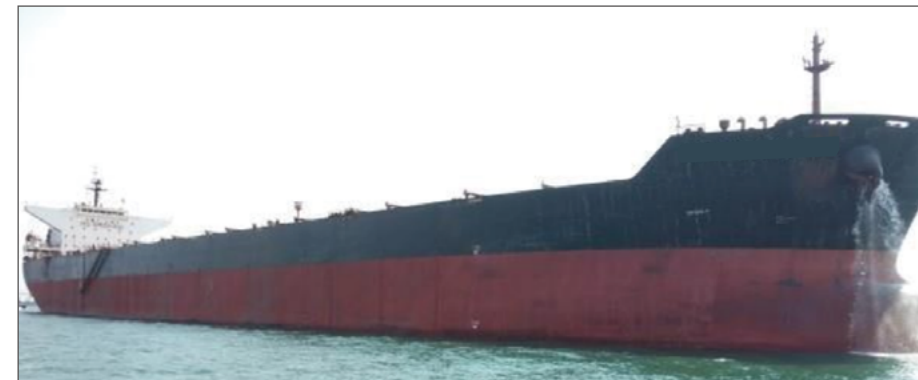
사고 당일 아침, 악천후 경보를 받았으나 작업계획에 반영하지 않았다. 상황이 악화되어도 갑판작업은 계속되었다. 악천후 지침은 강력하지 않았으며 어디까지가 악천후인지 그 경계가 명확하게 나와 있지 않았다. 갑판작업을 중단하기로 한 결정은 제 때 내려졌지만 악천후 체크리스트에 따라 헐거운 물품들을 고정하기 위해 갑판으로 간 선원들은 추가적인 보호장치를 받지 못했다. 선박은 하기 만재흘수선까지 선적되어 있었으나 동기 만재흘수선에서 겨우 13해리 떨어진 위도가 상대적으로 높은 동기계절대에 있었다.

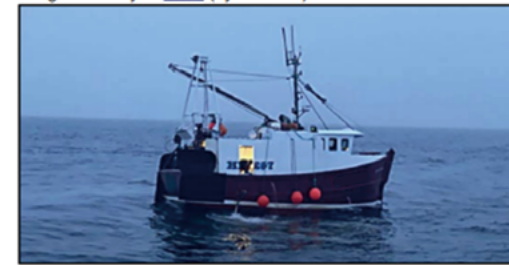
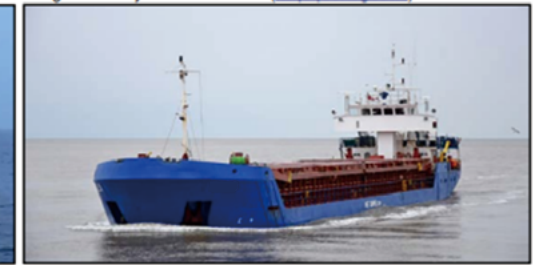
연안 인근에서 항해하던 연안 일반화물선이 제한된 시계 속에서 선체가 목재로 된 어선과 충돌하였다. 어선은 중대한 손상을 입었고 좌현으로 예인되는 동안 침몰하였다. 화물선은 경미한 손상을 입었다. 부상자는 없었다.

두 선박 모두 당직항해사가 효과적인 경계를 유지하지 않아 안개 속에서 충돌하였다. 어선의 경우 조타실에 아무도 없었으며 일반화물선의 경우 OOW는 행정업무를 하느라 경계에 집중하지 못했다. 일반화물선의 당직인원들은 레이더로 어선을 발견하였으나 상호 연계된 AIS 신호가 없었기에 레이더로 탐지되는 물체의 유효성을 육안으로 확인하려 시도하는 바람에 항로를 변경하려는 결정이 크게 지연되었다. 충돌 당시 두 선박 모두 국제해상충돌예방규칙(COLREG)에서 정의한 바와 같이 동력으로 운항되는 선박이었으며 규정에 따른 음향신호를 발신하지 않았다.

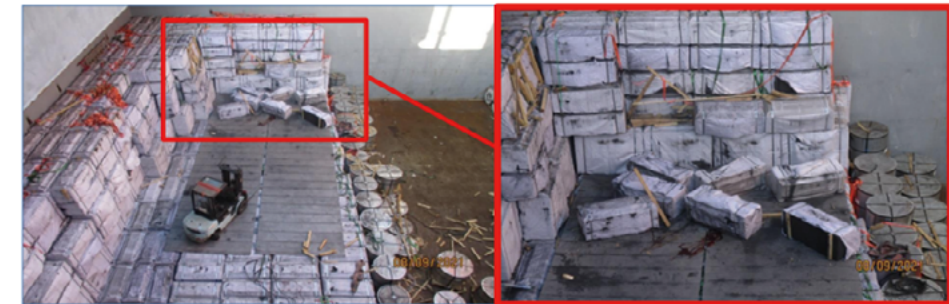
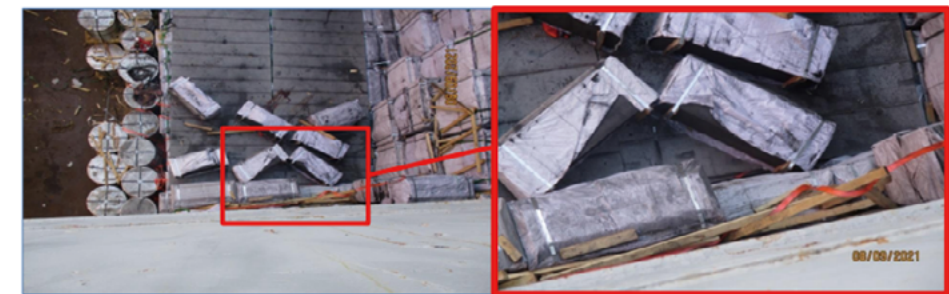
Image 10: Horizontal View of Fallen Cargo Block

It was concluded that the factors that contributed to the accident were leaving the stacking level of the load units over the tolerable level during the unloading procedure, not taking into account the balancing considerations produced by the non-standard sizes of load units, and the way the job was done, with no effective monitoring and decision-making mechanisms.

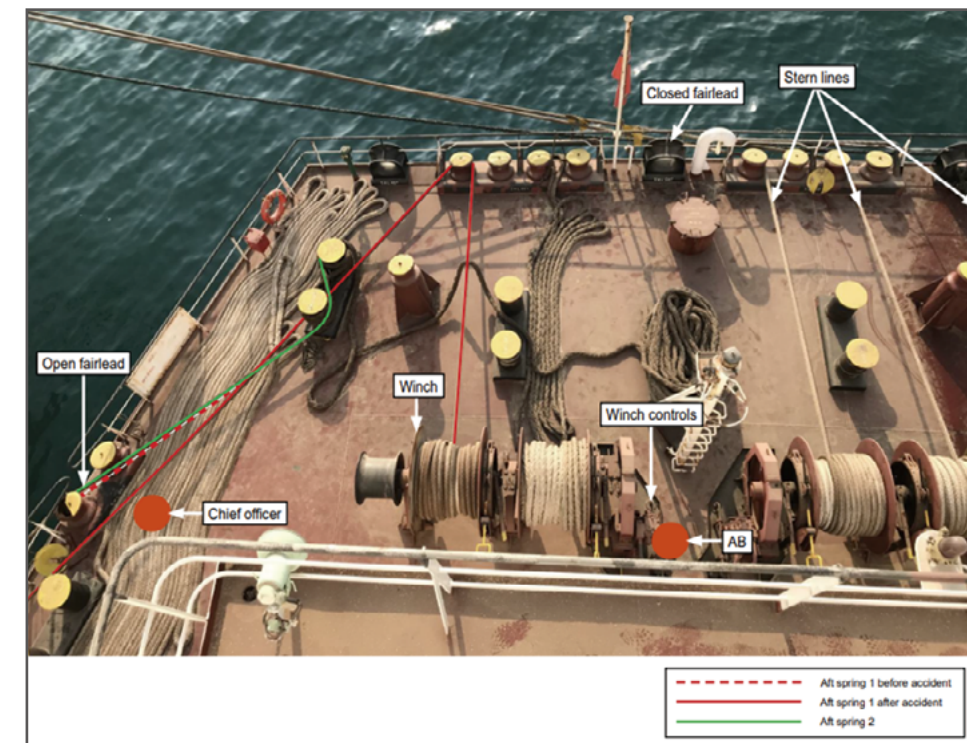
- The mooring line sprang free because the fairlead in use was open and the lines had adopted a hazardous upward lead caused by the difference between the vessels' freeboards that had developed while the during cargo operations.
- Leading two lines through the same fairlead restricted the space available and almost certainly contributed to the mooring line springing out of the fairlead and snapping tight.

- Operations need to be properly planned, risks assessed and the subject of a safety brief before they begin so that all hazards involved can be identified and appropriate control measures put in place. In this instance, the risk of the spring line jumping out of the fairlead had not been appreciated and the warping operation not sufficiently planned. Furthermore, the effect of the change in relative freeboard that had developed during the time the cargo operation had been under way had not been considered.

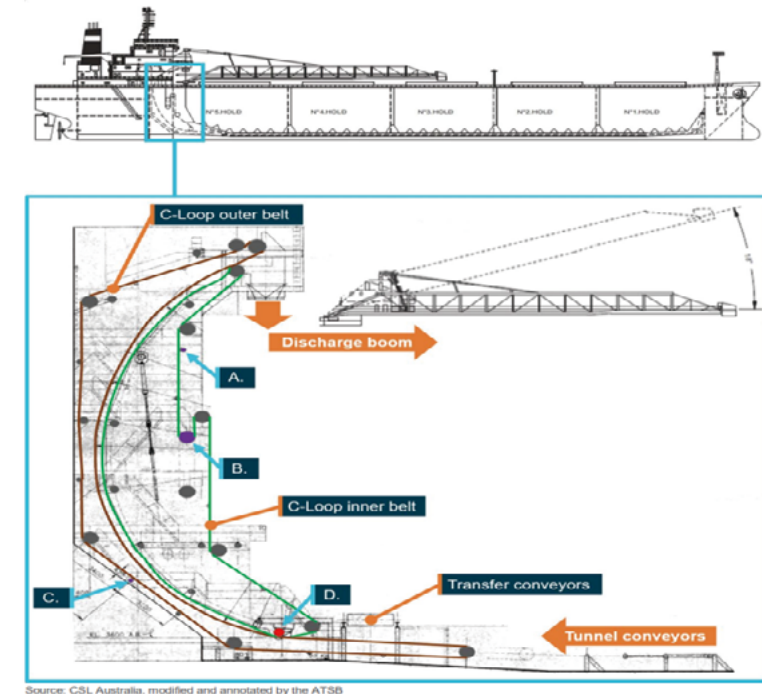
Figure 20: Location of idlers and pulleys of relevance to the fire investigation

The investigation concluded that the fire originated in vessel's C-Loop space and was likely the result of a failed bearing in the ship's conveyor system which created the heat necessary to ignite the rubber conveyor belt. The investigation also determined that the ship did not have an emergency contingency plan for responding to fire in the ship's SUL spaces and that there were technical failures of the ship's alarm systems during the emergency response to the fire. Furthermore, some aspects of the shipboard response likely aided the fire's development while others increased risk by removing shipboard capability.

The investigation found that the risk of fire in the vessel's C-Loop space was identified and documented by the ship's operators as being unacceptable about five years before the fire.

This risk rating was primarily due to the absence of an effective means of fire detection and fire suppression for the SUL system spaces. However, measures taken to address the risk were either inadequate or ineffective. Furthermore, the lack of adequate regulatory requirements or standards related specifically to the fire safety of SUL ships have been a factor in several fires, including the ship. The investigation also identified that the regulatory oversight of the vessel did not identify any deficiencies related to the safety factors identified by this investigation, or to the ship's inherent high fire safety risk and management of that risk.

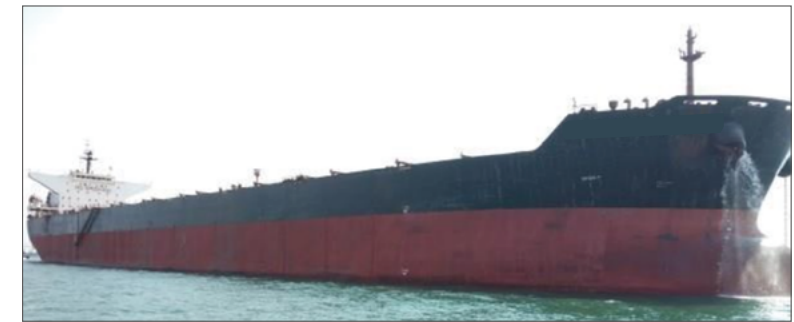
A heavy weather warning had been received that morning but had not been incorporated into the work plan – tasks on deck continued as conditions deteriorated. Guidance on heavy weather was not robust and did not include a threshold for what constituted heavy weather. The decision to stop work on deck was made in time but no additional protection was afforded to the crew who went on deck to secure the loose items in line with the heavy weather checklist. The vessel was loaded to its summer draught but was in relatively high latitudes in winter, just 13 nautical miles from the winter zone load line.

When expecting heavy weather, a timely termination of all operations on deck is vital to ensure the safety of the crew. If the crew are required to go on deck during deteriorating weather conditions, a thorough risk assessment should be performed and effective risk reduction measures, such as adjusting course and speed, implemented. Personal Protective Equipment (PPE) such as a harness, safety line and a floatation device should be worn as a minimum.

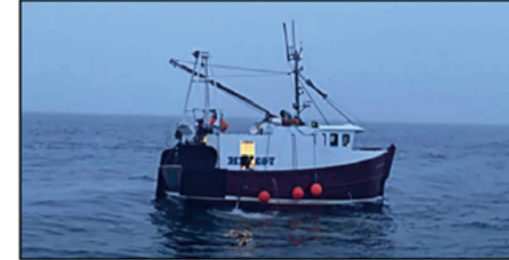
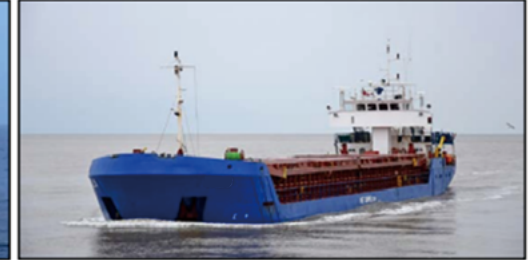
In the afternoon, while navigating close to the coast, a coastal general cargo ship collided with a wooden hulled fishing vessel in restricted visibility. The fishing vessel was severely damaged and sank while being towed to port. The cargo ship suffered minor damage. There were no injuries.

The vessels collided in fog because neither watchkeeper was keeping an effective lookout: the wheelhouse on board the fishing vessel had been left unattended and the officer of the watch onboard the cargo vessel was distracted from lookout duties with administrative work. The general cargo ship did detect the fishing vessel on radar but, as it did not have a correlating
