# 2018년도 주요 해외 해양사고 교훈사례집

해양수산부  
중앙해양안전심판원

IMO 협약이행 전문위원회  
5차, 2018년

# LESSONS LEARNED FROM MARINE SAFETY INVESTIGATION REPORTS

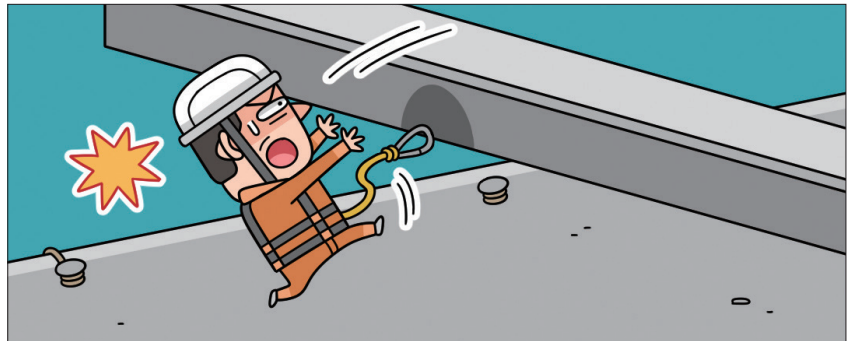
36,000GT 벌크선의 갑판장이 자신이 작업하던 6m 높이의 화물 크레인 그랩(grab)에서 내려가려고 준비하던 중 추락해 중상을 입고 사망했다. 이 선박은 석탄을 싣고 항해 중이었다. 다수의 선원이 주갑판에 적재된 화물 크레인 그랩의 와이어 로프 교체 작업을 부여받았다. 날씨는 양호했고, 고공 작업 허가를 포함, 필요한 고공 작업 예방 조치는 취해진 상태였다. 작업은 아침에 시작해 저녁에 마무리되었다. 선원 2명이 먼저 그랩에서 내려온 후 갑판장이 내려올 준비를 했다. 갑판장은 안전 장구 랜야드를 풀 직후 발을 헛디디면서 약 5m 아래 플랫폼 난간으로 떨어졌고, 다시 그 아래 갑판으로 1m 더 추락했다. 그는 머리에 부상을 입었다. 응급처치 후 갑판장은 선박의 병원으로 옮겨졌으나 사고 후 약 1시간 만에 사망했다.

- 갑판장은 그랩에서 내려오기 위해 안전 장구를 끈 직후 발을 헛디뎠다. 선박의 절차에는 고공 작업장 접근 및 퇴장 관련 위험이 언급되어 있지 않았으며, 그랩을 오르내리는 것에 대한 위험 평가가 있었는지는 판단할 수 없었다.
- 그랩의 모양과 크기, 위치로 보아 손으로 잡고 발로 딛기가 어려웠음을 알 수 있고, 갑판장은 이같은 위험에 대해 자신이 감당 및 통제할 수 있는 수준의 위험이라고 인식한 것으로 판단되었다. 선상에 준비된 추락 방지 장치는 수직 이동에는 적합하지 않았지만, 충격 흡수 더블 랜야드와 같은 장비의 사용이 더 적합했을 것이다. 해당 장비는 작업 위치로 올라가거나 그로부터 내려오려면 안전 장비를 반드시 풀어야 하는 형태였다.

- 고공 추락 위험을 적절히 해결하기 위해서는 선상에 충격 흡수 더블 랜야드 등 적합한 추락 방지 장비가 제공되어야 한다.
- 고공 작업을 위한 선상 절차 및 허가증에는 작업 위치로 오르내릴 때의 위험을 포함, 작업의 모든 단계에서 발생할 수 있는 추락 위험에 대해 다루어야 한다. 항로의 진행 순방향에서 항해하는 것은 충돌 위험을 최소화할 수 있는 한 가지 방법이다.
- 객관적이고 탄탄한 위험평가 절차는 고공 작업 위험에 대한 개인의 위험 인식 문제가 사고 발생 요인이 되지 않도록 보장할 수 있다.
- 선원들은 너무 빨리 안전 도구를 푸는 것의 위험을 인식하고 안전한 위치에 있기 전까지는 안전 장비를 해제해서는 안 된다.

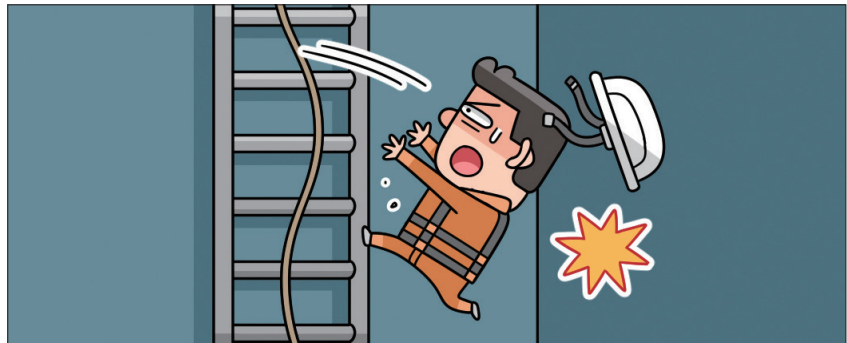
선박이 동중국해에서 공선 항해를 하던 중 선창 청소가 진행 중이었다. 풍력등급 3 수준의 바람과 낮은 파도 등 기상 상태는 양호했다. 선원들은 고압 물 분사기를 사용해 선창 호퍼 구조물의 일부인 비스듬한 격벽에서 이전 화물의 잔여물을 제거하고 있었다. 선원들은 격벽 상부에 접근하기 위해 경사진 격벽에 딱 붙어있는 사다리를 사용하고 있었다. 사다리의 꼭대기는 밧줄로 고정시켰고 바닥 쪽은 선원 한 명이 지지하고 있었다. 그리고 선원 한 명이 사다리를 타고 올라가 화물 잔여물을 제거하기 위해 물줄기를 격벽에 뿌렸다. 사다리에 올라간 선원은 사다리 위에 올라가 있는 동안 자신의 안전 장구에 부착된 안전선의 지지를 받고 있었다. 안전선은 격벽 상부의 패드 아이(pad eye)를 통과해 아래쪽 탱크 위에 있는 다른 선원이 제어했다. 이것은 오랫동안 행해진 선창 청소법이었다. 이 사고의 경우, 사다리에 올라서 있던 선원이 옆부분으로 사다리를 옮기기 위해 탱크 꼭대기로 내려가고 있었다. 탱크 꼭대기에서 위로 1m 정도의 위치에서 선원이 멈추어 안전선을 푸는 순간 균형을 잃고 뒤쪽 탱크 꼭대기로 넘어지면서 머리를 부딪쳐 의식을 잃었다. 부상당한 선원은 헬리콥터로 후송되었다. 선원들의 응급조치와 헬리콥터에 탑승한 의료 요원의 처치에도 불구하고 병원에 도착하자마자 사망 선고를 받았다. 사인은 두부외상이었다.

- 사고를 당한 선원은 탱크 위에 다다르기 전에 안전선을 풀었다.
- 선원의 안전모는 턱 끈으로 고정되어 있지 않아 추락하면서 벗겨졌다. 직접적인 이것이 사고 유발원인은 아니었지만, 안전모가 머리에 계속 씌어 있었다면 머리를 충분히 보호해서 해당 사고에서와같이 비교적 낮은 고도에서의 추락으로 인한 부상을 줄여줄 수 있었을 것이다.

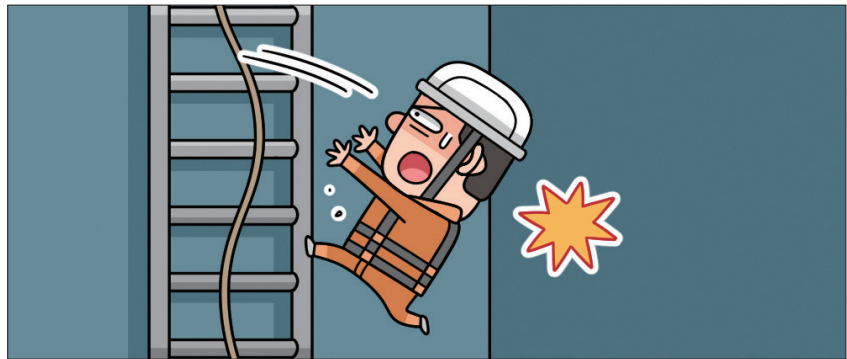
이 작업에는 선창 격벽 구석을 손으로 청소하는 것도 포함되어 있었는데, 이를 위해서는 고공 작업을 위한 이동식 알루미늄 사다리를 사용해야 했다. 선원 중 1명이 사다리를 올라갔고 선창의 탱크 상부 위 4m 높이에서 작업을 수행했다. 안전 장구와 랜야드를 착용하고 있었던 선원은 작업을 마치자마자 랜야드를 풀었다. 그때 균형을 잃은 선원은 2m 밑 경사진 측면 격벽으로 추락한 후 탱크 상부로 2m 더 굴러갔다. 선원은 선박의 병원으로 옮겨진 후 육상의 병원으로 후송되었고, 그곳에서 부상으로 사망했다.

- 사고를 당한 선원이 서 있던 곳에는 발이 걸려 넘어질 위험이 있는 곳이 몇 군데 있었다.
- 이동식 사다리를 기대 놓은 격벽 표면이 고르지 않았다.
- 선원이 랜야드를 풀 후 균형을 잃었을 때 추락을 방지할 수단이 전혀 없었다.
- 추락을 막을 수 있는 장치가 전혀 없었다.
- 선원들은 랜야드를 풀고 나면 개인의 주의와 경계만으로 사다리에서 추락하는 것을 막기에 충분하다고 인식하고 있었다.
- 해당 작업에 대한 감독이 이루어지지 않았다.
- 선창 내 추락 위험이 선박의 안전관리시스템에 구체적으로 명시되어 있지 않았고, 위험 평가에서도 파악되지 않았다.

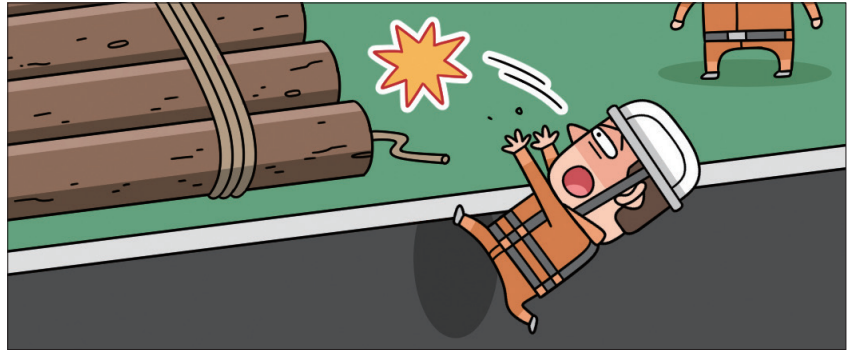
목재 운반 벌크선이 정박지에서 통나무를 선적하고 있었다. 1번 선창 위쪽 갑판에 통나무를 선적하는 작업이 완료되고, 다른 선창에서 선적 작업이 진행되는 동안 선원들은 1번 선창 위에서 목재를 묶고 있었다. 목재를 묶던 갑판원 한 명이 해상으로 추락했고 다른 갑판원이 구조를 위해 바다로 뛰어들었다. 다른 선박들의 지원을 받아 며칠에 걸쳐 광범위한 수색을 펼쳤지만 추락한 갑판원은 끝내 발견되지 않았다.

- 갑판원의 추락 원인은 확인되지 않았다. 그는 커버올(coveralls) 형태의 작업복과 장갑, 안전모, 징이 박힌 작업용 덧신을 착용하고 있었다.
- 사고를 당한 갑판원은 경력 선원이 아니었으며, 통나무 고정 작업의 경험이 없었을 뿐만 아니라 통나무 더미 위에서 작업할 때 발생할 수 있는 위험에 대해 선임 선원들로부터 교육이나 설명을 듣지 못했다.
- 보호 라인이나 난간은 설치되어 있지 않았고, 사고를 당한 갑판원도 적절한 추락 방지기에 연결된 안전 장구를 착용하고 있지 않았기 때문에 통나무 더미에서 추락할 때 이를 예방하거나 저지할 수 있는 장치는 전무했다.
- 바다로 떨어졌을 때 갑판원은 생존에 도움이 되는 구명조끼나 부양 장치를 착용하고 있지 않았다.
- 선박의 안전 관리 매뉴얼에는 통나무 더미 위에서 작업 시 안전선이나 안전 장구의 착용을 의무화하는 내용이 전혀 포함되어 있지 않았다.

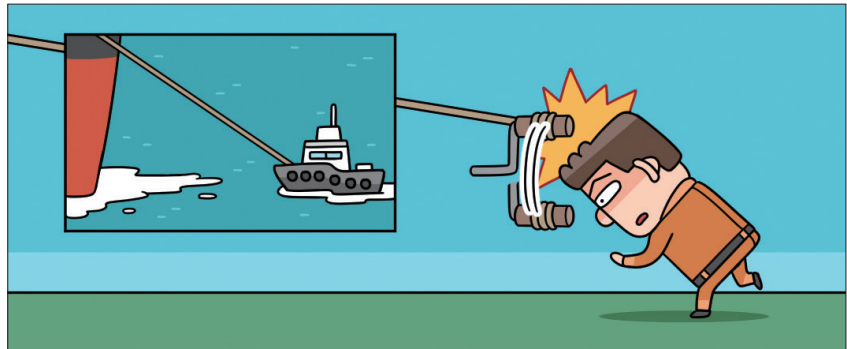
선원들이 일상적인 퇴선 연습을 실시하는 동안 16,000GT 벌크선이 정박지에 정박하기 위해 대기 중이었다. 밀폐형 대빛에서 발진된 구명보트가 작동되지 않아 회수하던 중이었다. 선박의 전기 기사가 호출을 받고 보트 갑판에 나와 윈치 컨트롤러의 고장 원인을 파악하고 있었다. 그동안 선장은 갑판장과 갑판원, 그리고 선원 한 명에게 수동으로 보트를 회수할 것을 지시했다. 선원들은 보트를 올리기 위해 수동 크랭크 핸들을 끼웠다. 전기 기사는 갑판장으로부터 모터에 관해 들은 뒤, 전원을 복구하기 위해 스위치 보드 위치로 갔다. 구명보트의 갑판에서 모터가 돌기 시작했고, 모터와 함께 호이스팅 슬롯에 끼워져 있던 수동 크랭크 핸들이 몇 바퀴 돌면서 핸들 가까이에 서 있던 갑판장과 갑판원을 쳤다. 갑판장은 회전하는 핸들에 머리를 맞아 두개골에 부상을 입었고, 갑판원은 엉덩이 부분에 가벼운 타박상을 입었다. 갑판장은 선상에서 사망했다.

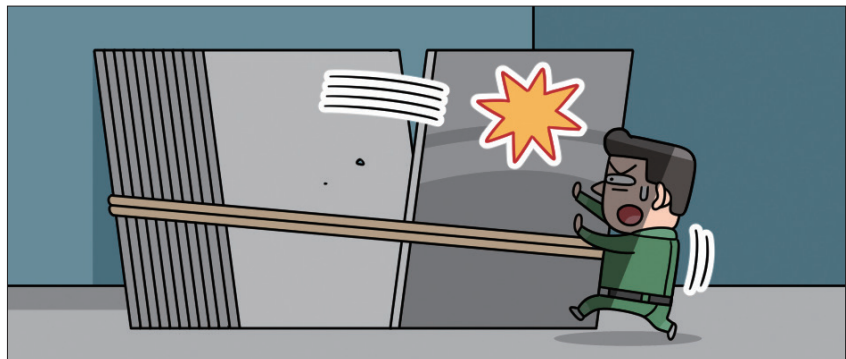
12,000GT 화학물/제품 운반선이 화학물의 선적을 완료한 후 정박지에서 다음 기항지 명령을 기다리고 있었다. 기관실 선원들은 설비 제작 작업 준비를 시작했다. 이 작업을 하려면 선박 크레인의 난간을 제작하기 위해 강판을 기관실 작업장으로 옮겨야 했다. 강판 11개는 조타장치실 옆 구역 기관실 구조물에 수직으로 적재되어 있었고 넘어지지 않도록 쇠줄로 서로 고정되어 있었다. 기관사 2명과 기관실 선원 1명으로 구성된 기관실 인원 3명이 쇠줄을 풀기 시작했다. 쇠줄이 제거되면서 횡파로 인해 선박이 흔들렸고 강판이 선원들 쪽으로 쓰러졌다. 강판의 양 끝에 배치되어 있던 기관사 2명은 떨어지는 강판을 피했지만, 강판 중간에 있던 선원은 피하지 못했다. 약 900kg 무게의 강판에 깔린 선원은 다발성 손상을 입었다. 그는 육지에서 치료를 받기 위해 중개회사가 마련한 들것에 실려 기관실에서 쾌속정으로 옮겨졌다. 선원을 소생시키려는 시도는 실패로 돌아갔고, 선원은 병원으로 이송 중에 사망했다. 해당 작업 전 팀에서는 툭박스미팅을 실시했다.

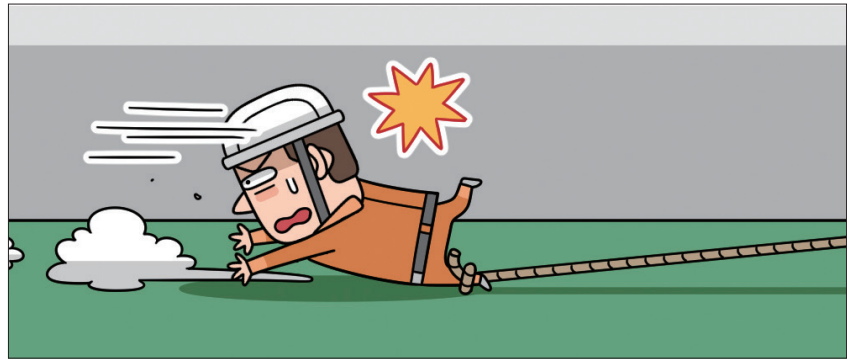
21,000GT 화학물/제품 운반선이 예인선의 지원을 받아 도선사의 안내 하에 정박지에 접근 중이었다. 선박이 우현 쪽으로 방향을 선회해야 했기 때문에 선수에서 전방 예인선이 발진되게 되어 있었다. 예인줄의 이음매는 선수루 말뚝에 고정되어 있었고, 이음매에는 메신저 밧줄이 연결되어 있었다. 예인줄은 쉽게 풀릴 수 있도록 느슨하게 매어진 상태였다. 갑판원은 폐쇄 축(closed chock, Panama lead)을 통해 밧줄을 느슨하게 풀고 메신저 밧줄을 기둥에 돌려 묶었다. 선박은 정박을 위해 계속해서 우현으로 선회하고 있었고 예인줄은 물속에 잠겨있었기 때문에 메신저 밧줄이 폐쇄 축에서 풀려나오는 속도는 빨라지기 시작했다. 계류 작업 담당 항해사는 갑판원에게 메신저 로프에서 비켜서라고 경고했다. 갑판원이 좌현에서 우현 쪽으로 기둥 사이를 이동할 때 기둥에서 밧줄이 풀리는 속도가 빨라졌다. 갑판원은 갑판 위로 넘어졌고 다리에 밧줄이 엉킨 채로 끌려갔다. 갑판원의 몸은 단일 포인트 계류 체인 스톱퍼 근처의 구조물과 충돌한 후 파나마 축을 통과해 선박 밖으로 끌려갔다. 그는 예인선의 지원으로 바다에서 구조되어 응급처치와 심폐소생술을 받았고, 응급치료 요원들에 의해 병원으로 후송되었지만 다음 날 사망했다.

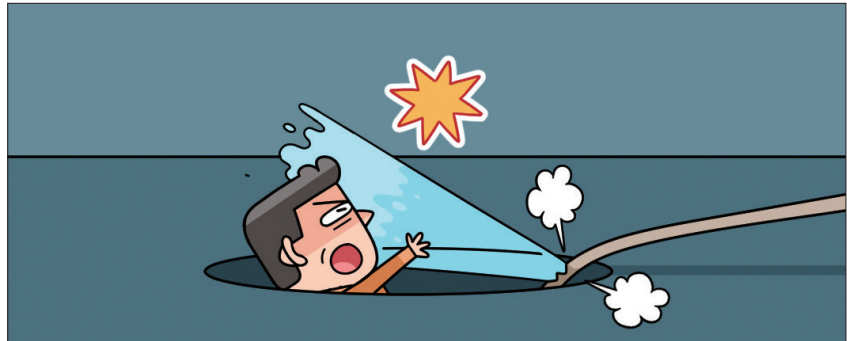
이른 아침 선박이 도착했을 때, 당직 기관사가 주기관 터보 차저 드레인(turbo charger drain)에서 물이 새는 것을 발견했다. 보일러/이코노마이저의 누수를 의심한 기관장은 누수 점검을 하고 오전 정규 근무 시간 중에 수리할 수 있도록 해당 장치를 차단하라고 지시했다. 약 5시간 후, 2등기관사는 설비 기술자와 함께 보일러실 인원 진입에 필요한 모든 안전 예방 조치를 취한 후 바닥 맨홀 문을 통해 보일러실로 들어갔다. 그들은 물이 새는 보일러 튜브를 찾아 아래쪽에서부터 구멍을 막았다. 이들의 다음 계획은 해당 튜브를 보일러의 위에서부터 연결한 다음 보일러를 재가동하는 것이었다. 설비 기술자가 바로 뒤에 있는 상태에서 2등기관사가 바닥 맨홀 문을 통해 퇴실하던 중 삽입되어 있던 보일러 튜브 마개가 빠지면서 튜브 일부가 함께 작게 찢겨 떨어져 나갔고, 보일러수 드럼의 뜨거운 물과 증기, 연기가 새어나가 설비 기술자를 덮치면서 설비 기술자는 즉사했다.

- 안전관리시스템에 보일러 작업에 대한 위험 평가 절차가 명시되어 있지 않았다. 기관실 팀은 의도한 절차에 관련된 모든 위험 요인을 파악하지 못했다. 보일러에서 보일러수가 빠지고 감압 된 사실을 기관실 팀에서 제대로 확인하지 않았다. 2등 기관사가 피로를 느꼈을 가능성이 있다.

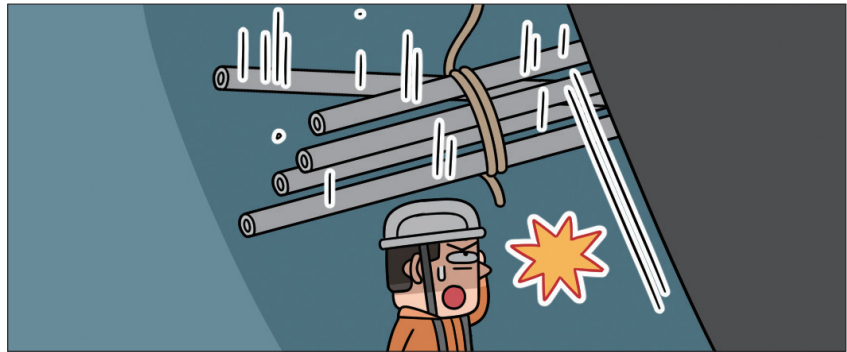
선박이 부두에 정박하고 있는 동안 무거운 스테인레스강 파이프 묶음을 선적하고 있었다. 경고도 없이 갑자기 선박이 흔들렸고, 선창 내 매달려 있던 파이프들이 견잡을 수 없이 흔들리면서 항만 노동자 3명이 매달려있던 파이프와 측벽 사이에 끼었다. 이 중 2명은 사망하고 1명은 중상을 입었다.

- 선체의 우현 해안 쪽 중앙 부분 방충재의 아랫면이 부두 방충재 위에 걸렸다.
- 간조가 되면서 화물 선적으로 흘수가 높아졌고 선박의 방충재가 갑자기 부두로부터 풀려나올 정도로 기울기가 커지면서 선박이 빠르고 심하게 흔들렸다.
- 이로 인해 선창 내 매달려 있던 파이프 묶음들이 흔들리면서 흔들리는 화물 호이스트와 선박의 측벽 사이에 갇혀있던 항만 노동자를 쳤다.

- 끊임없이 변하는 역학의 영향을 받는 선박 내, 위 또는 주변에서 작업하는 것의 위험성
- 좁고 사방이 막힌 화물 창고 내에 매달린 화물에 대한 작업을 하는 것의 위험
- 걸림 위험요소(snag hazard)를 파악해 제거하고 계류작 작업을 하는 것에 특히 주의를 기울이면서 부두에 정박한 선박의 상태를 비판적으로 평가하는 것의 가치
- 갑작스러운 선체의 흔들림을 고려해 화물 작업 계획을 수립하고 작업자 대피 구역을 파악하는 것의 가치

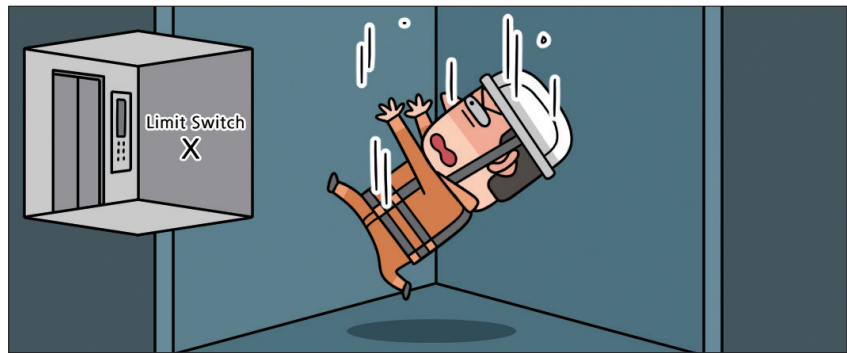
벌크선의 급식 담당 선원이 식자재 운반 승강기의 수직 통로에 빠진 채로 발견되었다. 당시 승강기는 모터가 계속 작동하는 상태로 안전 레일에서 빠져 있었다. 해당 선원은 승강기 통로에서 구조되었으나 사망한 것으로 확인되었다. 선원이 승강기 통로에 갇히게 된 경위는 확인되지 않았다.

- 원래의 회로 도면과는 달리, 승강기 문이 열렸을 때 승강기 작동을 방지하는 리미트 스위치(limit switch)가 문에 설치되어 있지 않았다.
- 승강기 제어 버튼은 단 한 번만 누르면 작동되었으며, 계속해서 누르고 있을 필요가 없었다.
- 선박이 건조된 후, 선박도 회사 직원도 승강기 문에 리미트 스위치가 없다는 사실을 알아채지 못했다.
- 식자재 운반 승강기는 선박의 정비 체계에 포함되지 않아 정기 점검이 이루어지지 않았다.

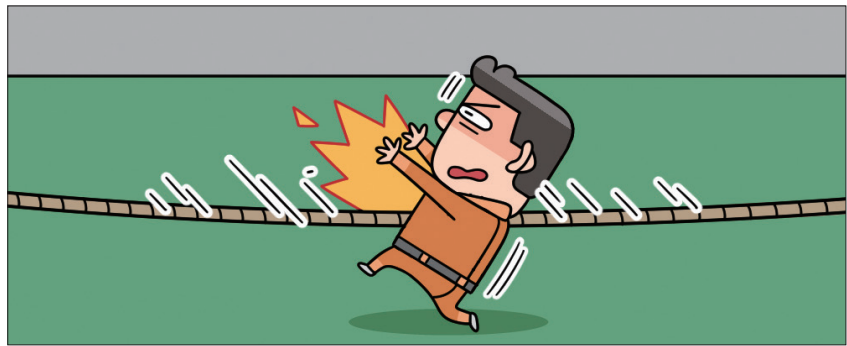
컨테이너선이 정박지를 벗어나고 있었고, 선박의 계류삭은 선박의 선미 쪽 계류 갑판에서 대기 중인 예인선 쪽으로 풀어진 상태였다. 계류삭이 고정되자, 예인선이 움직였고 이로 인해 줄이 갑작스럽게 팽팽해졌다. 계류삭은 선미 쪽 계류 갑판의 기둥에서 튕겨 나가 부근에 서 있던 선원의 흉부를 강하게 쳐 치명상을 입혔다.

- 선원이 스냅백(snap back) 구역에 서 있었다.
- 선원에 대한 감독이 적절히 이루어지지 않았다.
- 선미 쪽 계류 갑판 담당 항해사가 작업에 대해 숙지하지 못했다.
- 선미 쪽 계류 갑판 담당 항해사는 예인선의 줄 대신 배의 계류삭을 예인줄로 사용하는 것에 익숙하지 않았다.
- 예방 조치를 제대로 갖추도록 보장하기 위한 위험 평가가 제대로 이루어지지 않았다.
- 예인선과 선박 간의 의사소통이 효과적으로 이루어지지 않았다.

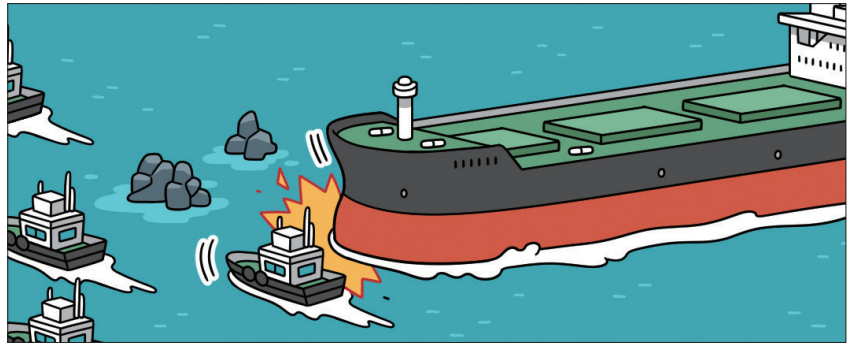
벌크선의 구상선수가 어선의 배 중앙부 우현 쪽에 부딪히면서, 어선이 심각하게 손상되어 해수가 대량 유입되었다. 이로 인해 어선은 잠시 후 좌초되었다. 어선에서는 선원 2명만 생존했고, 선교팀은 아무도 구조되지 못했다.

벌크선은 아무런 일도 없다고 생각했기 때문에 특별한 조치 없이 항해를 계속했다.

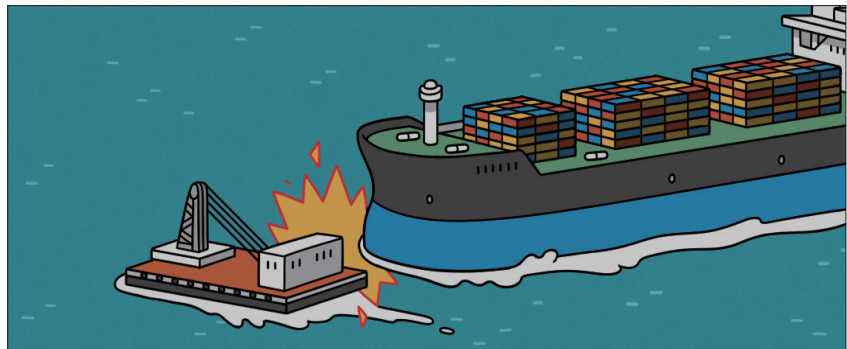
이른 밤시간에 3,000GT 화물선이 준설한 항로를 통해 출항 중이었고, 동시에 960GT 준설선이 반대편에서부터 진입하고 있었다. 시계는 양호했고 바람은 보통이었다. 화물선의 선교에는 선장과 숙련 갑판수가 조타수로 근무 중이었다. 선미 계류지점 근무를 마친 2등항해사 역시 선교로 이동했다. 2등항해사는 선교에서 AIS 장치를 켜고 엔진 텔레그래프를 맡았다. 그에 따라 AIS 신호는 충돌 1.5분 전에서야 사용할 수 있었다. 준설선의 선교 근무자는 선장뿐이었다. 준설한 해로에 진입한 후 선장은 레이더를 통해 전방의 상황을 확인했고, 레이더는 2.5마일 범위까지로 전환되었다. 선장은 그 어떤 레이더 목표물도 탐지하지 못했다. 해협의 유일한 굽이에 접근하는 동안 준설선은 항로의 가운데 지점에 근접했고 이후 코너를 가로질러 진행 역방향 항로로 향해했다. 그러는 동안 선장은 우현에서 좌현 방향으로 가로질러 가는 작은 배로 주의가 산만해져 있었다. 화물선 선장은 처음부터 준설선이 잘못된 방향의 항로로 접근하는 것을 인지하고 있었지만, 준설선이 늦지 않게 진행하여 바른 방향으로 항로를 변경할 것이라고 생각했다. 준설선의 상부 조명이 일렬로 정렬된 것을 본 화물선 선장은 충돌 위험을 인지했다. 화물선 선장은 호각을 불고 주간 신호 조명으로 불빛 신호를 보냈다. 한편 준설선으로 VHF 호출을 발신했지만 아무 반응이 없었다. 그러자 선장은 닻을 풀고 전속으로 후진하라고 지시했다. 준설선 선장은 코너 바로 앞에서 배의 방향을 바꾸기 시작했고, 항로를 변경하는 동안 화물선과 근접한 상황을 인식했다. 그는 호각 소리도 조명 신호도 알아채지 못했다. 화물선이 좌현 쪽으로 방향을 선회할 것으로 가정하고 수동 조타로 바꾼 후 방향타를 최대 좌타각으로 하고 기관은 후진 전속으로 했다. 두 선박은 잠시 후 충돌했다. 화물선이 준설선의 우현 쪽 배 중앙부에 부딪혔고, 그로 인해 준설선은 선창에 큰 구멍이 생기면서 전복되었다. 이후 준설선은 전손되었다. 화물선은 선수와 구상선수에만 경미한 손상을 입었다. 선원들의 부상은 없었고, 기름 유출로 인근 해조류 양식장에 피해가 발생했다.

- 화물선의 지휘부에서 준서선이 바른 방향으로 항로를 변경할 것이라고 너무 오랫동안 가정하면서, 항로의 오른쪽 바깥 방향으로 경로를 바꾸지도, 속도를 줄이지도 않았고, 신속하게 신호를 보내거나 VHF 호출을 보내지도 않았다.
- 선장은 준서선의 선교에 혼자 있었다. 그는 레이더에도, 전방의 해로에도 적절한 주의를 기울이지 않았고 해로의 잘못된 방향으로 항해했다.

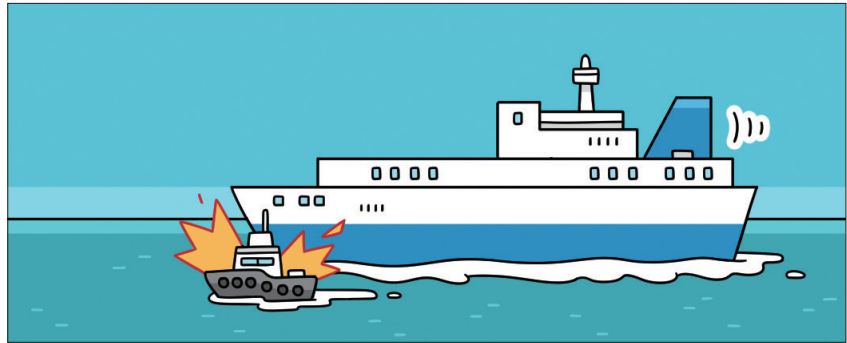
강풍 상황에서 예인선이 로로 여객선의 정박을 돕고 있었다. 여객선 선장은 해당 항구에 대한 도선 면제증을 소지하고 있었기 때문에 여객선에는 도선사가 승선하고 있지 않았다. 예인선은 예인줄을 연결하려고 시도하면서 여객선의 좌현 선수에 접근했고, 그때 예인선의 선미 쪽이 여객선의 구상선수와 충돌했다. 충돌로 인해 예인선은 여객선 앞에서 현 측이 정면이 되게 선회하면서 좌현 쪽으로 위태롭게 기울면서 침수되었다. 예인선은 결국 전복되고 선원 2명이 사망했다.

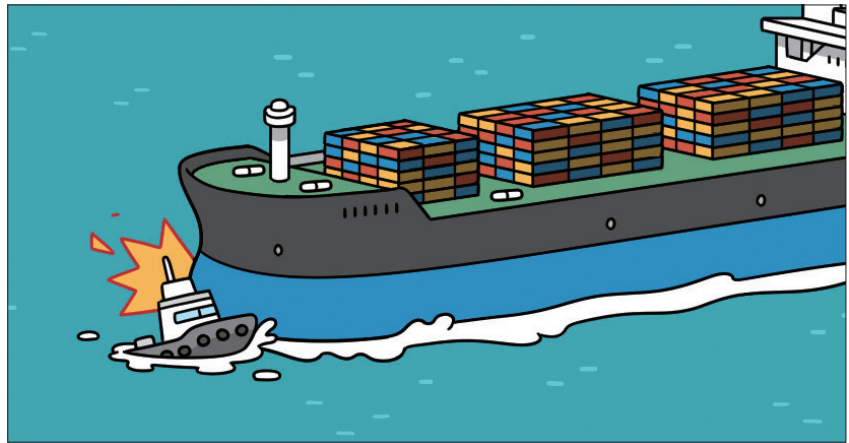
3,200GT 일반 화물선이 의무적인 도선사 안내와 선장의 수동 조타로 약 8노트의 속도로 항해하던 중 약 7노트의 속도로 항해하던 115GT 예인선과 충돌했다. 예인선은 선장의 지휘하에 숙련 갑판원이 조타하고 있었다. 충돌은 두 선박이 서로 각자의 위치와 항로를 보고한 후 야간 시간에 항로 상에서 발생했다. 일반 화물선의 선장은 자신의 항로 계획에 따라 먼저 항로의 중심부로 서서히 이동한 후 다시 동쪽으로 이동하면서 항로를 변경했다. 몇 분 후, 일반 화물선의 구상선수가 예인선의 좌현 측 선체 중앙을 들이받아 예인선이 부력을 잃고 침몰했다. 예인선에 타고 있던 선원 4명과 승객 1명은 물에 빠졌고, 몇 분 후 수로 안내선과 인근 수색 구난 선박에서 발견된 해난 구조선에 의해 구조되었다.

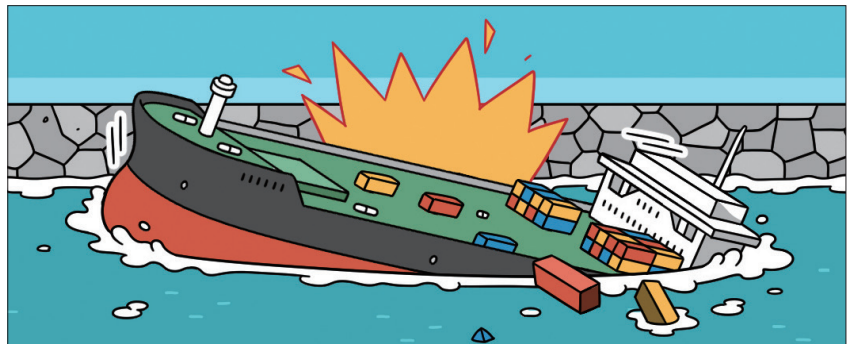
이른 아침, 선박이 항만 밖에서 단일 닻으로 공선 상태였을 때, 풍향이 바뀌고 풍속이 빨라졌으며 해상 상태가 악화되었다. 선박은 닻을 올리고 안전하게 바다로 나가려고 했으나 바람과 파도에 의해 항구의 방조벽으로 밀려 좌초한 후 침몰했고, 전손되었다. 승선 중이던 선원 18명은 부상자나 사망자 없이 무사했다.

- 선장은 해수면 분석과 해안 파도 분석표를 근거로 기상 상태가 악화될 조짐이 없다고 가정하고 기상 및 해상 상태 정보를 적절히 확보하지 않았다.
- 수로지에서는 해당 항구가 겨울철 서쪽과 북서쪽에서 불어오는 강풍과 격랑에 취약하다고 나타내고 있는데, 갑판 항해사들은 이 항구에서 겨울을 겪어본 경험이 매우 제한적이었다.
- 수로지에는 닻이 끌리거나 제 기능을 하지 못하면 선박이 해안으로 밀려갈 수 있다고 언급하고 있다.
- 선장은 공선 상태일 때 탁월풍 및 해상 상태로 인해 선박의 조종 능력에 제약이 발생한다는 사실을 이해하지 못하고 너무 늦게 출항을 시도했으며, 악천후로 인해 제어력을 상실했다.
- 결국 선박은 조종 능력을 상실했고 해안으로 밀려가 좌초했다.

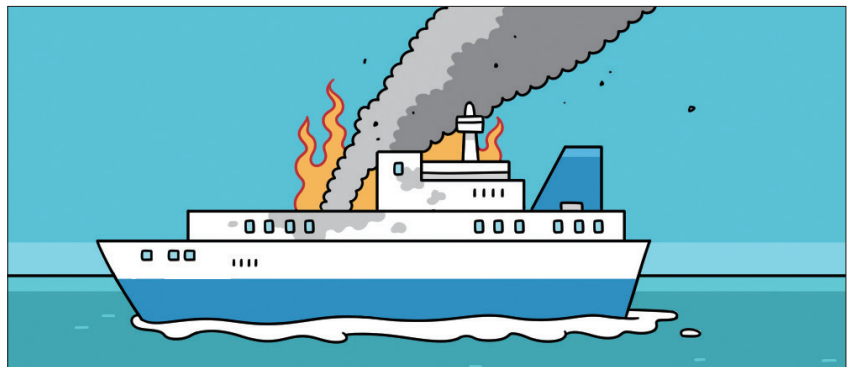
선박의 주기관 및 보조 기관에 대한 전원공급이 차단되면서 정전이 발생했다. 선장은 승객과 선원들에게 퇴선을 명령했다. 구명장비 전수를 활용할 수는 없었다. 대부분 생존자는 헬리콥터에 의해 구조되었고, 시신 11구가 수습되었다. 22명의 실종자가 더 있었고, 사망한 것으로 추정되었다. 선박은 상당한 손실을 입었다.

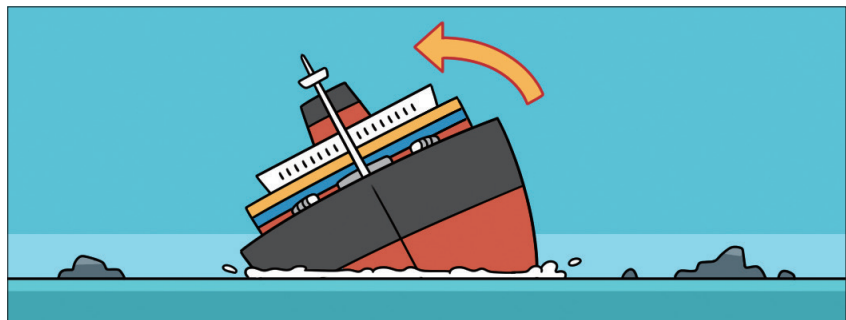
선박은 얼마 전 관리사가 바뀌고 선원이 전원 교체되었다. 이전 선원들과 간단한 인수인계 절차를 거친 후 선박은 화물을 싣지 않은 상태로 출항했다. 전임 선원들의 말에 따르면 이중 바닥 밸러스트 탱크는 전부 가득 차 있었고, 외측 밸러스트 탱크는 60~65%가량 차 있었다(전체 밸러스트 수용량의 약 80%). 교체된 신임 선원들은 밸러스트 탱크의 상태를 확인하지 않았다. 다음 항구에서 화물을 실은 총 116TEU의 컨테이너를 선창과 갑판에 선적했다(총 1,900톤으로 추정). 선원들은 밸러스트 수에 아무런 변경도 가하지 않았다. 이는 즉 선박은 선적한 화물 이외에도 전체 밸러스트 수용량의 약 80%를 여전히 채운 채 항해해야 했다는 의미이다. 선원들은 여전히 밸러스트 탱크의 상태를 확인하지 않았다. 선박은 다음 항구를 향해 출항했고, 그곳에서 최종 목적지를 향해 출발하기 전에 담수를 공급받았다. 출항 직후, 선박은 해협을 지나 북진하던 계절풍과 태풍이 결합된 악천후와 맞닥뜨린다. 선박은 좌우로 심하게 흔들리면서 우현 쪽에서부터 오는 바람과 파도를 맞아 우현으로 약 25도 기울어졌고, 약 1시간 후에는 기울기가 30도로 커졌다. 선장은 선박이 기울어진 원인은 파악하려고 시도하지 않고 조난신호를 보낸 후 12명의 선원 전원에게 구명뗏목으로 퇴선할 것을 명령했다. 구명뗏목에 타고 있던 선원들은 헬리콥터로 전원 안전하게 구조했다. 선원들이 헬리콥터에 탑승했을 때 이들은 선박이 약 45도로 기울어졌음에 주목했다. 갑판의 컨테이너는 전부 제자리에 있었고, 주기관과 발전기를 가동시킨 상태로 퇴선했기 때문에 조명이 여전히 켜져 있었다. 선원들은 선박의 장비나 시스템에 있어 뚜렷한 고장은 없었으며 갑판 위 컨테이너의 움직임도 없었다고 보고했다. 선창의 컨테이너들은 선박을 가로질러 빈틈없이 채우고 있었기 때문에 뚜렷한 좌우 움직임은 일어날 수 없으므로 이 컨테이너들이 선창에서 움직이지는 않았을 것이라고 가정했다. 6일 후 수색 시 선박은 여전히 바다 위에 떠 있었고 우현 쪽으로 15~30도 기울어져 있었다. 갑판 컨테이너는 전부 사라졌지만 해치 커버는 제자리에 있었고, 손상되지 않은 것으로 보였다. 그러나 4일 후 해난 구조 예인선이 도착했을 때 선박은 침몰한 상태였다.

- 선박이 기울어지고 뒤이어 침몰한 원인은 확정적으로 밝혀지지 않았다. 선원들은 당시 예측되는 기상상태의 심각성을 충분히 인식하지 못했고, 그 결과 악천후 대응 절차를 시행하지 않았다.
- 선박의 항로가 격랑의 횡방향으로 놓이면서 지속적인 시간 동안 선박이 크게 흔들렸다.
- 다른 명확한 요인이 부재한 상황에서, 선박이 크게 기울어진 것은 해수 유입 및/또는 밸러스트 탱크의 알 수 없는 상태 변화로 인한 안정성 변화와 관련이 있을 것으로 보인다.
- 선원들은 사상자 발생 3주 이상 전에 승선한 이후 각 밸러스트 탱크 내 수량을 확인하지 않았다. 따라서 선박의 안정성 컴퓨터로 계산한 출항 전 안정성 수치가 선박의 실제 안정성을 제대로 나타내지 못했을 수도 있다.
- 선원들은 선박이 기울어진 원인을 파악하기 위한 어떠한 조치도 취하지 않았기 때문에 교정 조치 역시 (가능한 조치가 있었다더라도) 취하지 않았다.
- 선원들은 사고를 당한 항해를 시작하기 전에 선박에 대해 충분히 숙지하지 않았던 것으로 보였다.
- 새로운 선박 관리회사가 선박의 운영을 맡으면서 회사는 신임 선원들에게 최소한의 자원과 도움만 제공한 것으로 보인다.

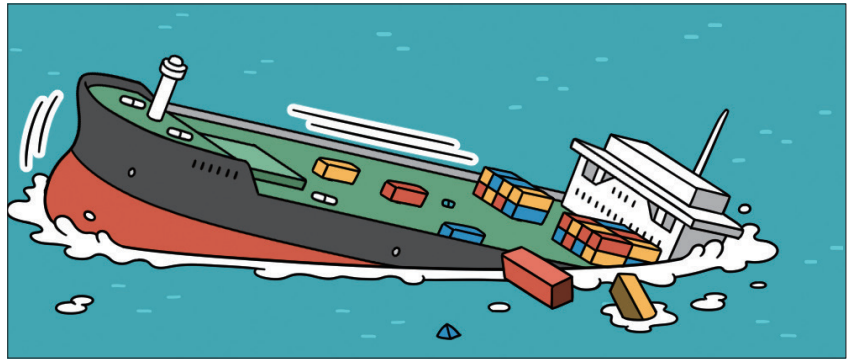
건화물선이 항구에 접근하고 있었고, 화물이 움직이면서 선박이 좌현으로 심하게 기울었다. 이후 열려 있던 수밀 비상문을 통해 기관실로 물이 들어왔다. 이로 인해 선박이 더 기울었고 선원들은 퇴선했다. 주기관들이 계속 작동하고 있어서 선박이 원을 그리며 돌고 있었기 때문에, 승선이 불가능하지는 않았지만 매우 어려웠다. 결국 선박이 여울로 좌초했고 이곳에서 전손되었다. 선박의 화물 고정 매뉴얼에서 요구하는 대로 화물을 적재, 고정하지 않았음이 사고 조사 과정을 통해 밝혀졌다.
