Marine Safety Investigation Report

on Bulk Carrier *ENVY*

– Fatality of stevedores –

Accident Date : 2021.03.18.

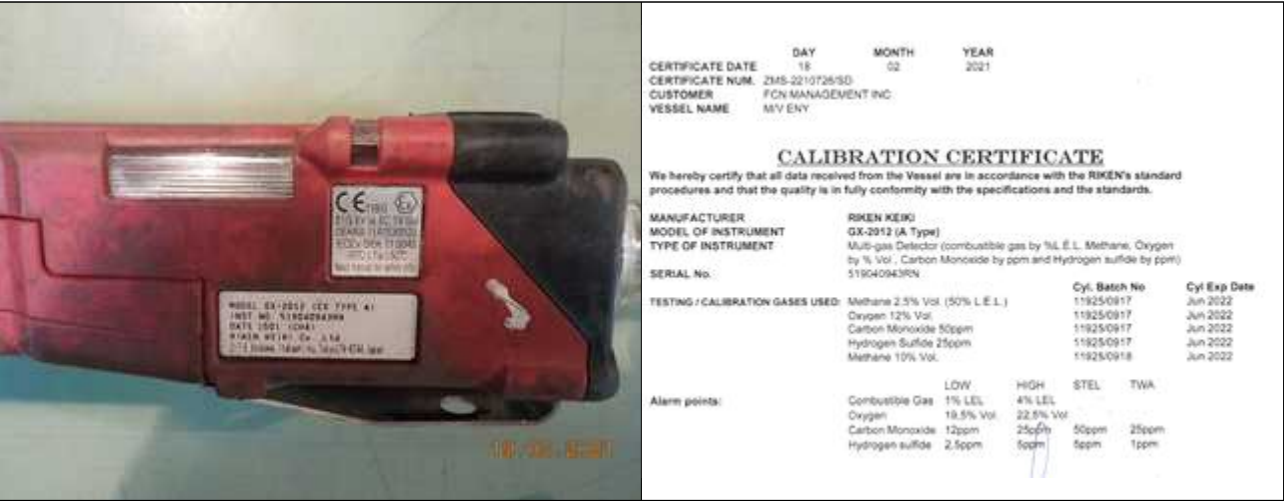
<Figure 5> Gas detector on *ENVY*

- 2.7.1 *ENVY* was equipped with an oxygen/gas detector to measure the oxygen and gas concentration before entering enclosed areas. The last calibration date of the equipment was February 18, 2021.
- 2.7.2 There were cargo hold air vents installed on the side of the cargo hold's hatch cover, but there was no mechanical ventilation device for forced ventilation.

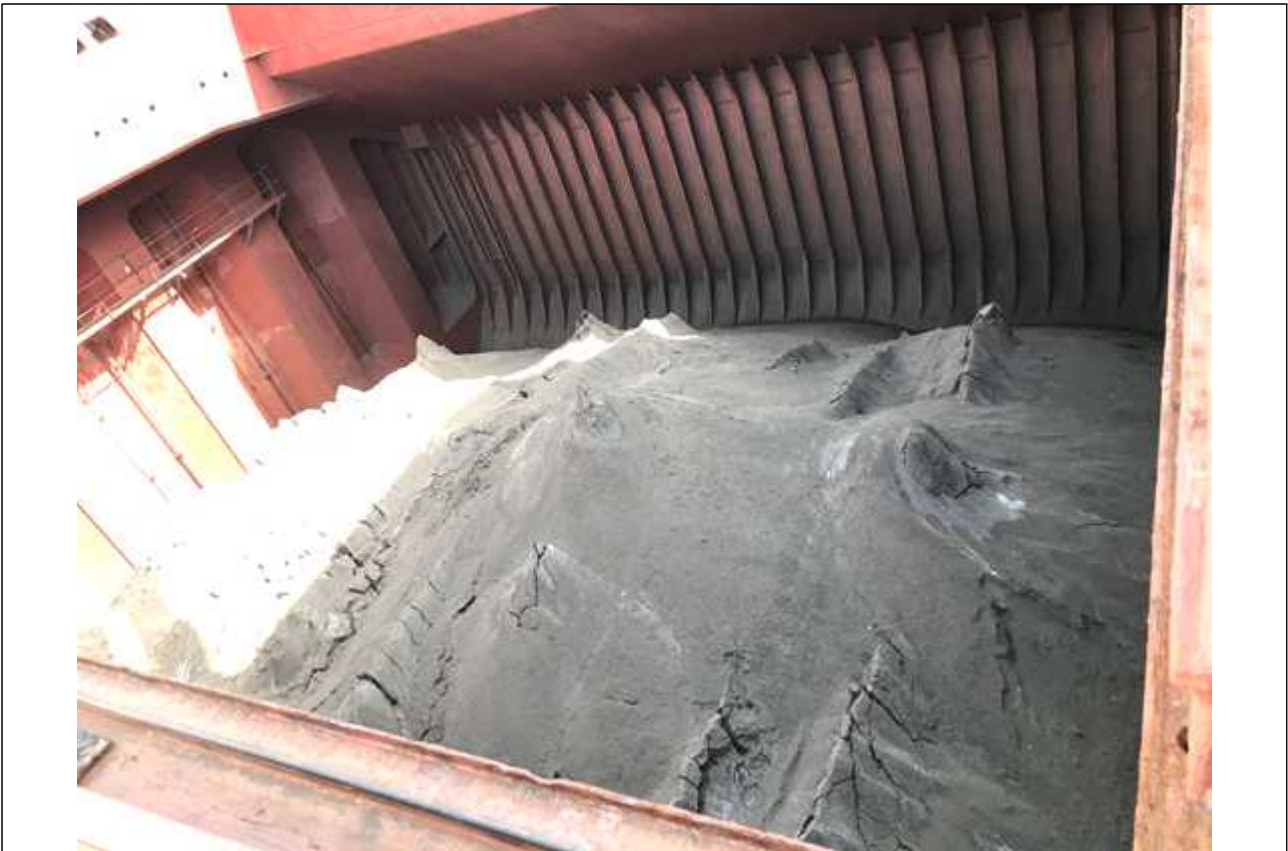
<Figure 10> Appearance of the cargo being loaded into the cargo hold at the time of the accident

3.2.2 At around 20:07 on the same day, some of the crew, at the foreman's request, started to open the cargo hatch cover. At around 20:12, the hatch cover of the No. 2 cargo hold was completely opened. Next, preparations were made to enable the ship's crane to be used. After the hatch cover of the cargo hold was opened, the stevedore on shore went up to the hatch coaming of the cargo hold on the upper deck to check the loading status of the cargo inside the cargo hold.

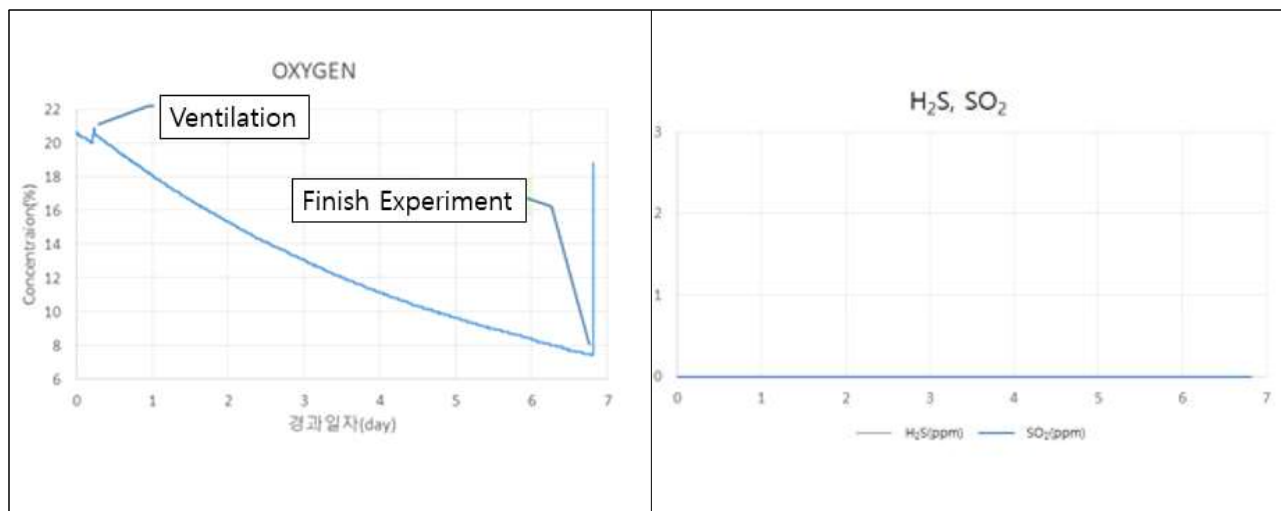
<Figure 12> Test results of zinc concentrates loaded on the ship

4.2.9 Looking at these test results, the cargo loaded on the *ENVY* at the time of the accident is judged to have been a cargo with the capability to absorb oxygen. However, this information was not specified in the cargo declaration, and such information was also not provided to the vessel in the appropriate way.

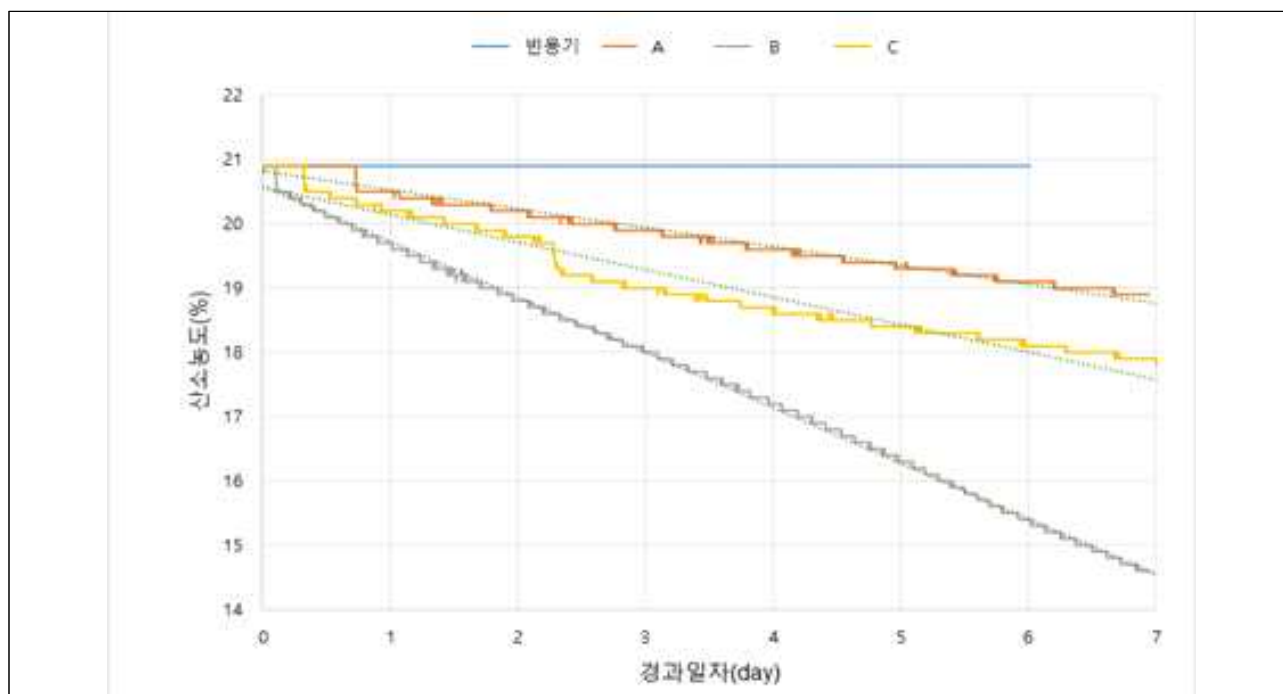
<Figure 13> Test results of zinc concentrate samples collected from three different ships

4.2.8 The results showed a tendency for the oxygen concentration to decrease in all cases, with some differences by cargo. After about seven days, the oxygen concentration of the zinc concentrates for A¹⁴⁾ decreased from 20.9% to 18.9%; for B,¹⁵⁾ decreased from 20.9% to 14.6%; and for C,¹⁶⁾ decreased from 20.9% to 17.9%.¹⁷⁾

17) The decrease in oxygen concentration caused by the zinc concentrates on the ship involved in this accident was more sudden than the decreases caused by the zinc concentrate samples collected from other ships. However, given the difference in test conditions, including the sample size, it is difficult to make a direct comparison.

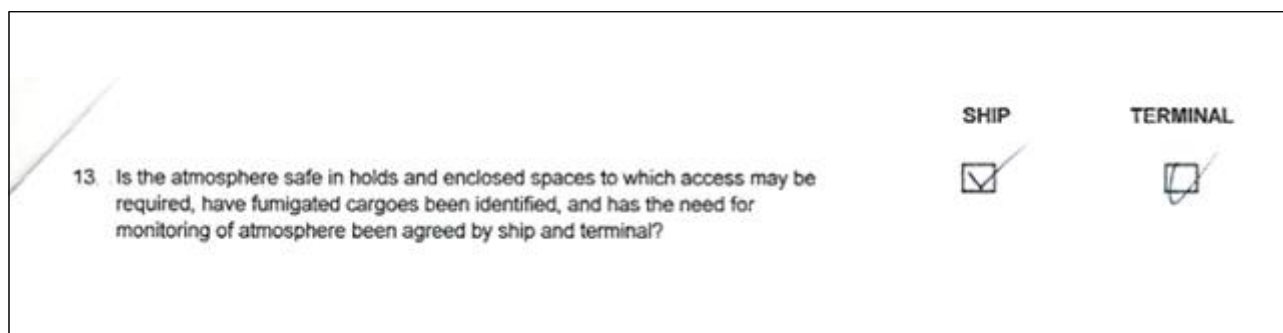
4.3.2 On the safety checklist, the C/O and shore foreman are required to check with each other whether the atmosphere in a cargo hold or any enclosed area is safe to enter or whether observation of the atmosphere, including in the cargo hold, is needed. To indicate that the atmosphere in the cargo hold was safe, the C/O and the shore foreman each marked that item on the checklist with a checkmark.

13. Is the atmosphere safe in holds and enclosed spaces to which access may be required, have fumigated cargoes been identified, and has the need for monitoring of atmosphere been agreed by ship and terminal?

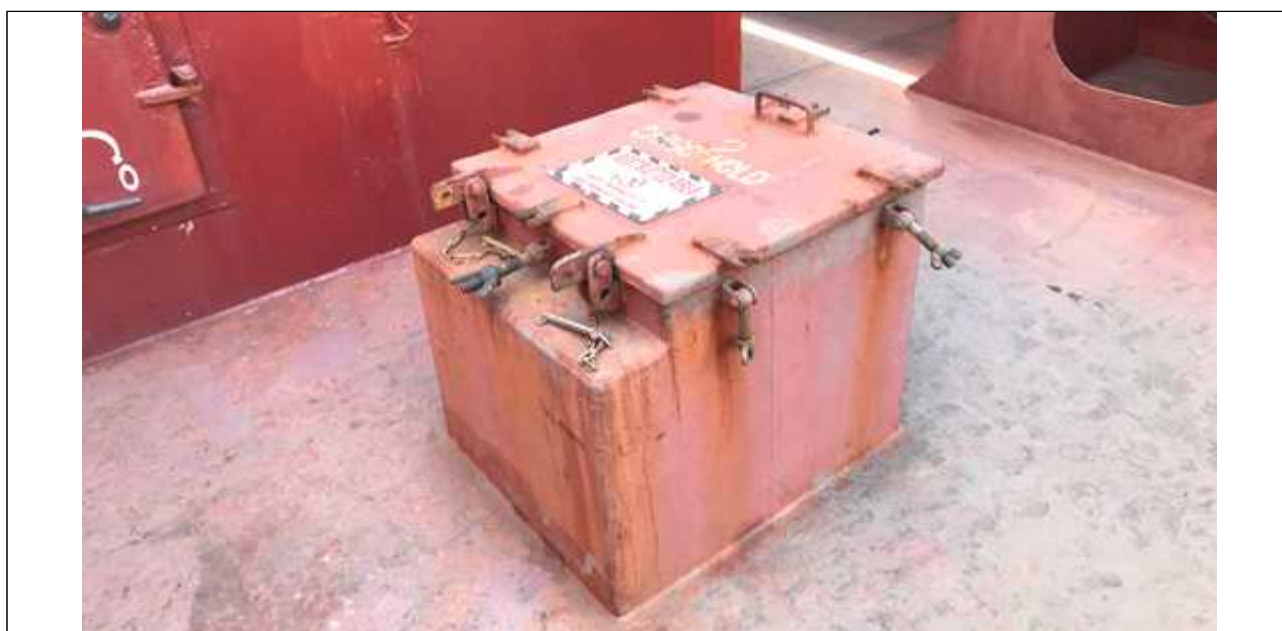
<Figure 19> Appearance of the access hatch of the No. 2 cargo hold and the restricted area sign

4.4.8 Meanwhile, “restricted area” signs were affixed to the cargo hold’s access hatches, but it seemed like there were no other measures in place to restrict anyone from entering, such as locking devices.²⁷⁾ The signs were not for safety but security purposes. Such signs are common on other ships, so even if the stevedore had seen it, it is assumed that he would not have perceived any danger.

4.4.9 The ship did not have any strict restrictions on entry to the restricted area, and the stevedore went inside the cargo hold by himself without any prior notification to the ship. As a result, the procedures for entry into an enclosed area were not followed.

27) According to the recommendations for entry into enclosed spaces aboard ships (IMO Res. A.1050(27)), since there could be a misunderstanding that the enclosed area concerned is safe to enter because the opening of the cargo hold has allowed for natural ventilation, it is stated that it is appropriate to place a person at the access hatch or close off the access hatch using physical methods such as ropes or chains with a warning.
