[MSI Report 2023-002]

Marine Safety Investigation Report

– Fatal Accident aboard Research Vessel Isabu –

Date of Accident: 5 July 2022

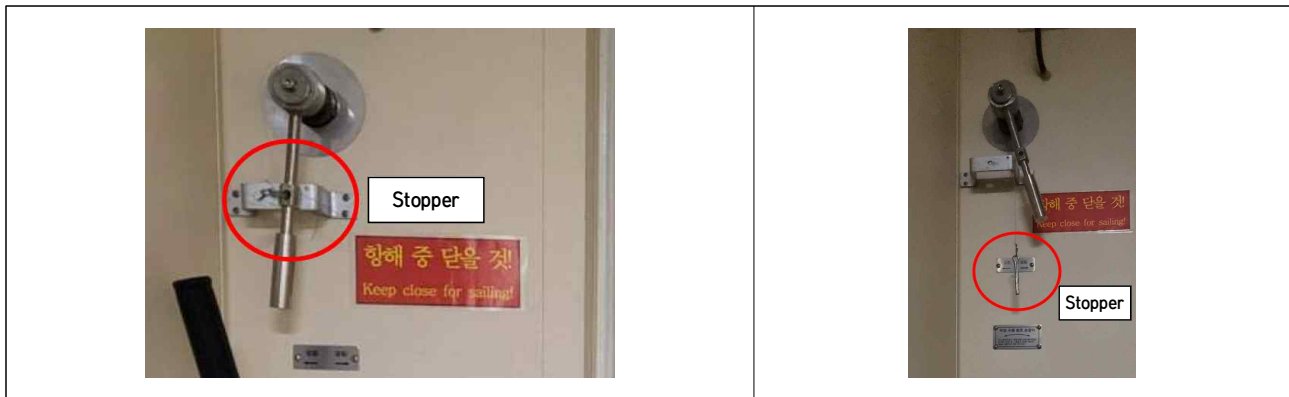
<Figure 10> Stopper in (left) and stopper out (right)

13) If the C/EE had released the control lever, the watertight door would have closed. That is because the solenoid valve and the limit switch which control the door's opening and closing do not work without power, returning the watertight door to the closing direction as designed in the basic circuit. The solenoid valve, the

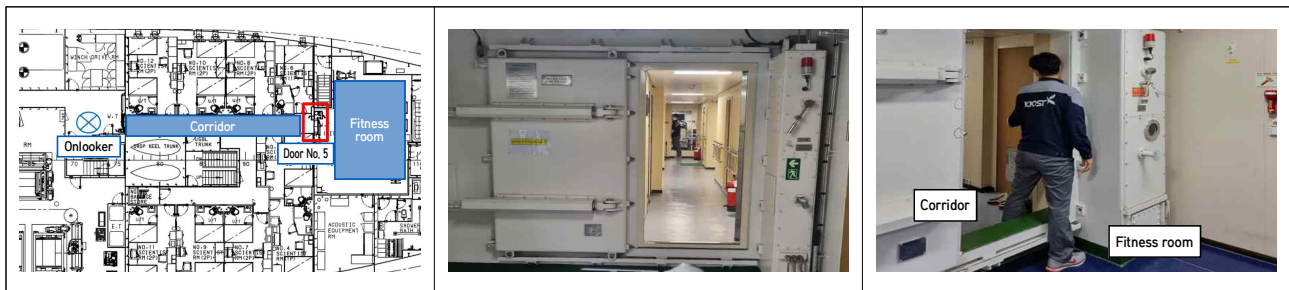
<Figure 11> Positions of the C/E on the scene and the watertight door (left); from the C/E's view (middle); and reconstructing the victim's posture (right)

3.3.2 When the C/EE was first discovered, the C/EE was facing the corridor of the accommodation area while standing pressed against the closing watertight door with each of the feet on a different floor: the right foot was in the fitness room; and the left one was in the corridor. The C/EE's body did not move.

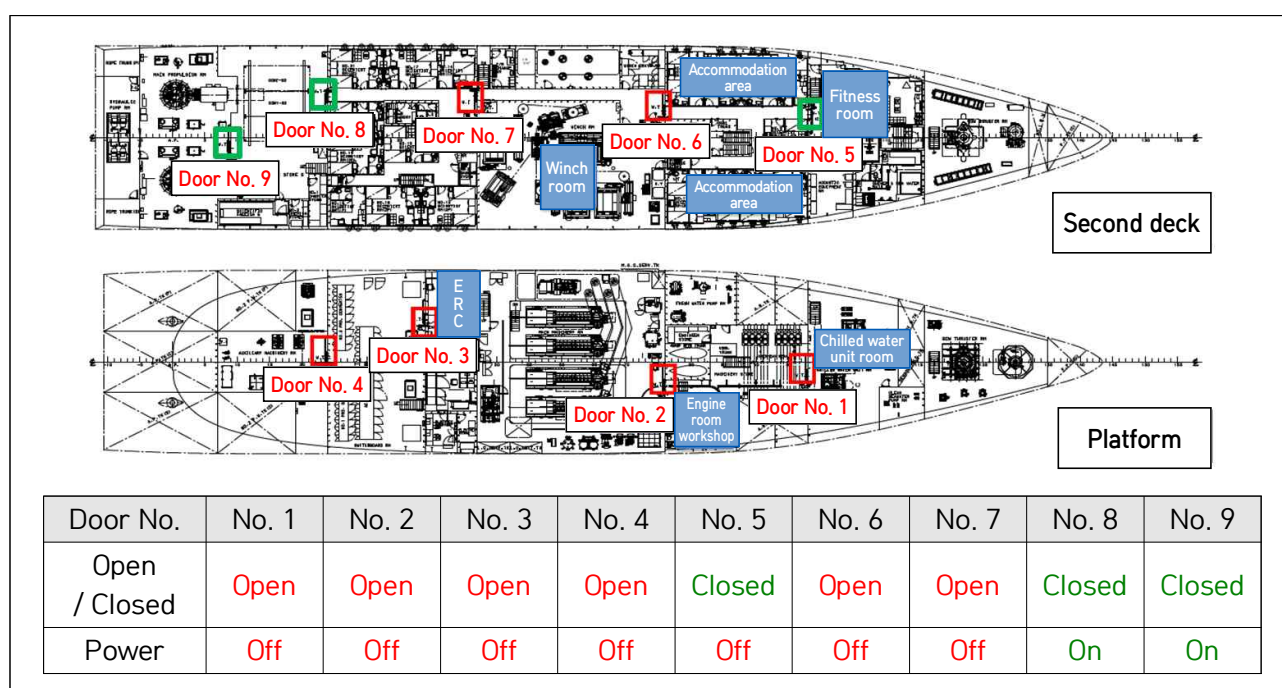
<Figure 12> Ordinary condition of watertight doors

4.1.1 According to the vessel, Isabu, three of the vessel's nine watertight doors were normally kept closed while the other six remained open. The closed doors were watertight door nos. 8 and 9 on the way to the machinery space on the second deck and watertight door no. 5 at the fitness room on the bow, where the accident occurred. The four doors on the platform and the two on the second deck were always open.

4.1.2 In addition, individual power switchboards connected to the watertight doors were all turned off, except those for watertight door nos. 8 and 9. The following shows the ordinary condition of opening and closure and power supply of the Isabu watertight doors.

- 4.1.3 A watertight door shall always be kept closed under the regulation II-1/22.1 of the International Convention for the Safety of Life at Sea (SOLAS). SOLAS regulation II-1/22.3 also stipulates that even if it is opened to permit passage or work, the door must be immediately closed when the transit through the door or the work is finished.

- 4.1.4 A ship's watertight bulkhead is a critical structure which enables the ship to maintain hull safety when facing structural damage and flooding from a collision or grounding. Therefore, the watertight door that controls the opening of the watertight bulkhead should be strictly operated and managed under the relevant regulations. In case of Isabu, however, the opening and closure of the watertight doors were set randomly, and the importance of their operation and management seems to have been neglected.

- 6.1.3 A watertight door is essential equipment that helps a ship to maintain buoyancy and safety of the hull by preventing water ingress when the ship faces flooding due to hull damage. Therefore, the door should always remain closed with the exception of watertight doors under maintenance.

- 6.1.4 However, as in the case of Isabu, if a majority of watertight doors are always kept open with their switchboards turned off and not ready for immediate operation, they could not be closed swiftly in the event of flooding, resulting in significant property damage and loss of life, which needs to be changed.

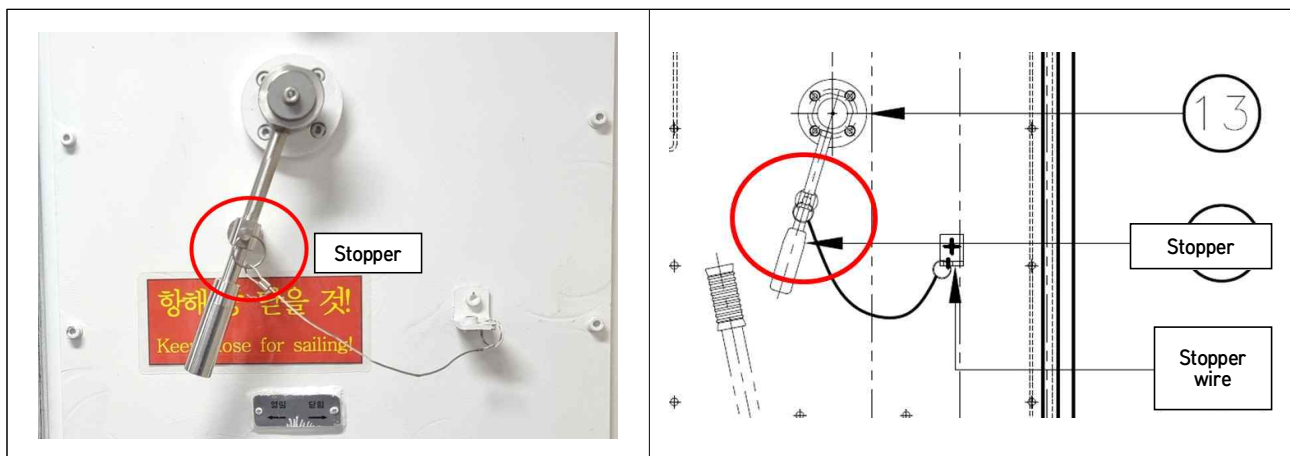
<Figure 13> Stopper in the opening direction (left) and stopper in the diagram (right)

- 4.2.1 This accident is assumed to have occurred when the C/EE re-inserted a stopper, which was set in the closing direction of the door control lever in the corridor. Therefore, understanding the usage of this stopper is key for analyzing the cause of this accident.
- 4.2.2 First, the watertight doors of Isabu have a stopper which fixes control levers in the opening direction. The stopper was manufactured and attached to the watertight door from the time the door was installed on the vessel. It is located only at the

- 4.2.3 A stopper at the actuating system is installed to set a door control lever and prevent potential malfunction of the watertight door should the door need to remain open for a long time for inspection. When it is opened, its control lever is in neutral, and as long as the lever is not turned to the closing direction, the door remains opened.²¹⁾ If the lever is activated due to negligence or malfunction, thereby closing the watertight door, an accident is likely to occur. That is why a stopper was installed so that a watertight door can remain opened while work is being carried out.

- 4.2.11 It is hard to deny that this accident was caused by the C/EE who had made the wrong decision while passing through the moving watertight door. However, the stopper intentionally installed in watertight door no. 5 is also considered a potential risk factor as presented the C/EE with the extra task of inserting it into the hole of the control lever.

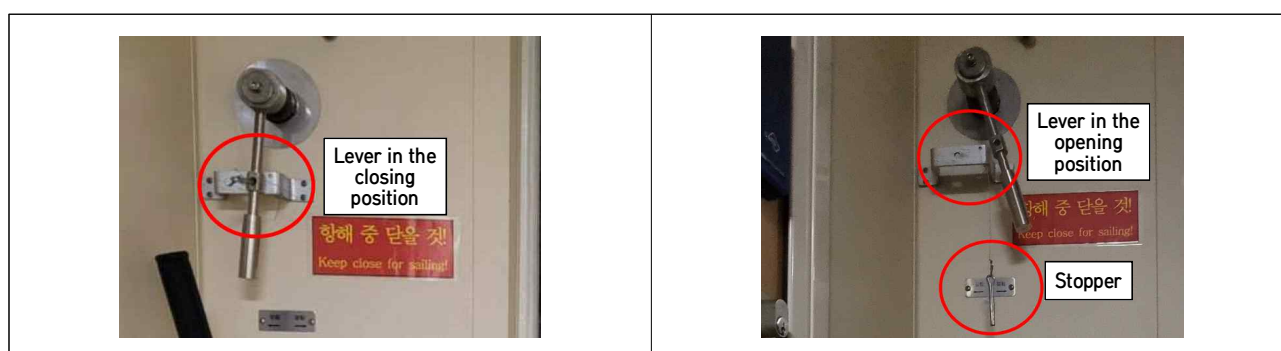
<Figure 14> Closed control lever in the corridor (left) and opened lever (right)

4.2.6 According to Isabu, watertight door no. 5 adjacent to the cabin area was kept closed and its control lever in the corridor was fixed with the stopper due to noise from the fitness room. Also, as researchers, who were not familiar with operating watertight doors, were mostly staying there, the door was kept closed, except special occasions such as classification surveys, to prevent accidents. In addition, the power switchboards of the watertight doors were all turned off, meaning that watertight door no. 5 was normally closed, or practically blocked off.

4.2.7 A watertight door has a hand-operated mechanism that allows it to be opened and closed manually from any positions under SOLAS regulation II-1/13.7.1.4. There are control levers on both sides of the door, moving interconnectedly. Thus, if a control lever on one side is fixed with a stopper while the door is closed, the door cannot be opened from the opposite side, hampering normal operation of the control levers.

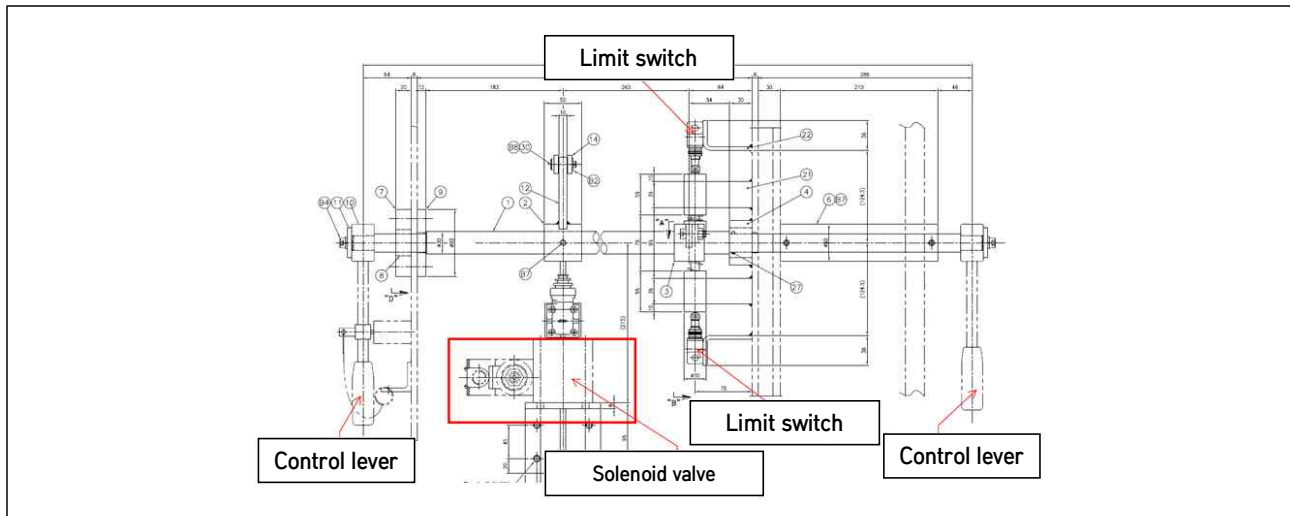
<Figure 15> Solenoid valve and limit switch in the diagram

- 4.3.9 Meanwhile, it was found out that watertight door no. 5 did not operate normally during the investigation. In principle, when a person moves a watertight door's control lever to the opening or closing direction, a limit switch sends out opening or closing signals to a solenoid valve. Then, the valve operates hydraulic lines to open or close the door. However, the on-site investigation identified that if a person had turned its control lever to the opening direction while the watertight door had been closing, the door would reopen. Following that, when the lever was in neutral, the door would reclose.

- 4.3.10 When asked, the manufacturer confirmed that there could be the case where a control lever failed to send opening or closing signals due to the defected solenoid valve or limit switch in the actuating system, requiring the lever to be repaired.²⁷⁾

4.3.11 This accident occurred when the switched-off watertight door was being closed by the residual oil pressure, meaning that the defect of the power-driven parts are less likely to have caused this accident. However, such a defect may affect smooth operation of the door. Thus, it seems appropriate for the vessel to conduct regular operation inspections and, if necessary, to carry out maintenance or repair so that watertight doors are kept in normal condition.

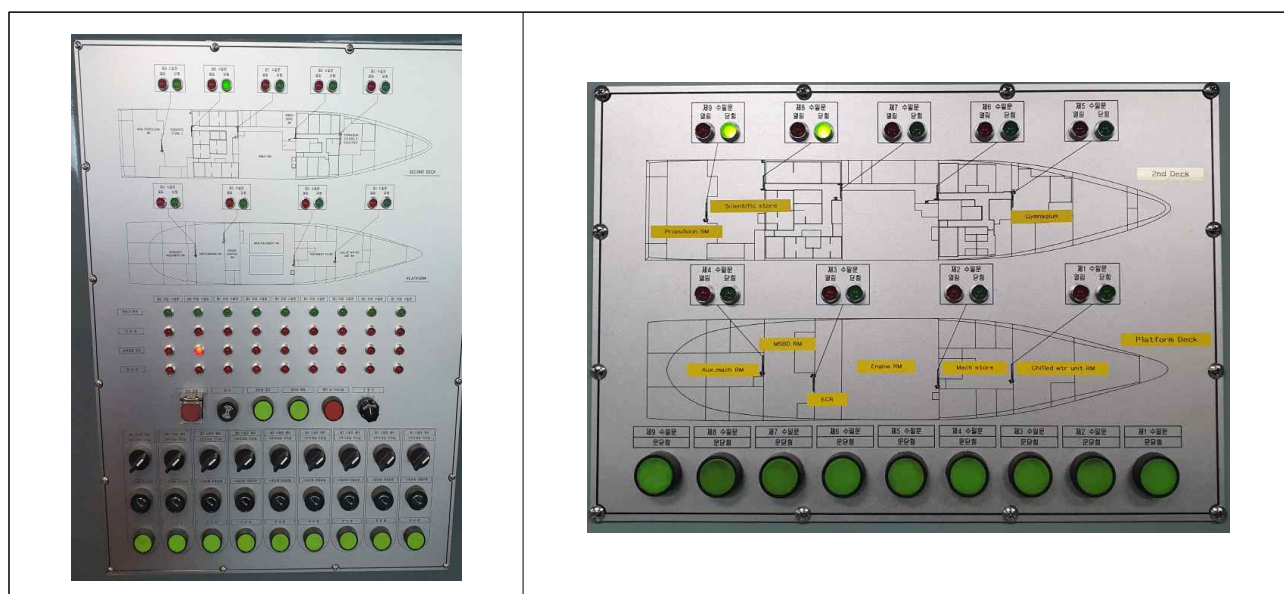
<Figure 16> Remote control console of the bridge (left) and ECR (right)

4.6.2 The remote operating system of the bridge and the ECR can only close the doors. The doors can be closed from the bridge in the following three ways: First, if a person pushes the red "emergency close" button with a cover attached on the console, all the watertight doors will close at once. Second, if a person sets the key switch³⁴⁾ for each watertight door on an "automatic close" mode, the doors will close individually. Third, when a person pushes the green "door closing" button for an individual door, it will close. However, the ECR has only a green "door closing" button.

4.6.3 Under SOLAS regulation II-1/13.8.1, the central control console at the bridge shall have a "master mode" switch with two modes of control, a "local control" mode and a "doors closed" mode. However, the control console of Isabu has slightly different terms and functions: its red button is labelled "emergency close" instead of "doors closed," and the "manual close" mode of individual doors means a "local control" mode.

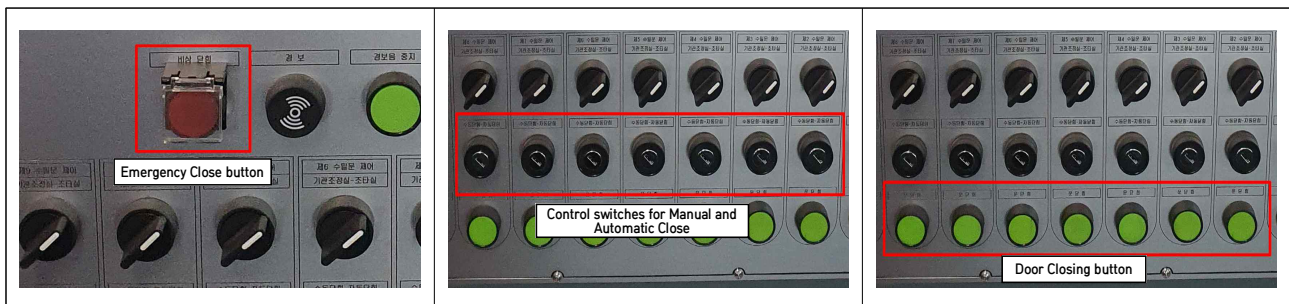
<Figure 17> "Emergency close" button (left); "automatic close" switch (middle); and "door closing" button (right)

4.6.5 It seems that the various functions of the control console on Isabu are likely to confuse the crew when they fail to understand their differences and functions. Therefore, it is considered important to provide sufficient training for the crew and
