Marine Safety Investigation Report

on Chemical Tanker *Golden Bridge Hana*

– Fatality of a crew member –

Date of Accident: 29 August 2019

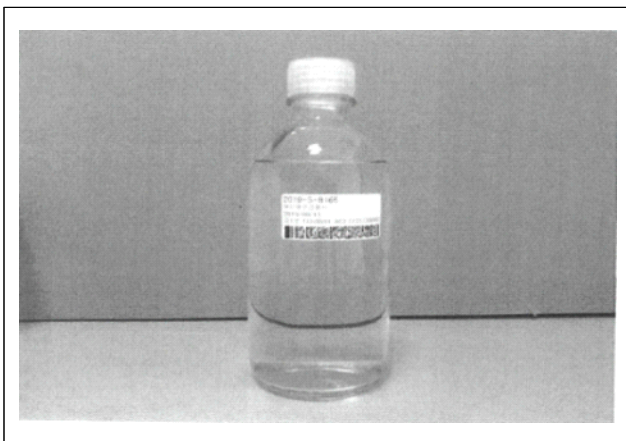
- 3.2.5 At around 16:17, the surveyor moved to No. 2 COT (P) and lowered his sampling device into the cargo tank to collect a sample. In the process, the lower part of the sampling device was damaged; its stainless steel bottom plate and a glass bottle dropped onto the bottom of the tank, and the glass bottle broke.

<Figure 5> A glass sampling bottle

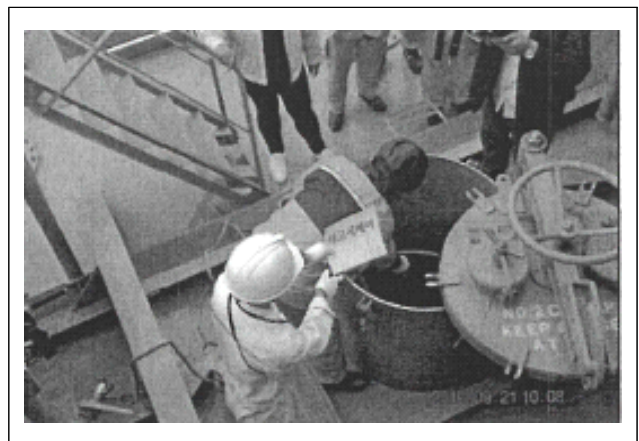
<Figure 6> Reenactment of the cargo sampling by the cargo surveyor

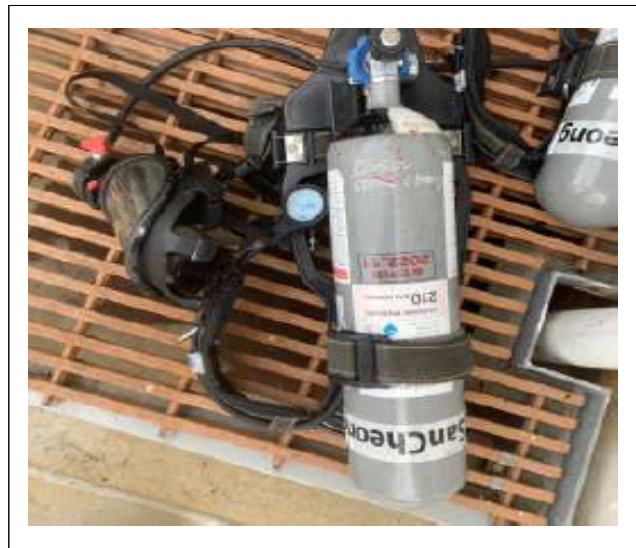
<Figure 10> The SCBA worn by the bosun

- 4.1.2 His fall inside the cargo tank may have been due to sudden confusion or fainting after inhaling toxic gas through gaps between his face and a loosened facepiece.

- 4.1.6 These circumstances collectively suggest that the facepiece of the SCBA lost its firm seal on the bosun's face as he fell forward onto the floor, which had 50cm of VAM on it. Lethal gas and liquid VAM appear to have leaked into the facepiece, and the bosun inhaled them.

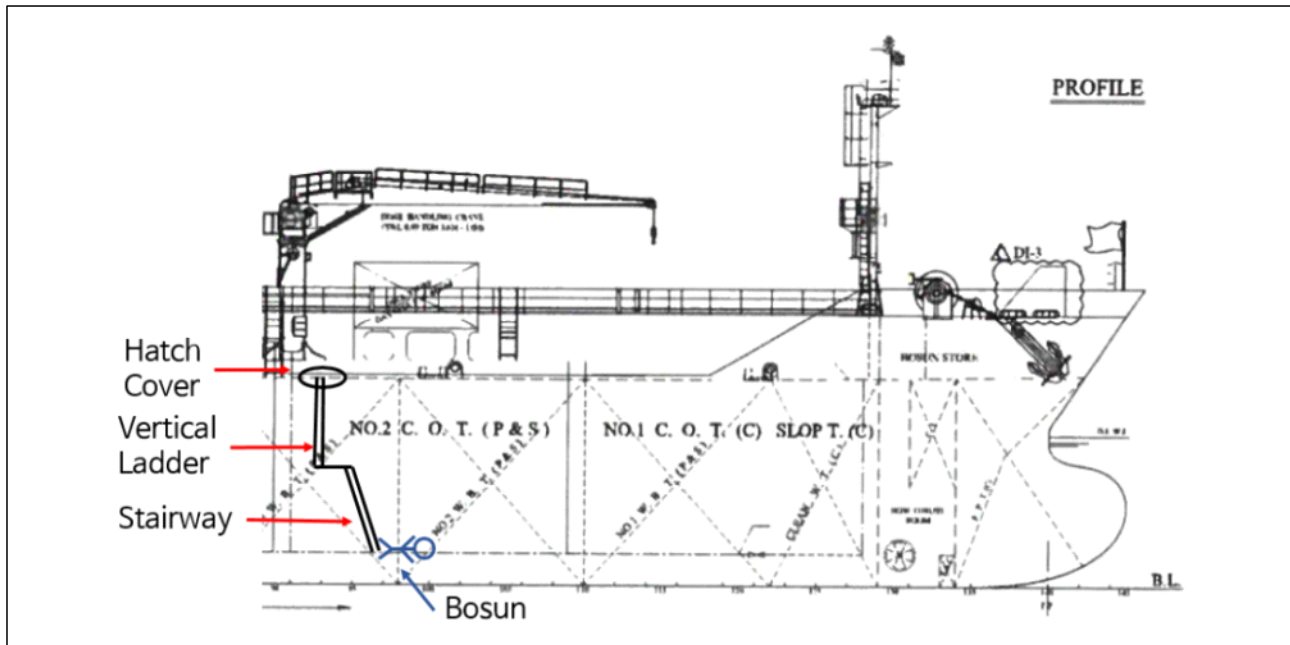
<Figure 11> Structures of the stairways inside the cargo tank

- 4.1.1 The bosun entered the cargo tank by first climbing down a vertical ladder and then down a step ladder. When he reached two or three steps from the bottom, he fell forward onto the tank floor.

- 4.1.3 The possibility also exists that the bosun lost his footing or slipped on the stair treads as he approached the top of the liquid cargo, which was 50cm deep in the bottom of the tank. He may have been changing his position on the step ladder as he sought to remove the bottle or some other item that had been dropped, or to spot them inside the dark cargo tank. The heavy air cylinder he was carrying would have made it hard for him to keep his balance on the ladder. In addition, the facepiece of the SCBA (Self-Contained Breathing Apparatus) restricted his visibility, and he may have lost his footing or slipped as he tried to look closely beneath him while standing on the step in the darkness.

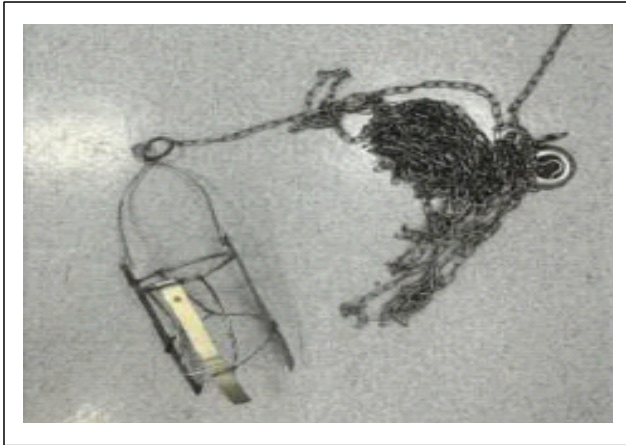
- 4.4.1 The cargo surveyor collected cargo samples with his own sampling device, and its bottom plate was detached from the body. The plate and the glass bottle on top of the plate both fell to the bottom of the cargo tank.
- 4.4.2 This sampling device consists of a stainless steel case, which can accommodate a glass bottle with a diameter of 12cm, a bottom plate, and chains connected to the plate, as described in [Figure 12]. The case and the bottom plate are made separately, and the plate is attached to the case at three points.
- 4.4.3 This tool lacks a sophisticated design, given its structure and the way each part is attached. Also, the bottom plate could possibly have come loose because of its own defect or a weakening of the attached points after long exposure to chemicals and etc.

<Figure 12> The sampling device

5.2.3 Also, the bottom plate of the sampling device and the glass bottle placed inside the device fell to the bottom of the cargo tank while the surveyor was taking samples. It is presumed that those parts were dropped because the sampling device had been originally defective or the connections between the device body and its bottom plate had weakened over time after having been exposed to chemicals and etc.

- 6.5.1 Cargo surveyors and other relevant persons should maintain their sampling devices so that they function properly at all times.
- 6.5.2 In case it becomes necessary to use sampling devices owned by a cargo surveyor, not the ones maintained by a vessel, the master or the C/O should check their conditions thoroughly before using them for cargo sampling.

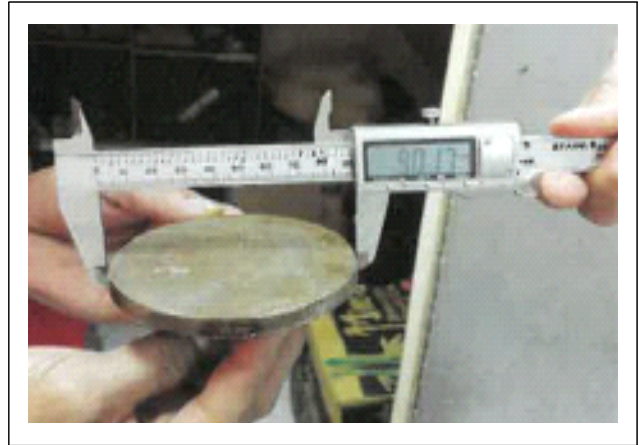
<Figure 13> The bottom plate of the sampling device
