Marine Safety Investigation Report

on Chemical Tanker *Onsan Chemi*

- Fatality of a crew -

Date of Accident: 23 November 2020

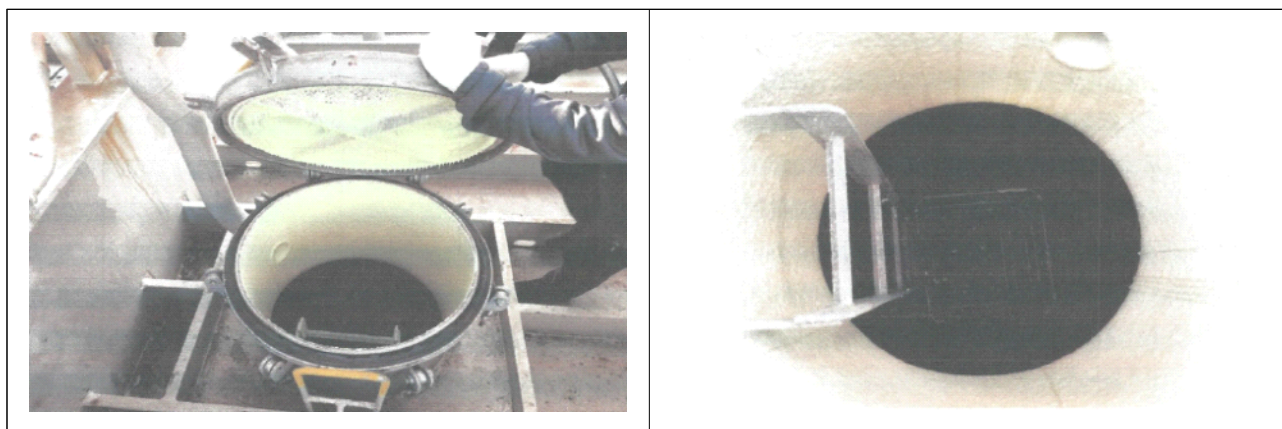
[Figure 4] Hatch of CT No. 4 (P)

2.6.1 CT No. 4 (P) is where the accident occurred; the tank has a volume of about 675m³ and a length of about 7.8 meters. The inside of the tank is made of molybdenum (Mo)-containing low-carbon stainless steel (SUS-316L), which has strong corrosion and acid resistance as well as excellent strength to store high-temperature cargoes.

2.6.2 This cargo tank is installed with one access hatch, which is fitted with a ladder so that persons can

climb down into the tank.

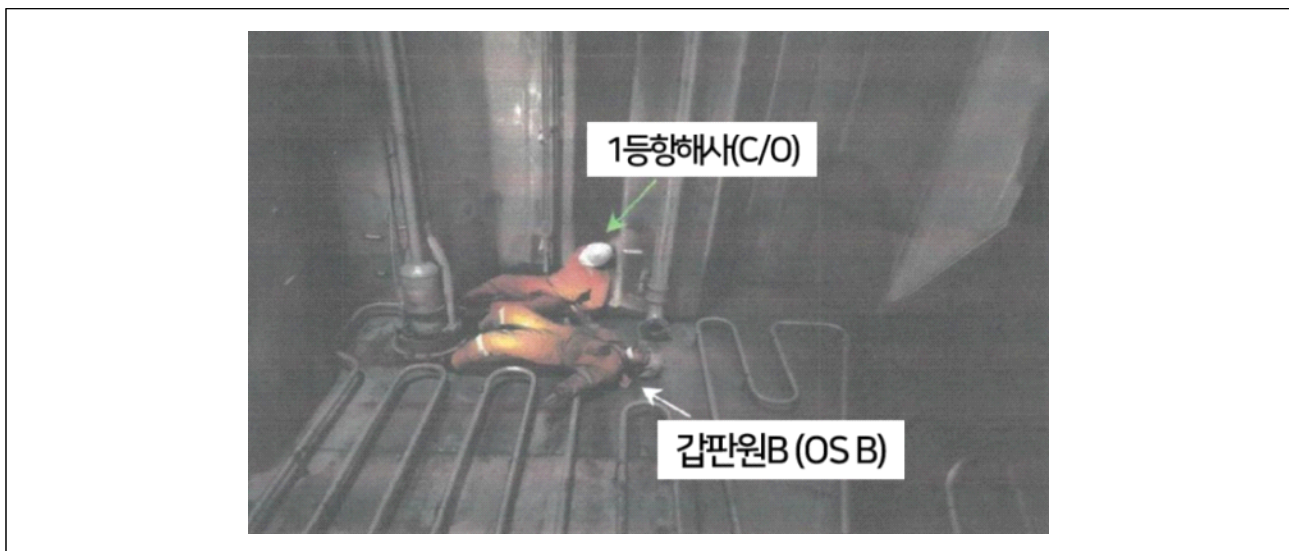
[Figure 8] Reenactment of the situation where the C/O and OS B collapsed
(Source: Korea Coast Guard Station Busan)

- 3.2.12 The C/O, having been informed of the accident by OS A, went to CT No. 4 (P) while the bosun and OS A went to the stern. The C/O then went into the tank alone to rescue OS B, and while attempting to do so, he collapsed on the floor as well.

- 4.1.7 Given this conclusion, the C/O is presumed to have died from gas poisoning and/or oxygen deficiency, because he entered a cargo tank where hazardous gas was generated from residue and oxygen was insufficient.
