[MSI Report 2021-001]

Marine Safety Investigation Report on *M/V MILANO BRIDGE* - Contact with gantry cranes -

Date of Accident: 6 April 2020

Korea Maritime Safety Tribunal
Marine Safety Investigation Team

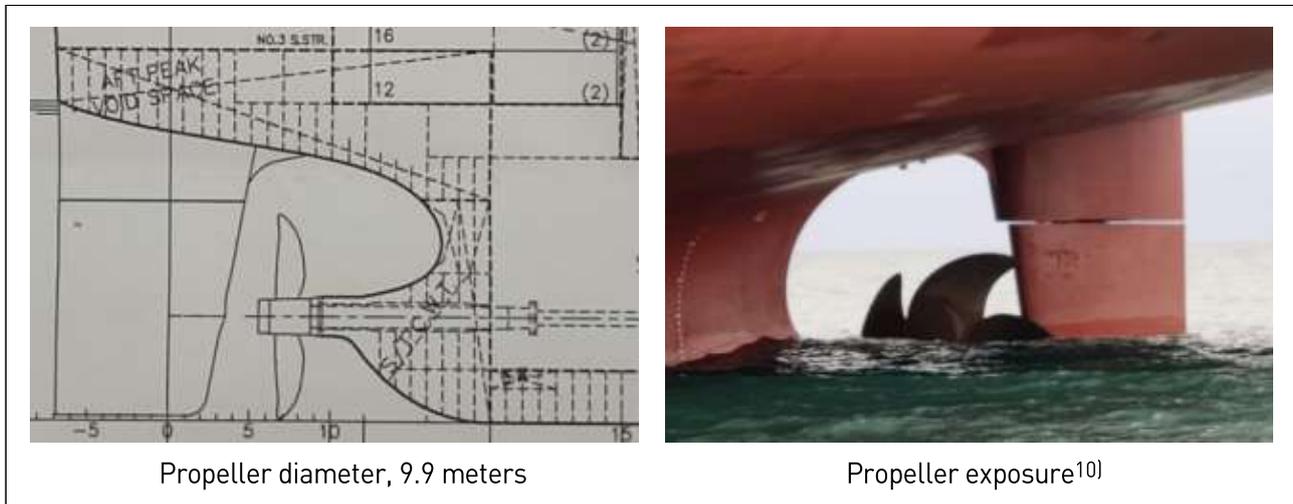
<Figure 5> Propeller exposure at the time of the accident

2.7.5 When the accident occurred, her aft draft was 6.9m, and about 3.2m, or 32% of her propeller diameter was above the waterline. The upper part of the blades and even the upper part of the rudder were out of the water.

10) This picture of the propeller conditions of *Milano Bridge* was taken right after the accident. The conditions are presumed to be the same as the ones at the time of the accident.

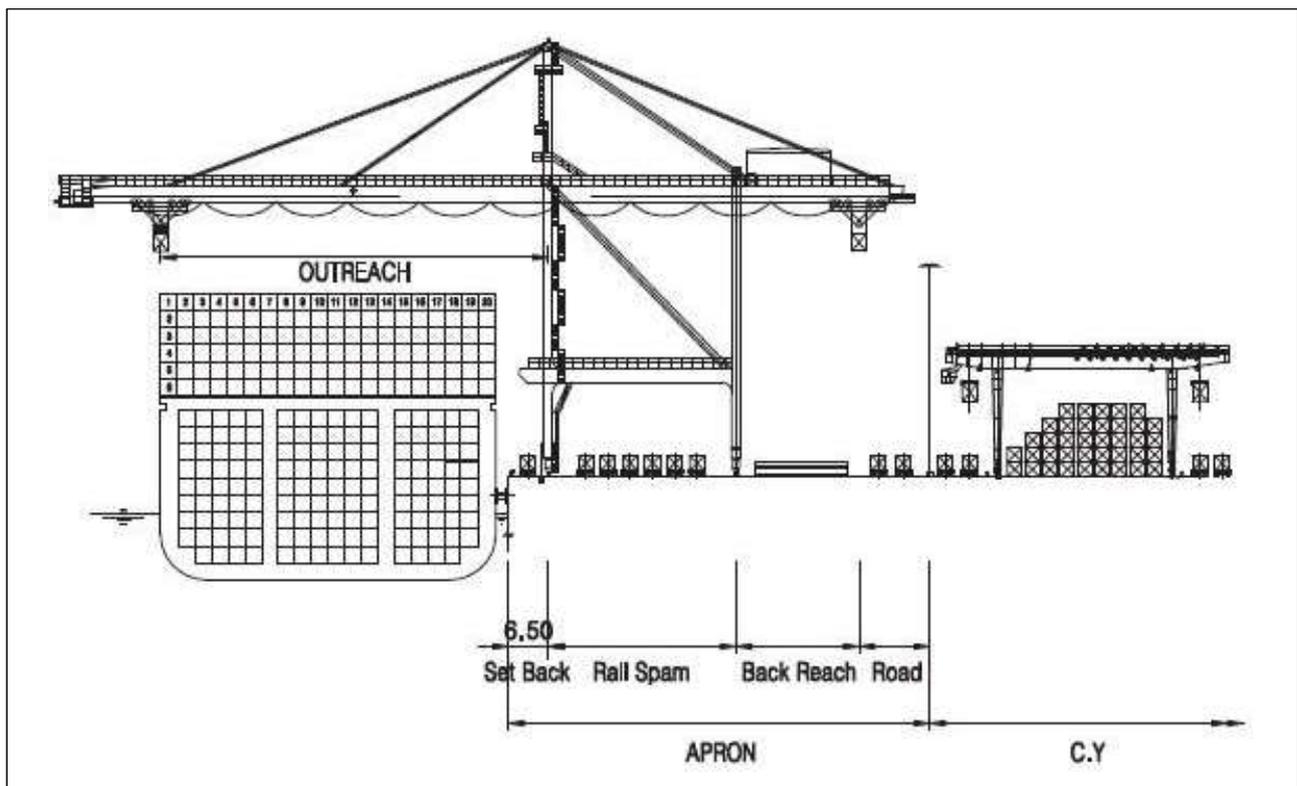
<Figure 9> Apron of Pier No.2

2.9.3.2 As prescribed in Article 4.3.2 Container Terminal Design Code of the Design Standard for Ports and Fishery Harbors (KDS 64 60 10), aprons shall be designed so that containers can be temporarily laid, or that loading equipment such as cranes and vehicles can be easily operated. In general, setbacks are designed to be 3.5 to 6.5 meters, depending on the characteristics of the bollards, gantry crane cable trays, and terminals. In the case of Pier No.2 at Busan New Port, the setback was about 6.5 meters.

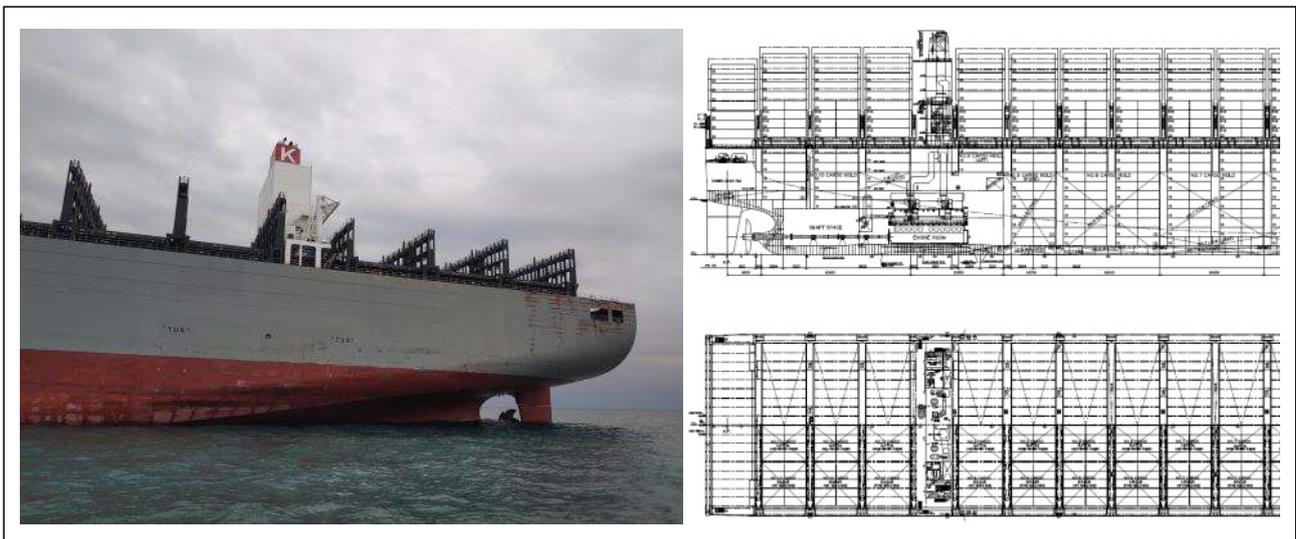
<Figure 10> Aft body of *Milano Bridge*

2.9.3.4 Containerships have a flared bow and stern. As *Milano Bridge* also has a flared stern, the deck areas of cargo hold Nos.8 to 10 at the stern are like those midships. But, the area narrows sharply at the lower part near the propeller and rudder.

2.9.3.5 If a containership approaches the quay wall at a large angle with her upper part significantly exposed above the waterline due to a low draft, the upper part is likely to cross over the quay line. *Milano Bridge*, too, given both the aft draft and water depth of the quay wall at the time of the accident, was likely to have had the upper part of the side shell of her stern enter further into the quay without contacting the wall, depending on the berthing angle. And, in that case, avoiding contact with a gantry crane would have been particularly difficult while turning to starboard just ahead of the pier.

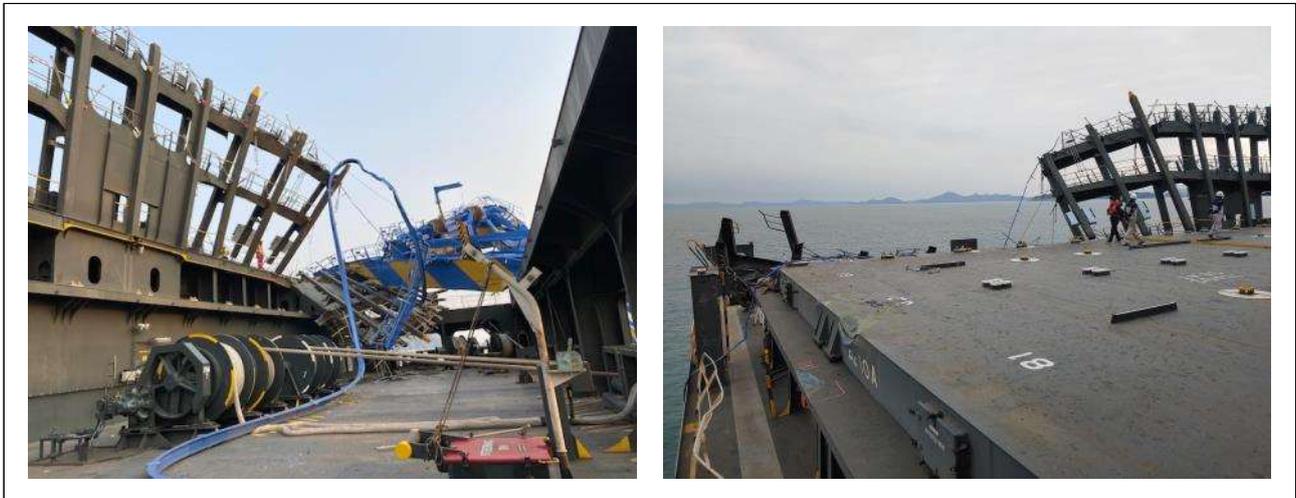
<Figure 14> Damage to the stern of *Milano Bridge*

2.13.1 After colliding with *Milano Bridge*, one gantry crane at Pier No.2 crashed and fell onto the vessel, causing damage to the port stern shell plate, aft lashing bridges and hatch coaming (Frames 10 and 11), and causing dent on part of the port side wing bridge as well. Later, *Milano Bridge* collided with the containership, M/V *Seaspan Ganges*, berthed at Pier No.7, on her way out from the pier, leaving dents¹⁸⁾ on the

part of the port shell plate of *Milano Bridge*.

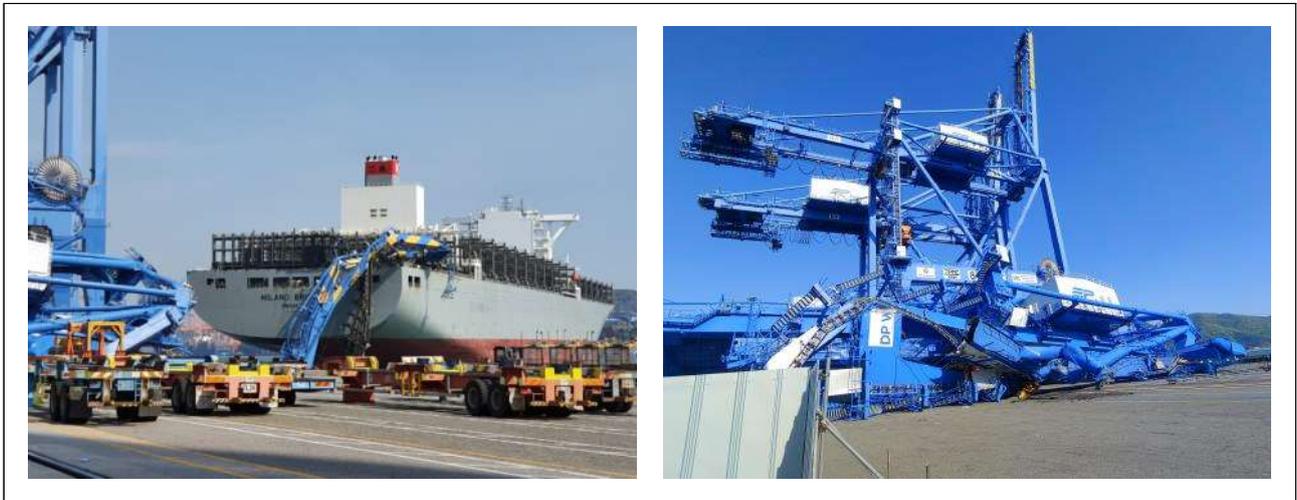
<Figure 16> Collapsed and damaged cranes

2.13.2 *Milano Bridge* contacted Gantry Cranes Nos.85, 84, 83, and 81, which were standing by for cargo operations at the pier. Nos.85 and 81 were a total loss,¹⁹⁾ while Nos.84 and 83 sustained damage that required 9-months of repair at Jinhui Shipping Repairing & Building Factory Co., Ltd., in China. Apart from that, a rail track of

¹⁹⁾Gantry Crane No.85 collapsed and was destroyed after colliding with *Milano Bridge*. Nos.84 and 83 sustained partial damage. When investigating No.82, no damage was found. As for No.81, the boom of the crane collided with the wing bridge of *Milano Bridge*, and its legs collapsed, causing a total loss.

the gantry crane at Pier No.2 and asphalt sustained damage²⁰).

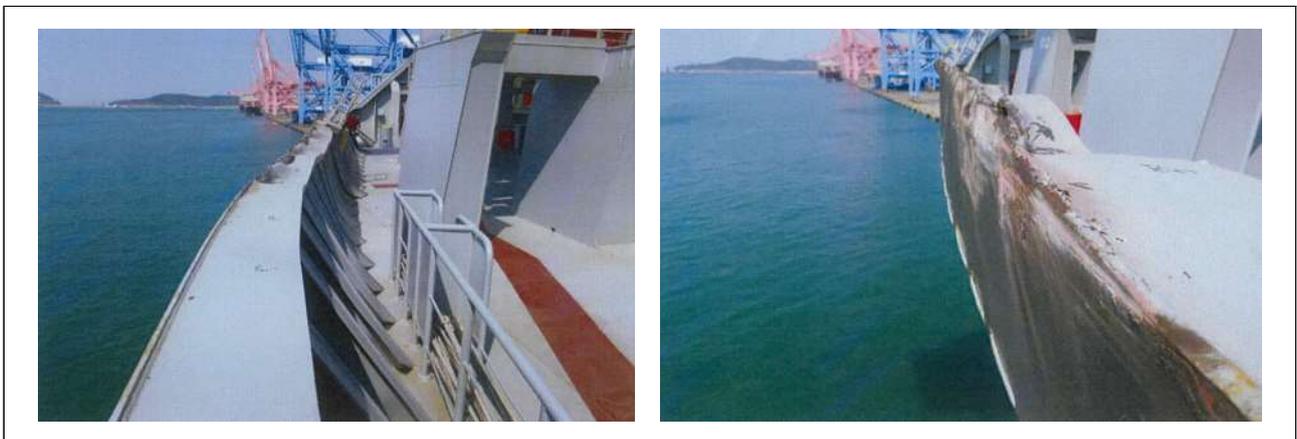
<Figure 17> Dents & damaged areas of M/V *Seaspan Ganges*

2.13.3 Also, M/V *Seaspan Ganges*, a containership docking at Berth No.7 of Pier No.2, east of the berthing place of *Milano Bridge*, sustained damage²¹) to the port bow shell plate (bulwark plating, etc.) and empty forepeak tank (upper bracket, etc.).

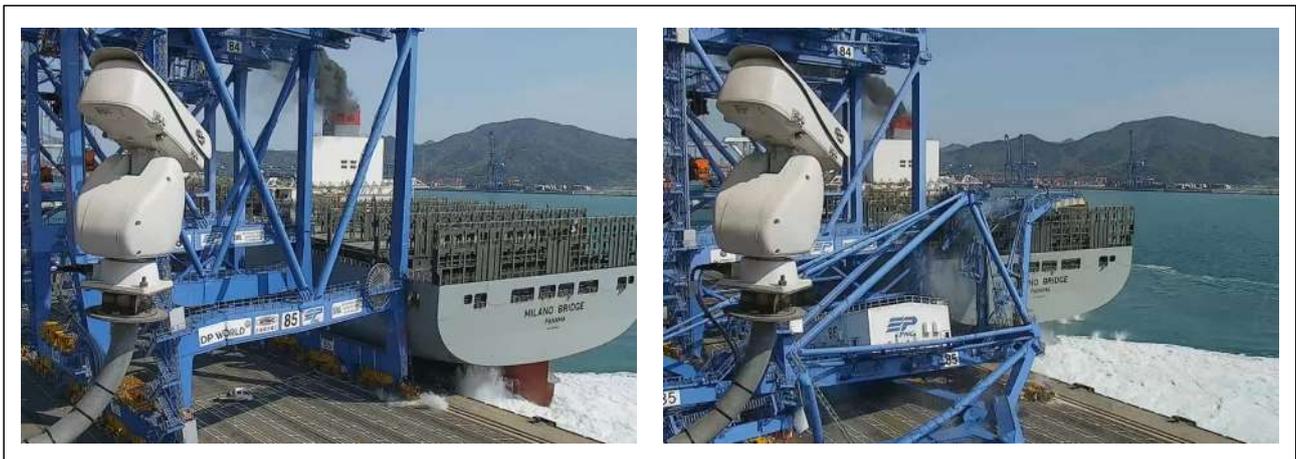
<Figure 23> Collision between *Milano Bridge* and the gantry crane (CCTV)

with the port wing bridge of *Milano Bridge*, cutting the support frame of the crane and collapsing its lower part.

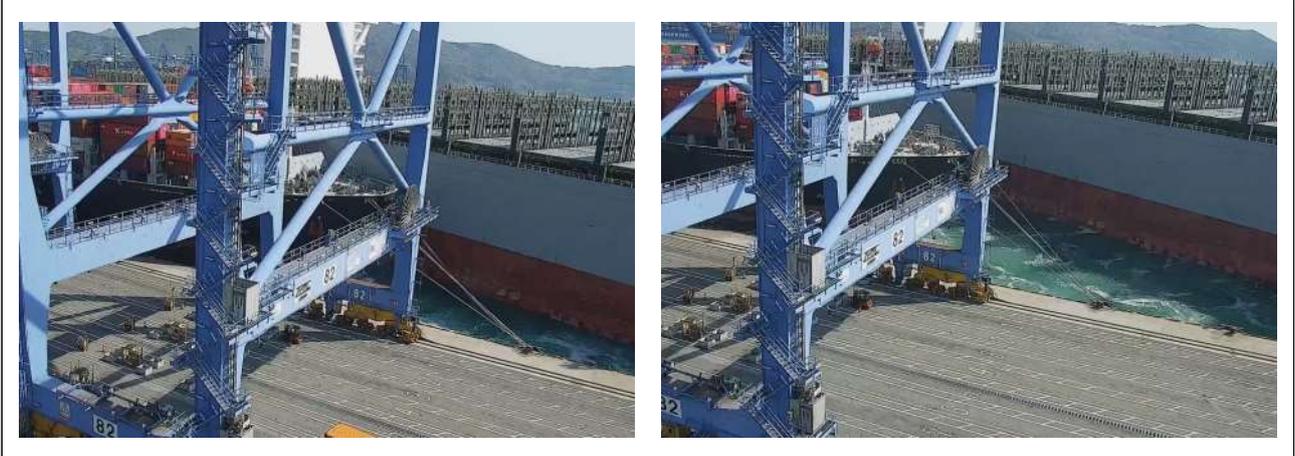
<Figure 24> Collision between *Milano Bridge* and M/V *Seaspan Ganges* (CCTV)

Seaspan Ganges, berthed on the starboard side at Berth No.7 of Pier No.2, causing dents and scratches.

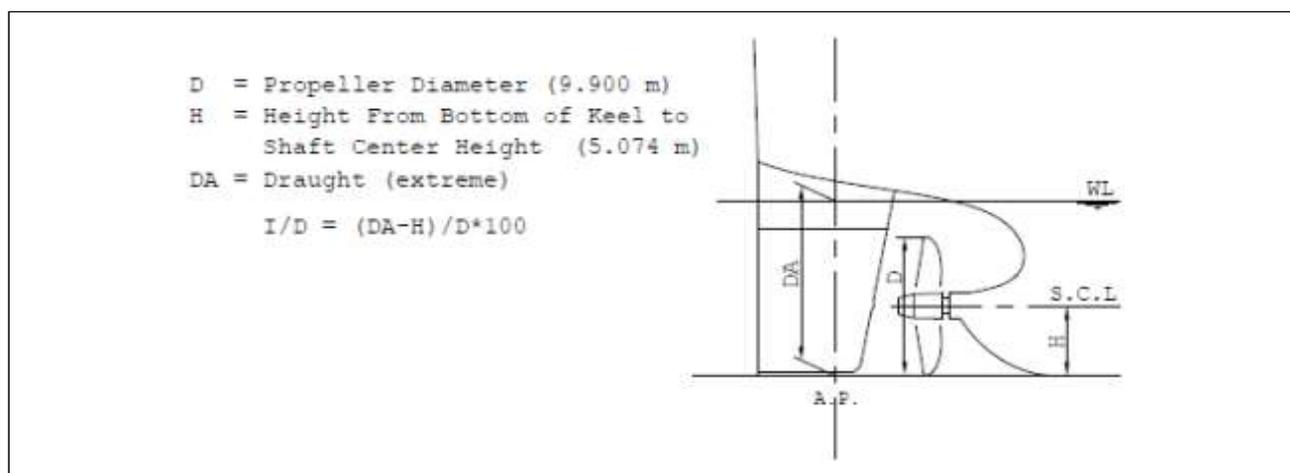
<Figure 26> Calculation for the propeller immersion ratio of *Milano Bridge*

4.3.4 A more specific calculation of the immersion ratio is illustrated in Figure 26, based on which the I/D value is calculated to be 18.4.³⁰⁾ It means the immersion ratio of *Milano Bridge* is estimated only at 68.4% (50+18.4) at the time of the accident.

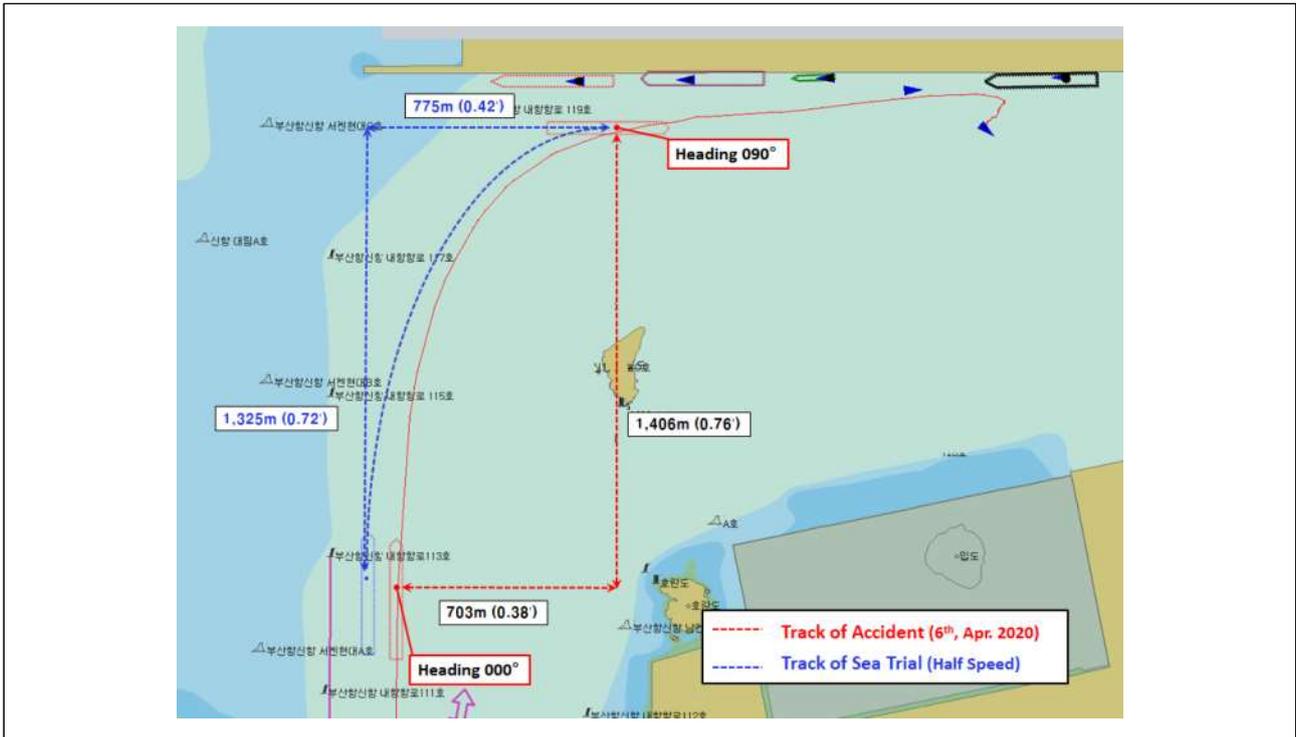
<Figure 29> Track comparison

4.4.1.7 The vessel put To Islet on the starboard side and made a large course change of 90° to turn starboard from 14:36 to 14:43 (approximately 7 minutes and 45 seconds on a per second basis). In the following table, such a track (from Point A to C) was compared with the track of *Milano Bridge* during the sea trials,³⁴⁾ when she was in ballast at half ahead (10.6 knots), like the conditions at the time of the accident.

Track	Navigation conditions	Time consumed	Advance	Transfer	Remark
A 90° course change during the accident (A)	Draft aft: 4.5m Draft forward: 6.9m Speed: 9.4kn	7m 45s	1,406m	703m	Use main engine, rudder, tugs, and bow thrusters to speed up her turning.
Maneuverability performance during the sea trials (B)	Draft aft: 4.72m Draft forward: 10.27m Speed: 10.6kn	6m 5s	1,325m	775m	Keep starboard 35°
Difference (B-A)		+1m 40s	+81m	-72m
