## LESSONS LEARNED FROM MARINE SAFETY INVESTIGATION REPORTS

SUB – COMMITTEE ON  
IMPLEMENTATION OF  
IMO INSTRUMENTS  
4TH SESSION  
2017

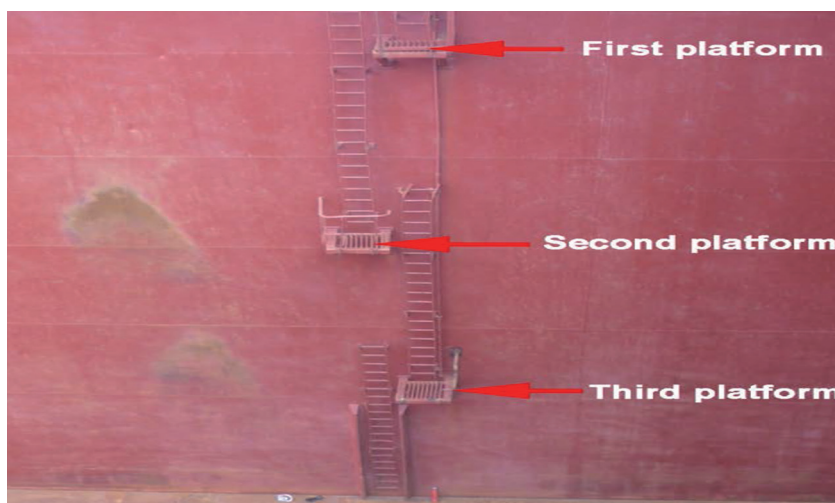
- The platform was cluttered with equipment that the crew member was using to effect the repairs and was not guarded by hand rails, making the platform a congested and dangerous place to work.
- A single halogen light had been rigged about one metre above the platform. The light was another obstacle that the crew member had to work around.
- Although shipboard procedures required the crew member to use a safety harness for the task, he was not wearing one at the time. Wearing a safety harness and connecting it to a secure point would have arrested his fall.

Figure 1.2 Number five cargo hold ladder: note that the handrails have been removed from around the third platform SOURCE Investigation report(ATSB)

- Working at height without the protection of hand rails is a hazardous situation. It is important that seafarers follow industry best practice of using a safety harness when working at height.
- It is important when working in dark spaces that sufficient lighting is used to illuminate the immediate and general working area without obstructing the workers.

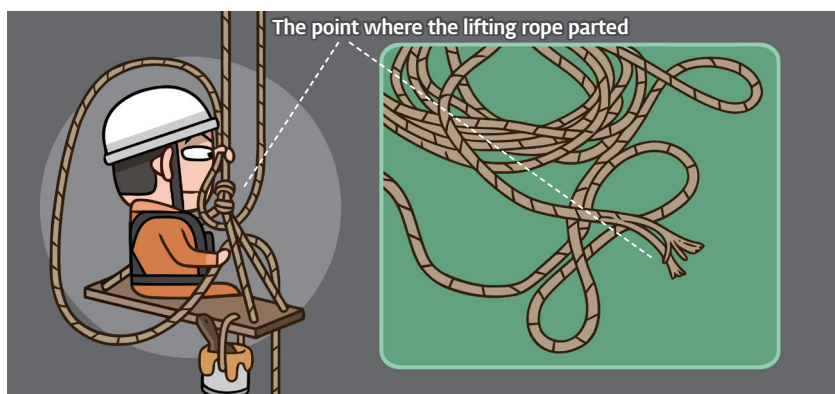
- The rope holding the Bosun's chair was in poor condition - the main reason for its failure. Further, the crew were heaving the rope to recover the man sitting on the Bosun's chair instead of using a safer method, such as a rope ladder for the man to climb up to the deck.
- Although a permit to work over the side had been issued, basic precautions were not in place. These include using a personal flotation aid, effective fall prevention equipment and proper supervision.

Figure 2.1 Damaged part of the lifting rope

- Safely working over the side of a ship relies on an effective permit to work that ensures suitable precautions are in place, including the wearing of an appropriate flotation aid and proper use of fall prevention equipment.
- Work over the side must be properly supervised to ensure all measures identified in the permit to work are followed.
- Preventing a person falling overboard should always be a primary objective.
- Wearing a flotation aid significantly improves the chances of a person's survival and recovery, and its design should be appropriate for the work being undertaken.
- It is also essential to have effective man overboard recovery measures in place, including properly trained crew and maintained equipment such as rescue boats.
- Seafarers, shipowners, ship operators.

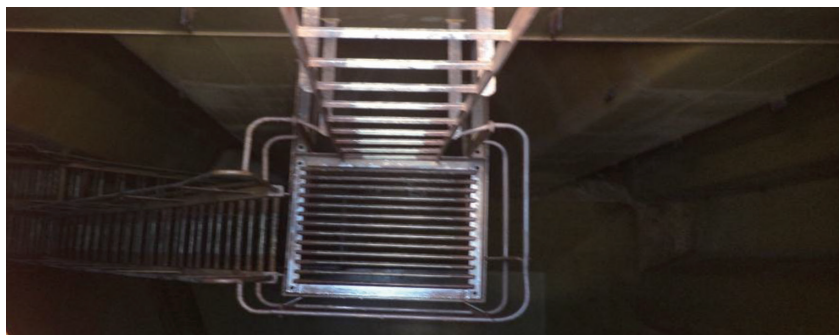
- At the time of the accident, the ambient temperatures on deck and inside the cargo oil tanks were about 33°C and 37°C respectively. The superintendent might have suffered from heat exhaustion that caused him to lose his grasp of the vertical ladder while he was entering 4S cargo oil tank in the afternoon under high ambient temperature.
- The vertical ladder had no guard rings, which could have prevented him from falling sideways after he lost his grasp of the ladder.

Figure 3.2 Access ladder inside 4S COT SOURCE Investigation report(HKSAR, The Hong Kong Special Administrative Region)

- It is necessary to take extra precautions and to use fall arrestors as far as practicable to avoid falling when climbing on a vertical ladder that is not fitted with guard rings.
- Account should be taken of the impact of heat on the human body during prolonged periods of work in a hot climate.

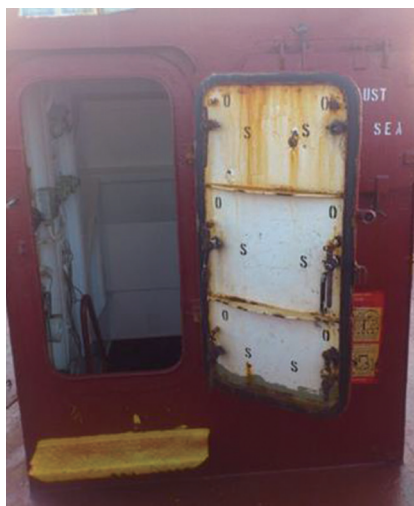
- The weathertight door opened in heavy weather because it had not been properly secured for sea or checked before the onset of bad weather.
- The crew member who died was on the fore deck with the ship heading into heavy weather. The officer of the watch did not consult or advise the master of his intentions and did not take sufficient account of the risk of sending a man forward in heavy weather without taking any precautions.
- The crew member also did not take sufficient account of the risk of going forward in the prevailing conditions or challenge the instructions of the officer of the watch.

Figure 4.2 The weather-tight door on the fore-castle deck SOURCE Investigation report(HKSAR)

- It is dangerous to go on a ship's deck in heavy weather. If going on deck is considered critical for the ship's safety, the master needs to risk assess the operation and take all precautions to minimize the risks.
- Turning the ship away from heavy weather to reduce rolling/pitching and the risk of shipping seas is an essential precaution to take before anyone goes on deck.
- It is essential to properly secure a ship for sea, including closing all weather/watertight doors and other openings on deck.
- Monitoring forecast weather at sea is essential so that necessary precautions, including checking that weather/watertight openings are securely closed, are taken before encountering heavy weather.

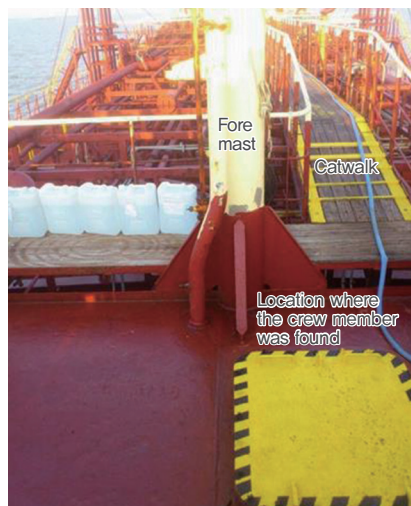
Figure 4.3 Location where the crew member was found SOURCE Investigation report(HKSAR)

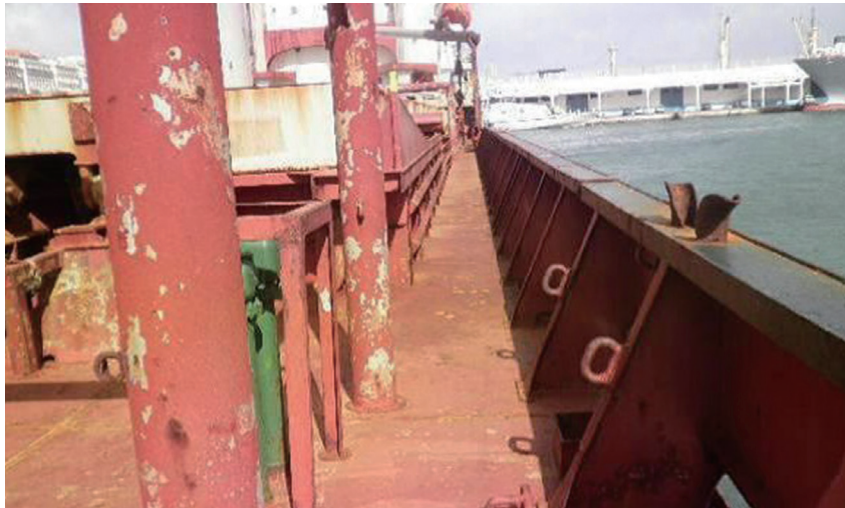
- The ship was anchored in heavy weather instead of being hove to or seeking shelter from the storm.
- The crew members were sent on deck in heavy weather.
- Neither the Master nor the Chief Mate and other crew who went on deck adequately considered the high risk of going on deck in heavy weather.

Figure 5.2 View on main deck in way of the hold No.2 SOURCE Investigation report(Panama Maritime Authority)

- Anchoring a ship in heavy weather is hazardous and its anchoring equipment is not designed to be used in heavy weather.
- Good seamanship requires a Master encountering heavy weather at sea to consider all safe options, one of which must include the ship being hove to until the weather moderates.
- It is dangerous to go on a ship's deck in heavy weather. If going on deck is considered critical for the ship's safety, the Master needs to perform heavy weather risk assessment in advance and take all necessary precautions.

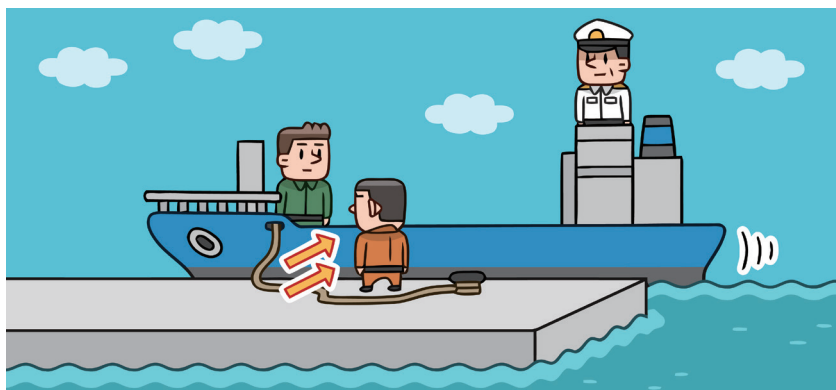
- The stevedore moved into a hazardous area, where mooring operations were still underway. The ship's crew on deck could not see him or the mooring line on the wharf from their positions, and no one on the bridge noticed him.
- The shore mooring linesmen did not prevent the stevedore from entering the hazardous area where they were still conducting mooring operations. The mooring gang company's safety management system did not have adequate procedures to prevent unauthorized entry to prohibited areas. There were neither warning signs for such areas nor other physical measures to prevent entry to them. The safety oversight of the company managing the wharf (with respect to supervision of the mooring gang company) was also inadequate.

Figure 6.1 The Scene of the casualty SOURCE Investigation report(China MSA)

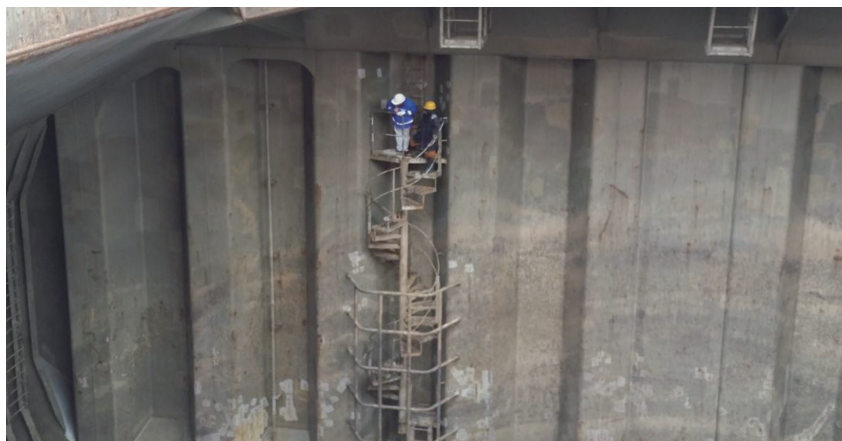
Figure 7.2 Inside cargo hold no.3 SOURCE Investigation report(Panama Maritime Authority)

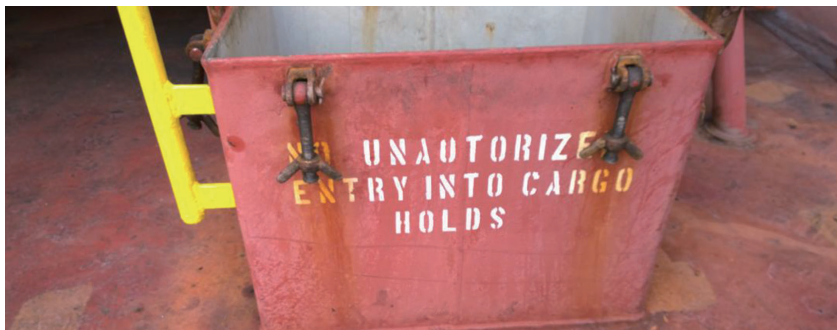
- AB1 was instructed by the Bosun to enter the cargo hold despite the access hatch being marked “NO UNAUTHORIZED ENTRY INTO CARGO HOLDS” and no crew members having been ordered by an officer to do so.
- None of the required precautions were taken to provide safe access when AB1 was instructed to enter the cargo hold.
- The Bosun, AB2 and OS1 all entered the cargo hold unaccompanied to provide help without first taking any safety precautions.

Figure 7.3 Manway Access to Cargo Hold No.3 SOURCE Investigation report(Panama Maritime Authority)

- Access to enclosed spaces without required safety measures in place occurs frequently and leads to casualties.
- Self-contained breathing apparatus sets should be placed close to the entrances of enclosed spaces during entry, and be readily available for use in an emergency.
- The need for authorized entry of enclosed spaces, required precautionary safety measures and relevant training should be stipulated at safety meetings and during newcomer familiarization.
- Effective enclosed space entry training and drills should take into account the instinctive reaction of seafarers to provide assistance and highlight that doing so without appropriate safety equipment is hazardous and can result in additional casualties.

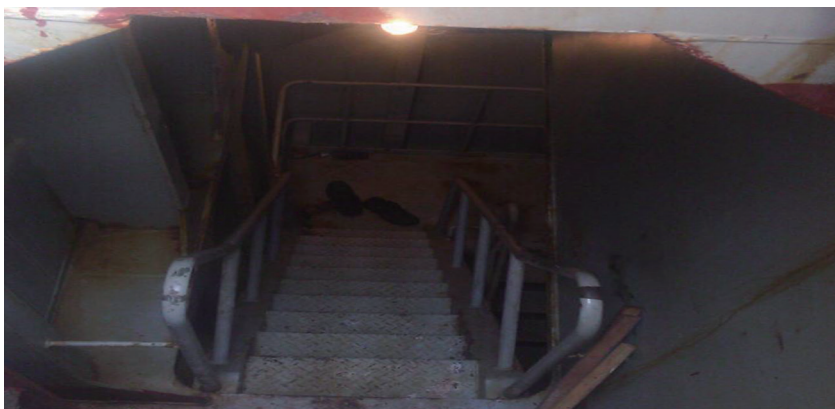
- The existing shipboard operational procedures did not take account of the carriage of timber cargoes and the danger posed by oxygen depletion.
- There were no warning notices at the point of entry to the cargo hold, on either the outside or inside of the access hatch cover.
- An enclosed space entry procedure had not been detailed as a key shipboard operation in the Safety Management System(SMS).
- The human instinct of wanting to save a colleague resulted in the Chief Engineer and second Officer entering an unsafe space without suitable precautions for their own individual safety.

Figure 8.2 No.3 Cargo Hatch View from top looking down onto platform 2 at base of stairway  
SOURCE Investigation report(Isle of Man Ship Registry)

- There are inherent dangers associated with entry of enclosed spaces, particularly cargo holds, no matter what type of cargo they may contain, including those posed by oxygen depletion from the timber cargo.
- There is a need to ensure that all persons who are required to enter an enclosed space positively identify the atmospheric condition against parameters, which should be stated in the SMS together with procedures for safe entry.
- Effective enclosed space entry training and drills should take into account the instinctive reaction of seafarers to provide assistance and highlight that doing so without appropriate safety equipment is hazardous and can result in additional casualties.

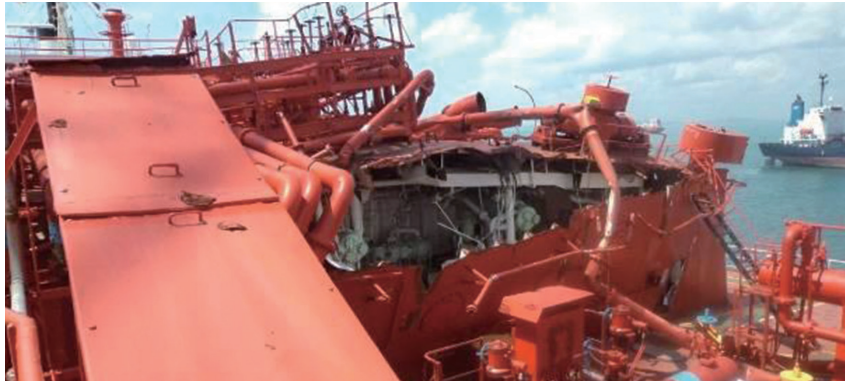
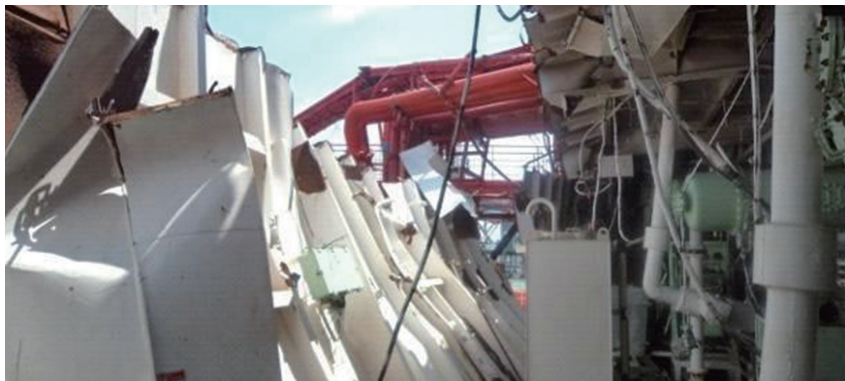
Figure 9.1 Photo of the accident(Fwd cargo compressor Room) SOURCE Investigation report(Panama Maritime Authority)

Figure 9.2 Photo of the accident(Out Side cargo compressor Room) SOURCE Investigation report(Panama Maritime Authority)

- The ship's managers had not made arrangements for the work to be done while the ship was at a repair facility; instead, they allowed it to be carried out during a laden voyage. The facilities and equipment on board were not suitable for the work. No permit to work was issued; risks were not properly assessed and no specific safety precautions were planned. No officer had been assigned to supervise the work.

- The source of ignition was not established but it is believed to have caused a flashback from the cutting torch along the hose connecting it to a cargo compressor.

- Whenever possible, hot work within the cargo area of a vessel carrying flammable cargoes should be carried out in a repair yard after all gas-freeing processes have been carried out and the area declared safe.

- If it is imperative that hot work has to be undertaken during the voyage, it should only be undertaken after a detailed risk assessment has identified ALL significant risks arising out of the work activity – including an evaluation of the suitability of the tools to be used – and suitable mitigation measures have been put in place. This should include procedures for any repairs or maintenance pertaining to any kind of hot work, particularly in areas exposed to hydrocarbons which would cause a serious accident, threatening life and property. The assessment should also take into account any existing precautions to control the risk, such as permits to work, agreed procedures as per SMS, use of personal protective equipment, use of safe tools, and a "Stop Work Policy."

- Under no circumstances should attempts be made by the crew to tap-off cargo gas to progress repair work. Any modification to cargo lines should be approved by the Administration and the vessel's classification society.

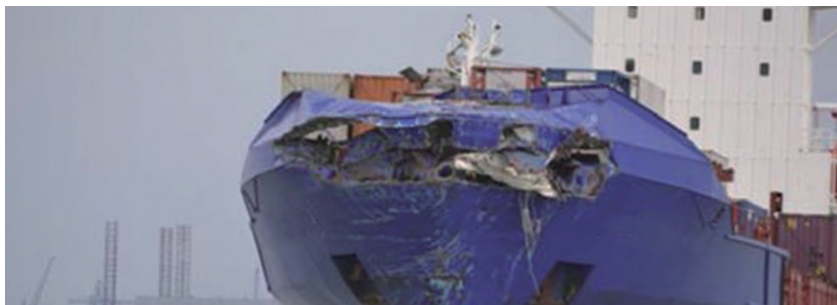
Figure 11.3 Photo of the ship in the collision(After) SOURCE Investigation report(Bahamas Maritime Authority)

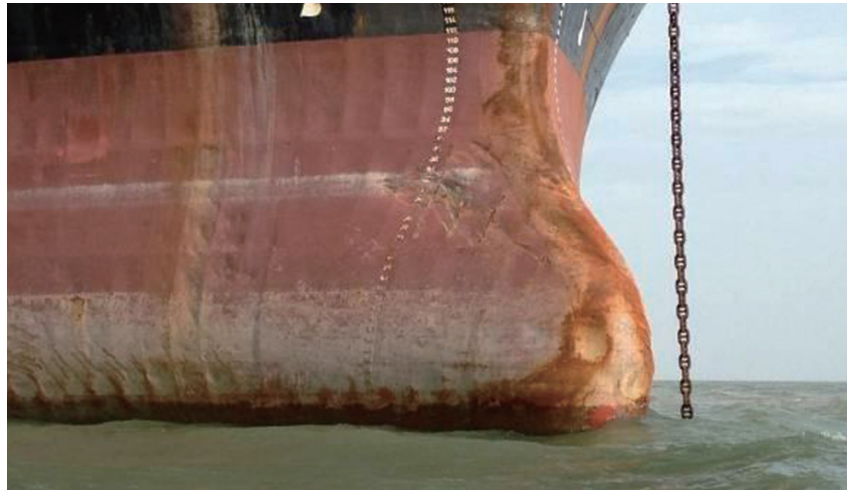
Figure 12.1 Photo of the ship after collision(Bulk Carrier) SOURCE Investigation reportInvestigation report (Panama Maritime Authority)

- The speed of the bulk carrier was too high to turn it around at the turning basin.
- After the engine was stopped, there was a delay in executing the engine astern order to further reducing the ship's speed.
- There was no detailed discussion between the master and pilot about maneuvering the vessel and the master was not aware of what the pilot intended to do.
- The ship's passage plan to the jetty did not take the starboard turn at the basin into consideration.
- The pilot was tired and not feeling well. Fatigue might have adversely affected his performance.

- The speed should be lowered to the minimum necessary to manoeuvre the ship while approaching a jetty.
- The passage plan should be detailed from berth to berth, taking into consideration the vessel's manoeuvring characteristics and the local conditions.
- The master and pilot should fully discuss the passage plan and have the same understanding on what they intend to do.
- Bridge Resource Management (BRM) should be effective to facilitate coordination and information exchange between the bridge team and the pilot. Crew members and pilots should be well trained in BRM.

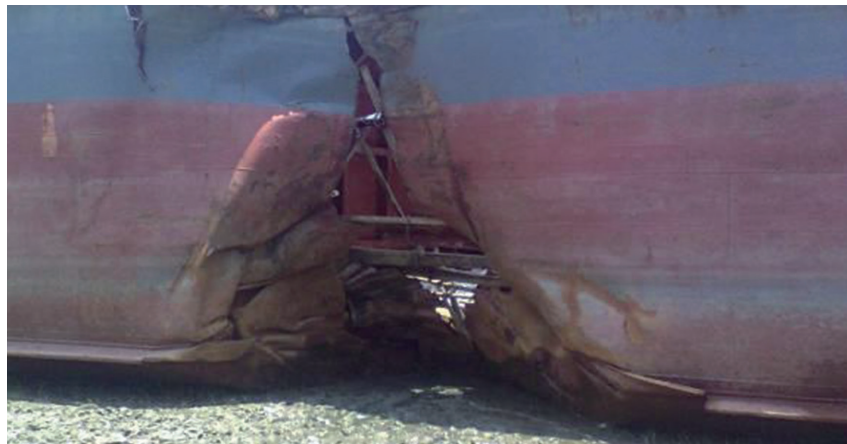
Figure 12.2 Photo of the ship after collision(Coaster Barge) SOURCE Investigation report (Panama Maritime Authority)

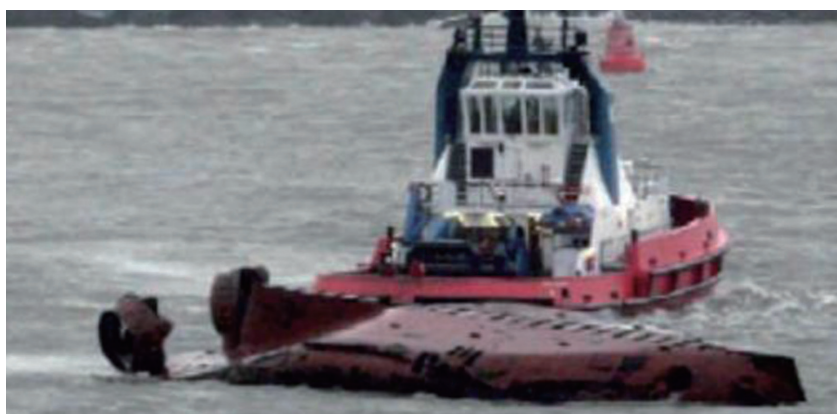
Figure 13.2 The capsized tug SOURCE [www. tugspotters.com](http://www.tugspotters.com), Investigation report(The Dutch Safety Board)

- The tug did not comply with the required stability parameters, which meant it was prone to excessive heeling during operations and down-flooding.

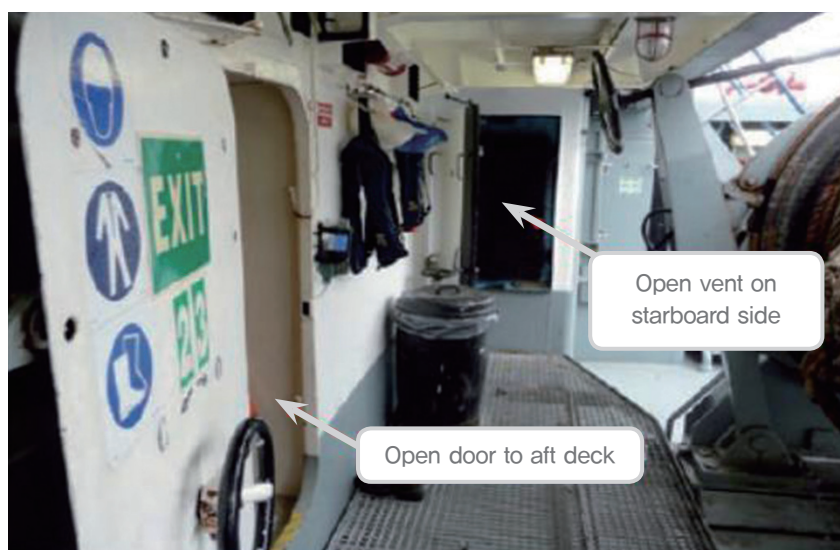
Figure 13.3 The door leading to the after deck on the tug(sister ship)  
SOURCE Investigation report(The Dutch Safety Board)

- Establishing a tow between a tug and ship should be conducted at safe speed in order to give the tug greater manoeuvrability and avoid it having to depart from the "safe zone" where dynamic interaction is less likely to occur.
- Ship masters (especially those holding a pilot exemption certificate) and tug masters must have a thorough understanding of both the theoretical and practical aspects of safe tug/ship operations.
- Tugs should be fit for the purpose they are being used. They require good stability and sufficient power and manoeuvrability for the intended operation.
- Down-flooding will quickly erode any reserves of stability and will be a major factor contributing to a capsize. During critical or high-risk operations all doors and other openings that need not be open should be securely closed.

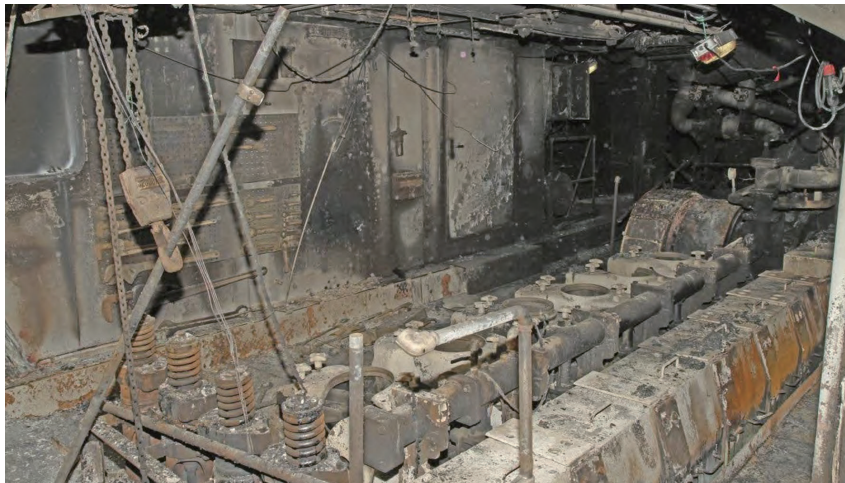
- After the fire, two different leakages were found in the fuel system, one from fuel injector pump No.5 fuel return pipe – which was completely fractured just below the pump flange – and one from the shared fuel return line drainage ball valve at the forward end of the starboard engine at floor plate level. The body of this valve was found detached from the pipe and lying on the floor plates. The indicator cock adjacent to No.5 fuel pump was not insulated, and it was concluded that the hot surface had ignited the escaping fuel.

- All four fastening bolts for the fuel injector pump were found to be loose, allowing the pump housing to move. Subsequent examination of the fracture surfaces showed that the fuel return pipe most probably broke as a result of fatigue fracturing, caused by the cyclical vertical loads caused by the movement of the pump body. The pump body was moving because the holding down bolts had not been correctly secured after the pump had been replaced twelve days previously. The fire spread to vital control equipment. Spray shields/covers were originally fitted by the engine manufacturer in front of each range of fuel pumps. These were not in place at the time of the fire. Had they been in place, they might have prevented fuel and flames impinging on the control equipment.

Figure 14.2 Starboard side of the main engine room SOURCE The police, Investigation report(AIBN)

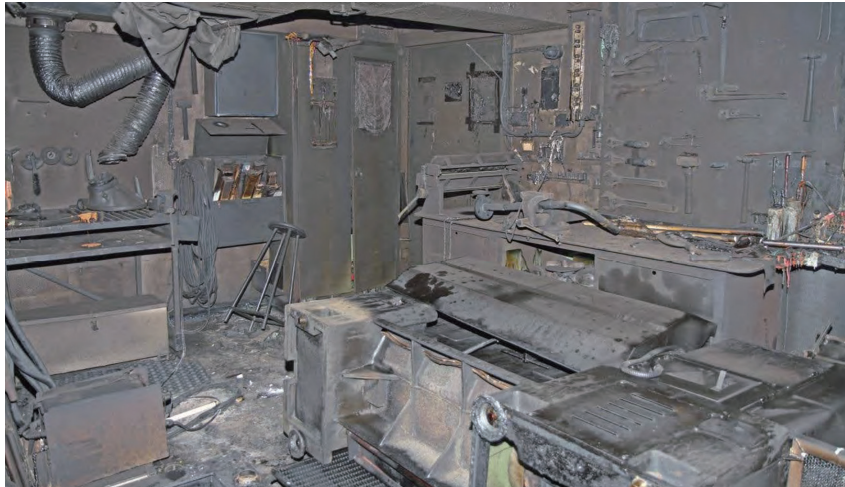
Figure 14.3 The interior of the workshop on the starboard side SOURCE The police, Investigation report(AIBN)

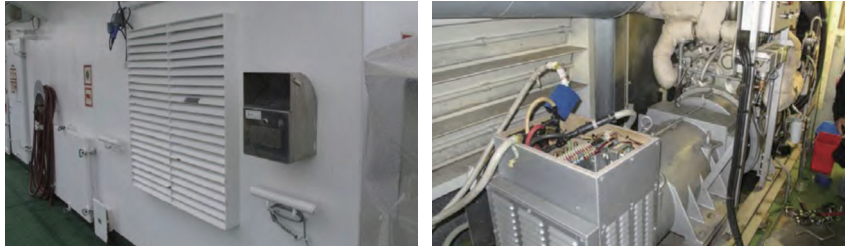
Figure 15.1 Damper of the emergency generator SOURCE Investigation report(AIBN)

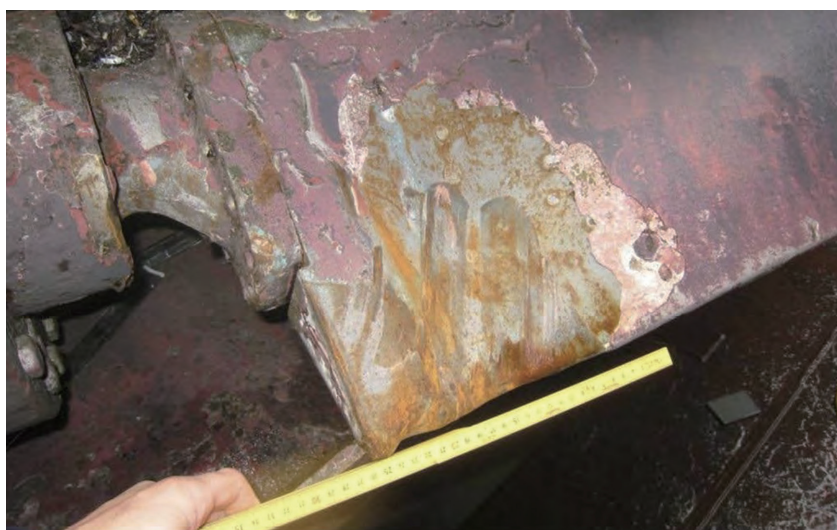
Figure 16.1 damage sustained on the starboard stabiliser fin SOURCE DNV, Investigation report(AIBN)

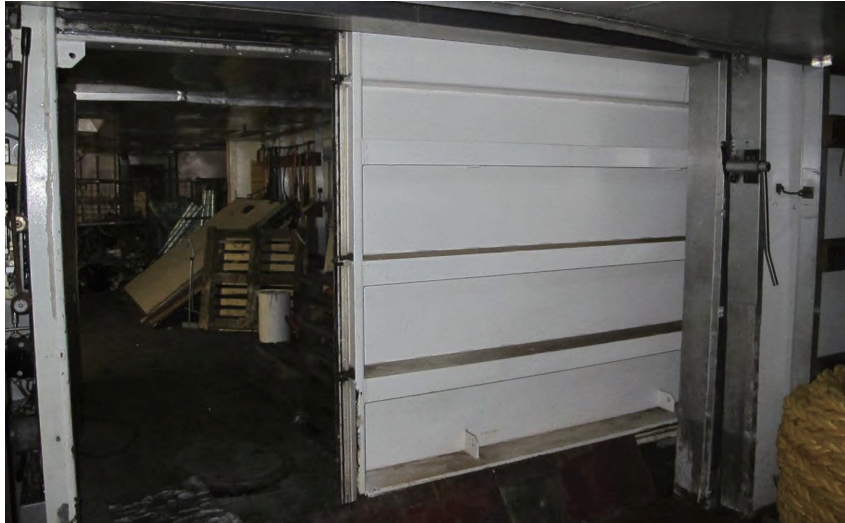
Figure 16.2 The watertight sliding door between cargo hold no 1 and cargo hold no.2  
SOURCE Investigation report(AIBN)
