2021년도 주요 해외 해양사고 교훈사례집

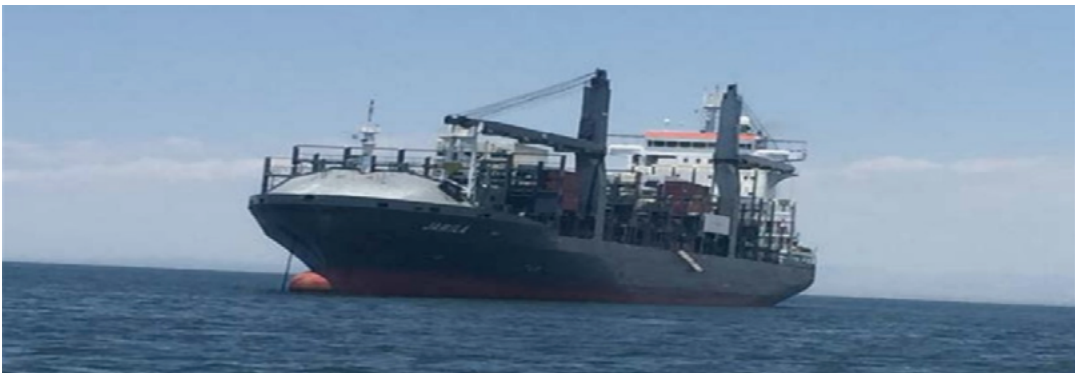
컨테이너선 A호는 조업 중인 다른 선박 무리를 통과하는 동안 어구를 서로 당기며 와이어로 연결된 상태로 조업 중인 어선 두척을 피하지 못하고 충돌하였다. 이번 충돌사고로 두척의 어선은 침몰되었고 이로 인해 선원 두 명이 익사하였으며, 컨테이너선 A호는 선체 표면이 손상되었다.

Figure 1.1 Container ship 출처 Investigation Report (LIBERIA MARITIME AUTHORITY)

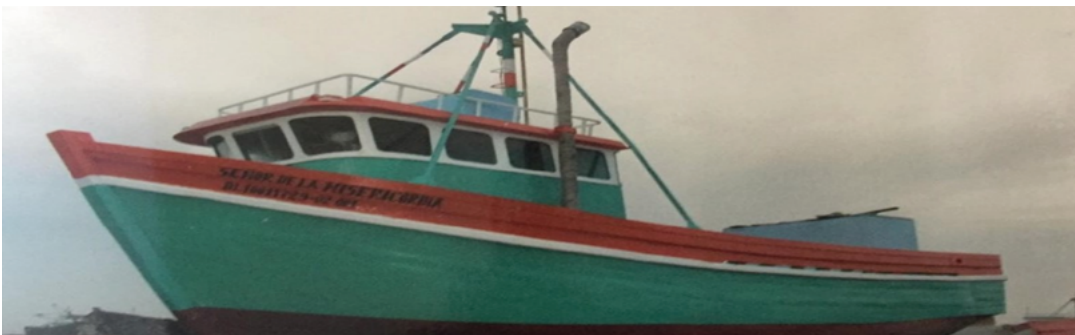
Figure 1.2 Fishing boat 출처 Investigation Report (LIBERIA MARITIME AUTHORITY)

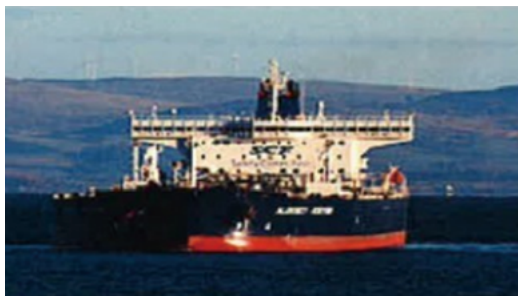
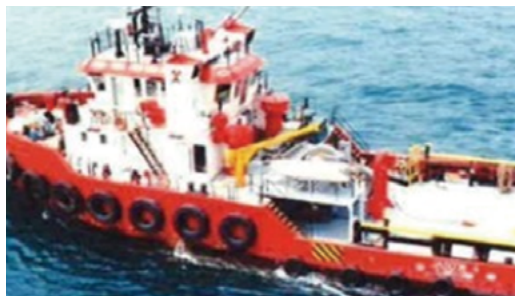
악화된 기상과 예인선의 당김으로 인해 유조선을 SBM에 연결하고 있던 선수체인이 끊어졌고 유조선은 SBM에서 떨어지며 표류하기 시작했다. 이로 인해 SBM과 유조선에 연결된 화물호스가 손상되었다.

그 후 예인선은 VHF를 통해 선내 비상상황을 알렸다. 예인선 갑판 위에는 해수가 유입되어 있었고 큰 파도가 두 차례 연속 예인선을 강타하자 심하게 횡요하다 전복되었으며 이후 빠르게 침몰하기 시작했다. 이를 목격한 나머지 또 다른 무어링마스터가 즉각적인 지원을 요청하여 또 다른 예선이 바로 도착하였으며, 즉시 생존자 수색작업을 시작하였다.

Figure 2.1 Oil tanker · Tug boat 출처 Investigation Report (LIBERIA MARITIME AUTHORITY)

심한 악천후 상황속 유조선과 SBM의 접촉을 방지하기 위해 유조선과 연결된 예인선이 예인줄(tow line)을 당겼고, 그로 인해 SBM과 유조선을 연결하던 선수체인이 끊어졌다.

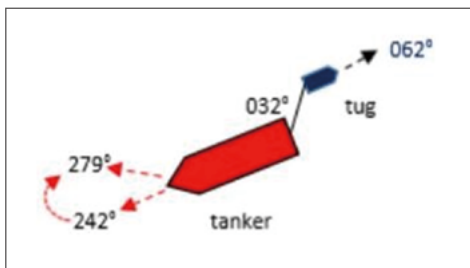
* 예인선의 선수미선이 예인줄의 방향과 직각이 되면 갑판 상부 예인줄을 잡은 비트에 피예인선박이 끌어당기는 강한 힘을 받음과 동시에 수면하부에는 조류 유압이 반대방향으로 작용하여 예인선은 대각조 횡경사 하며 동요하게 되는데 이를 거팅(girting)현상이라고 한다.

[그림 1] 예인줄과 유조선의 각도는 032°(유조선 선수방위 기준 5시 방향)로 예인선의 중심선은 유조선 중심선과 평행하였으며, 예인선 와이어는 거널에서 갑판실까지 미끄러졌고 첫 번째 파도에 부딪혔을 때 예인선은 우현으로 기울었다.

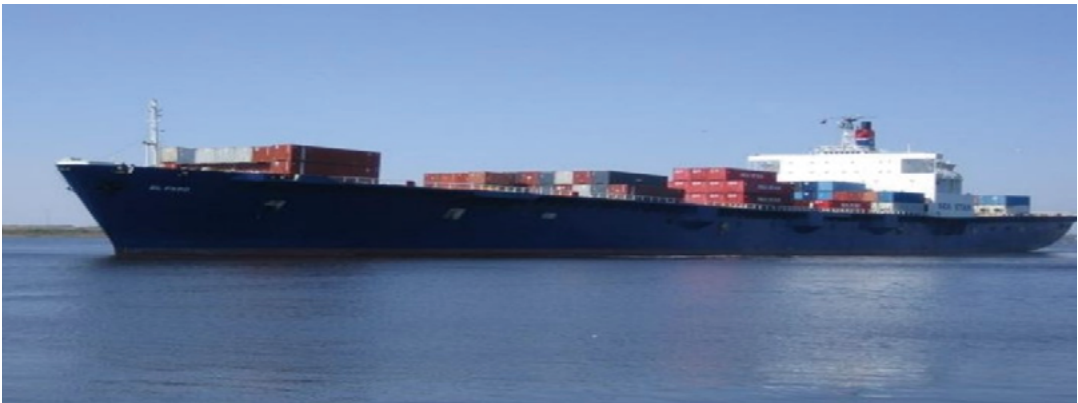
해수는 개방된 현장을 통해 화물창으로 유입되기 시작했고, 이로 인해 선박은 계속 우현으로 기울게 되었다. 종경사 및 횡경사로 인해 더이상 윤활유 섬프탱크 저수위로 추진기관의 작동을 유지할 수 없었으며, 이로 인해 선박은 표류하며 현측에서 강한 바람과 파도를 맞았다.

이후 침수는 점점 더 심해졌고 선박은 침몰하였다. 선박은 침몰되기 10분 전 조난경보를 보냈지만 생존자 위치를 파악할 수 없었다.

Figure 3.1 Container Ship 출처 Investigation Report (UNITED STATES COAST GUARD)

- 유지보수가 잘 되지 않은 선내구조와 통풍 댐퍼(ventilation damper)는 선박의 수밀성을 약화시켰다. 선박개조로 인해 만재흘수선(load line draft)이 높아 복원성이 낮아지고 악천후에 대해서는 취약해 졌다.
- 하역인부에 대한 관리감독 부족으로 선내 화물은 화물고박매뉴얼에 따라 튼튼하게 고박되지 않아 외력을 받을 때 화물이 이동하며 흘수선 아래의 선체 일부가 손상되었다.
- 기관사들에게 횡경사로 인한 엔진의 운영한계 및 악천후를 대비 필수 준비사항에대하여 충분히 알려주지 않았다. 그 결과 선박은 섬프탱크 내 윤활유 수위가 권장 수위보다 더 낮은 상태에서 출항하였고, 그 결과 주기관 추진장치 작동을 위한 윤활유 석션(suction)을 할 수 없었다.
- 선박의 복원성 소프트웨어로는 침수부위를 파악할 수 없었으며, 그 결과 침수지점을 파악할 수 없었던 선원들은 통풍구 입구를 닫을 수 없었다. 또한 승인받은 손상제어계획(damage control plan)이 있었다면 선원들은 선박 상태의 심각성을 인지하고 비상상황에 대응할 수 있었을 것이다. 그러나 이 역시 필수요건이 아니었기 때문에 본선에는 구비되어 있지 않았다.
- 선사 또한 안전한 항해, 수밀성, 악천후 대비, 악천후 상황 속 비상대응, 항해사의 수행실적을 평가하는 절차와 관련한 안전관리체제(SMS)의 효과에 대해 적절히 관리 감독하지 않았다.
- 선원훈련에 손상제어, 복원성 회복 수단, 기상학 및 선박조종은 포함되지 않았으며 RRDA(Rapid Risk Damage Assessment) 서비스에 가입했음에도 불구하고 해당 서비스에 대한 훈련도 없었다.
- 선박에 있는 개방형 구멍정이나 구멍뿔목을 적시에 사용했다 가정하더라도, 극심한 악천후 속에서 선원들을 제대로 보호할 수 없었을 것이다.

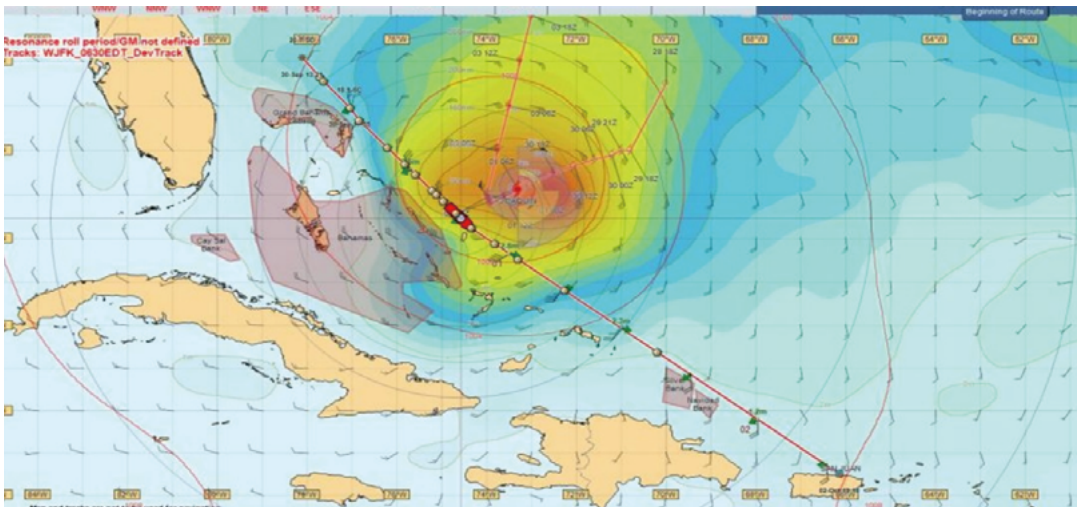
Figure 3.3 Course line 출처 Investigation Report (UNITED STATES COAST GUARD)

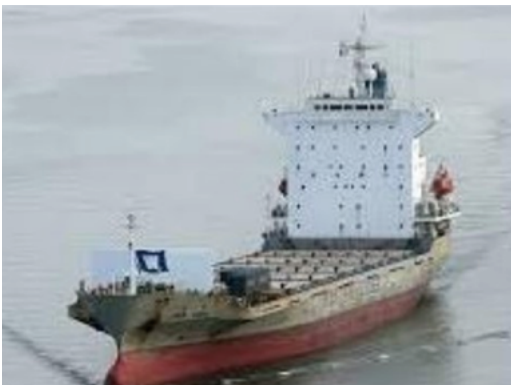
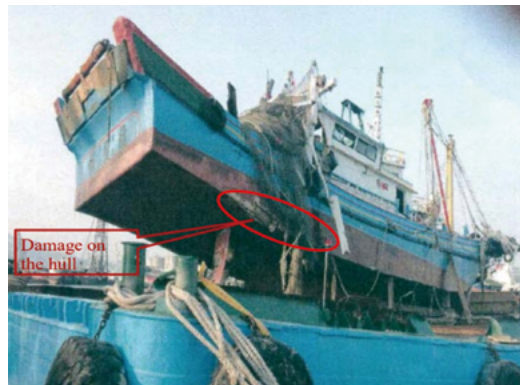
컨테이너선은 해당 위치로 선속 15.3kn로 이동하던 중 어선과 충돌하였으며 그로 인해 어선이 전복되었다. 어선 정장(coxswain)은 전복된 선박의 조타실 안쪽에 갇혔고 이후 익사하였다. 그 외 선원들은 바다에 빠져 실종되었다.

Figure 4.1 4.2 Container ship · Fishing boat 출처 Investigation Report(HONGKONG Special Administrative Region Marine Department)

- 1972년 국제해상충돌예방규칙(COLREG)을 준수하지 않았다.
 - 두 선박 모두 적절한 경계태세를 유지하지 않았다. 6해리 이상의 거리에서 컨테이너선 레이더에 어선의 표적반향 신호(target echo)가 나타났지만 충돌위험을 판단하기 위해 위치를 표시하거나 확인하지 않았다.
 - 피항선이었던 어선은 규정 16(Rule 16)을 따르지 않고, 컨테이너선의 항로를 피하지 않았다.
 - 컨테이너선은 유지선으로서 횡단상황에서 항로와 속도를 유지하되, 필요시 피항을 돕는 최선의 조치를 취하라는 규정 17(Rule 17)을 준수하지 않았다.

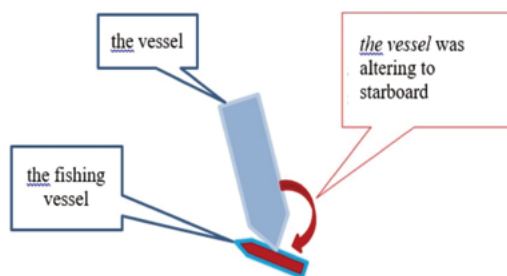
Figure 4.3 충돌상황도 출처 Investigation Report(HONG KONG S.A.R.M.D)

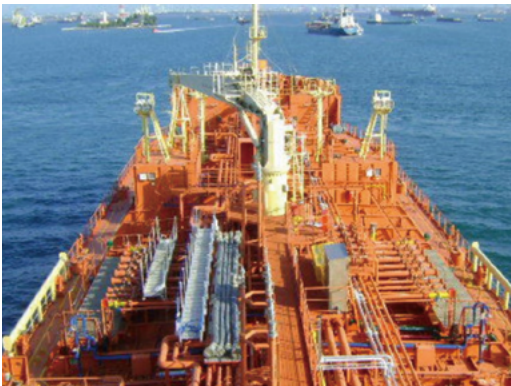
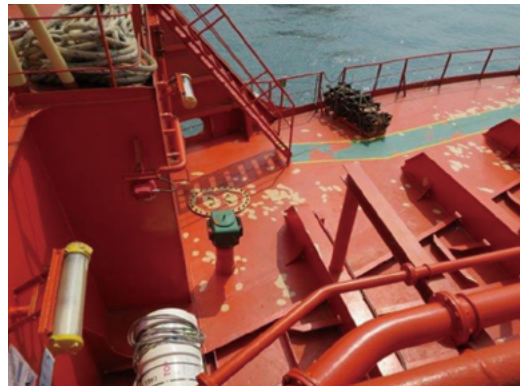
선장이 선속을 낮추고 갑판 위로 닥칠 파도를 줄이기 위해 변침을 하였다. 이들은 앵커 와이어 래싱(anchor wire lashing)이 떨어진 것을 포함, 다른 문제를 발견하였고 창고문제를 해결하고 선수루 창고를 점검하기로 결정하였다. 이러한 임무를 하는 동안 이들 중 한명은 우현 양묘기를 확인하기 위해 창고를 떠났고, 다른 3명은 창고 안에 남아 있었다. 떠났던 선원 한 명이 창고로 다시 돌아올때 큰 파도가 선수루를 지나 좌현에서 우현으로 덮쳤고 그는 파도에 휩쓸려 선외로 추락했다. 선장은 수색을 시작하였고, 다른 선박 두 척과 구조헬기도 수색에 동참하였다. 그러나 해당 선원을 찾지 못하였고 선원은 사망한 것으로 추정되었다.

Figure 5.1 5.2 Tanker · Foreward deck 출처 Investigation Report (Republic of the Marshall Islands Maritime Administrator)

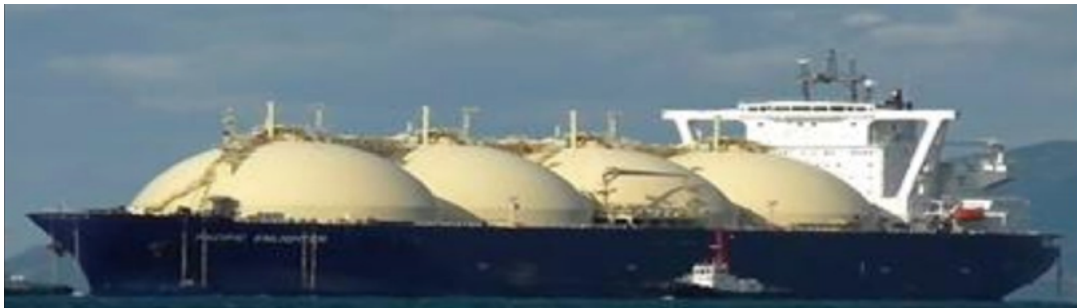
조선소에서 액화천연가스운반선의 이안작업 중, 조선소 근로자 2명이 계선용으로 사용된 계류식 테일로프에서 풀린 밧줄의 중간부분(bight)에 맞았다. 그들 중 한 명은 치명상을 입었다.

Figure 6.1 LNG Carrier 출처 Investigation Report (Transport Safety Investigation Bureau (TSIB) Ministry of Transport Singapore)

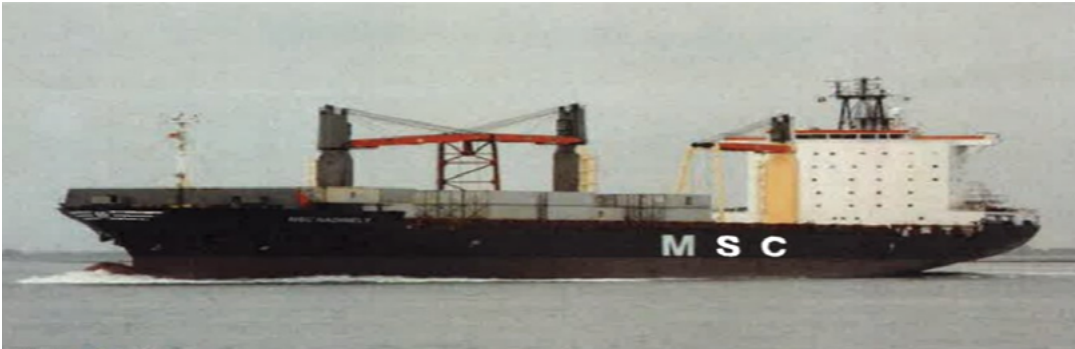
도선사 사다리를 준비하는 동안 갑판장은 동료선원에게 창고에 있는 필요한 물건을 가져오도록 요청하였다. 동료선원이 물건을 가지고 돌아왔을 때 사다리를 준비하던 갑판장과 도선사 사다리가 사라졌다. 갑판장을 수색하기 위해 경보를 울렸다. 갑판장이 발견되었으나 병원에서 사망하였다. 현장에서는 안전장비가 발견되었고, 갑판장은 구명조끼를 “착용”한 것으로 목격되었으나, 구조될 당시에는 구명조끼를 착용하고 있지 않았다.

Figure 7.1 Container ship 출처 Investigation Report (LIBERIA MARITIME AUTHORITY)

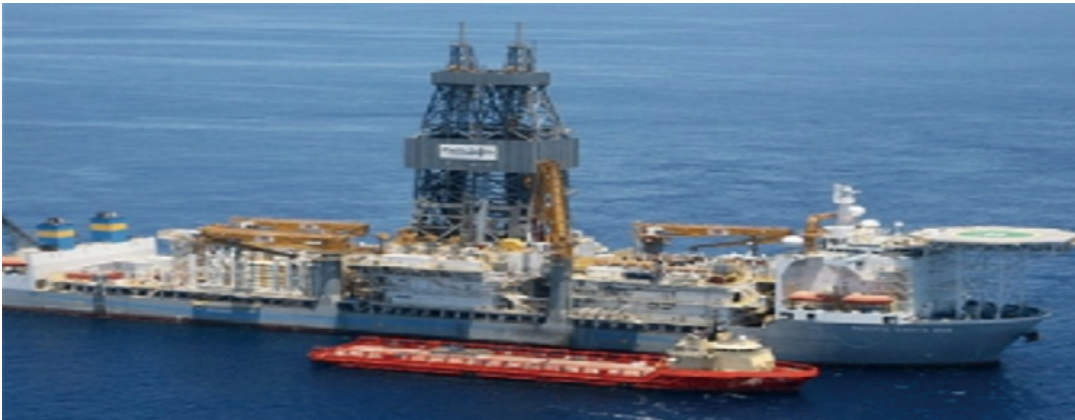
제32섹션 배관을 제거하는 동안 배관 걸쇠가 제대로 열리지 않았고 처리장비 하중으로 인해 배관이 구부러졌다. 채굴인부가 세트백 공간에 들어서는 순간 걸쇠가 풀어졌으며, 배관 하단이 튀어 오르면서 인부의 머리를 강타하였다.

Figure 8.1 Drill ship 출처 Investigation Report (LIBERIA MARITIME AUTHORITY)

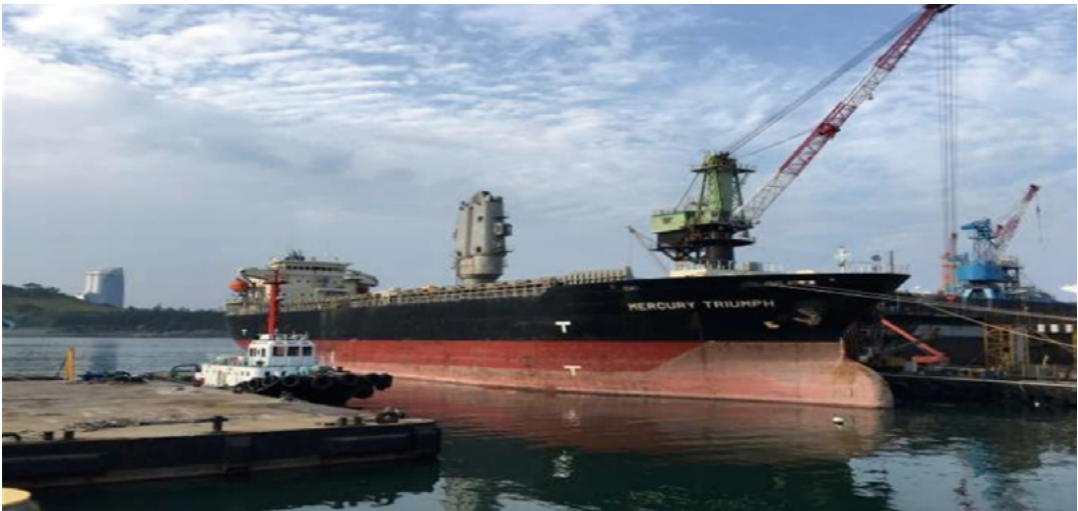
화물선 선장은 240도로 항해중 침로의 270도 방향으로 6해리 떨어진 거리에서 본선 좌현 선미방향으로 접근하는 상대선박을 확인하였다. 30분 후 화물선 이항사는 상대선박이 침로를 변경하여 상대선박과의 최근접점(CPA)이 0.8해리로 좁혀졌다는 사실을 인지하였다. 상대 선박이 화물선 쪽으로 우선회는 상황에서 화물선 이항사는 VHF를 통해 상대선박에 연락하였으나 응답이 없었다. 이항사는 충돌을 피하기 위해 우현전타하였지만 두 선박 간 충돌을 피할 수 없었다.

Figure 9.1 General cargo ship 출처 Investigation Report (PANAMA MARITIME AUTHORITY)

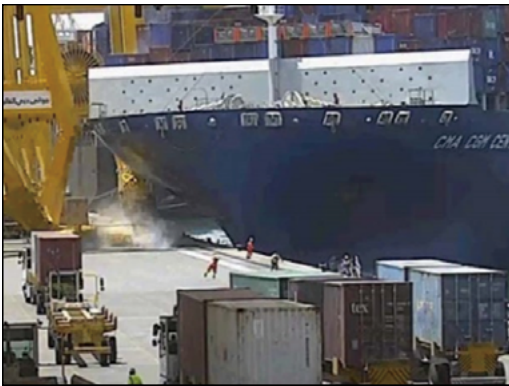
선장은 도선사에게 선박이 너무 빠르게(2.4kn) 움직이고 있다고 알리며, 반속 후진과 전속 후진 명령을 내리며 감속을 시도했지만 선박의 속력은 줄지 않았고, 3분 뒤 선박은 부두와 강하게 접촉하였다.

Figure 10.1 10.2 Heavy contact with quay 출처 www.porttechnology.org/news

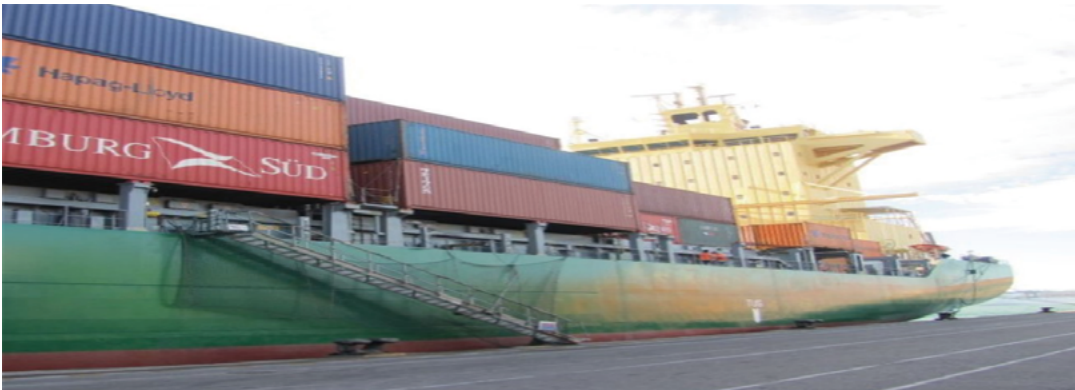
길이 210m의 28,000GT 컨테이너선은 악천후 속에서 항해 중 좌현 앵커가 느슨하다는 사실을 알게 되었다. 선장은 앵커를 다시 고정하기 위해 선박이 풍하측에 위치하도록 선회하였다. 하지만 거대한 파도가 선수루를 덮쳤고 선수에서 앵커를 고정하기 위해 작업중이던 선원 3명 중 1인인 1등항해사는 파도에 선외로 쓸려 나갔고, 갑판수(AB)는 심한 부상을 입었다.

Figure 11.1 Container ship 출처 Investigation Report (Republic of the Marshall Islands Maritime Administrator)

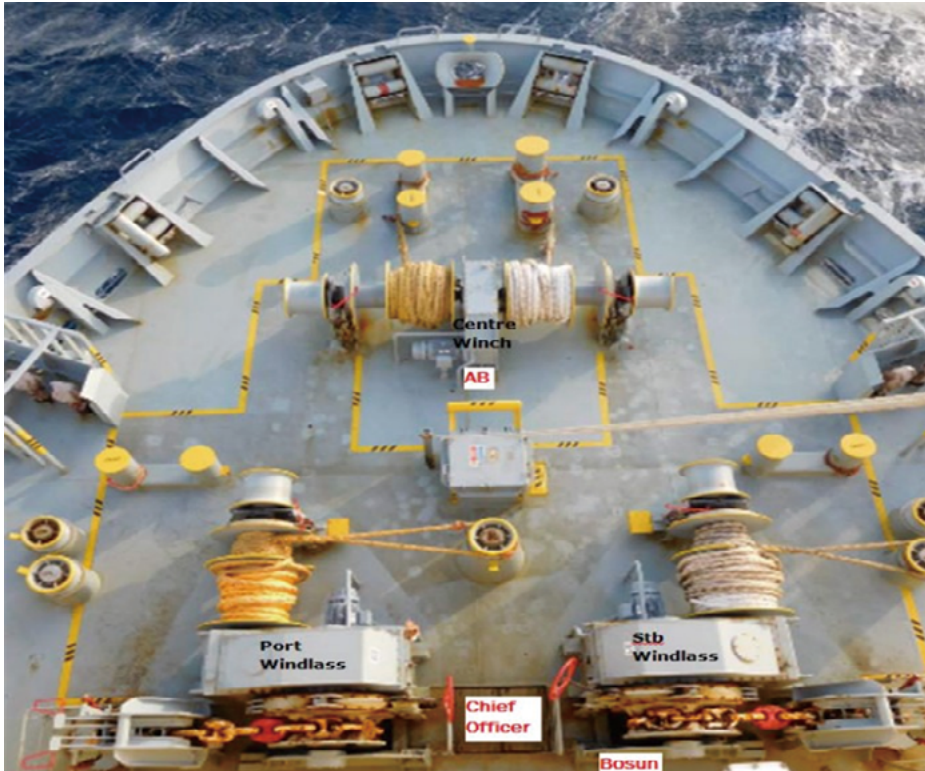
Figure 11.2 Container ship Fore castle deck 출처 Investigation Report (Republic of the Marshall Islands Maritime Administrator)

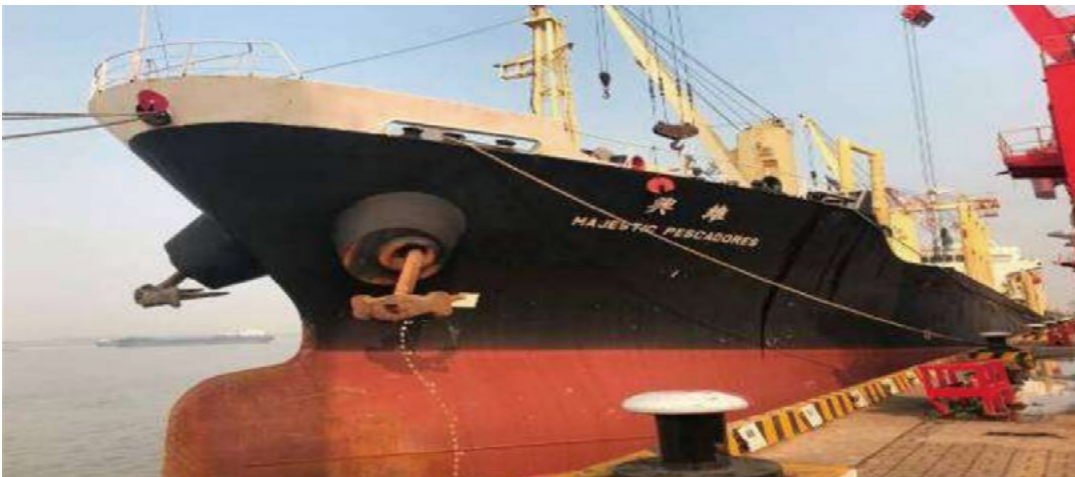
하지만 그 순간, 하역작업 중인 화물 바지선이 본선과 심하게 부딪히며 선박 전체에 큰 진동이 일어났다. 충돌로 발생된 갑작스러운 선박의 움직임으로 피스톤 리프팅 장비 속 고정볼트가 풀리며 피스톤로드 등 부속품이 기관실 바닥으로 떨어졌다. 일기사는 피스톤로드 푸트(piston rod foot)와 크로스헤드 어셈블리 사이에 끼이게 되었다.

Figure 12.1 General cargo ship 출처 Investigation Report (PANAMA MARITIME AUTHORITY)

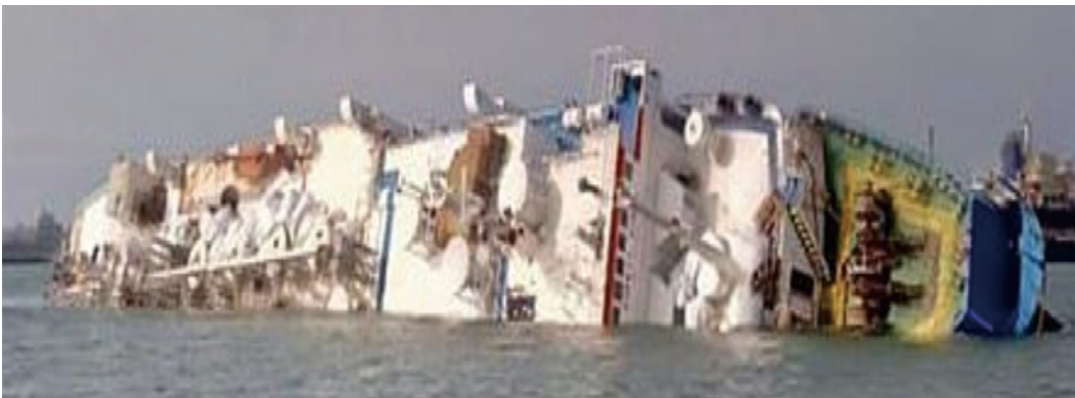
약 15,000마리의 양을 적재한 총톤수 4,000GT 가축운반선은 도선사와 예인선 두 척의 도움을 받으며 출항하였다. 출항 중 예인선이 본선과 연결된 예인줄을 당기는 동안 본선은 3~4도 기울어졌으며, 예인이 끝난 뒤에도 선박의 기울어짐은 계속되며 결국 복원성을 잃고 전복되었다. 선원들은 모두 전복이 완료되기 전 미리 퇴선하여 구조되었다.

Figure 13 Live stock carrier carrying almost 15,000 sheep 출처 www.tradewindsnews.com (by google)

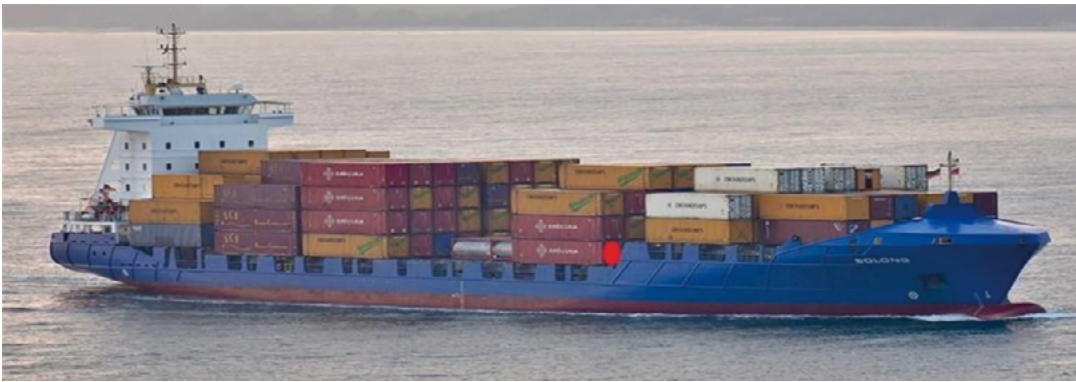
30,000GT 컨테이너선이 입항했을 때 하역근로자가 작업을 할 수 없을 가능성이 있어, 선원들은 직접 화물을 해체할 준비를 시작했다. 추락방지 장치와 부유 장치를 착용하지 않은 선원이 선체 바깥쪽 컨테이너를 해체를 위해 길고 무거운 래싱로드(lashing rod)를 제거하던 중 중심을 잃고 해상으로 추락하였다.

Figure 14.1 Container ship 출처 Investigation Report (Portuguese Maritime Accident Investigation and Aeronautical Meteorology Authority Office(GAMA))

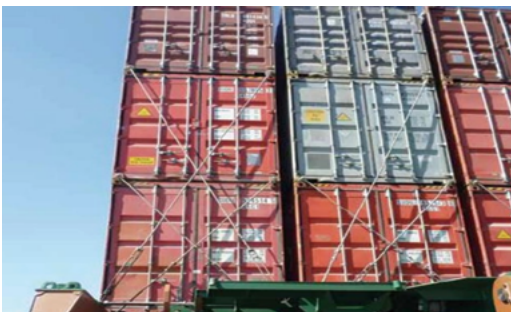
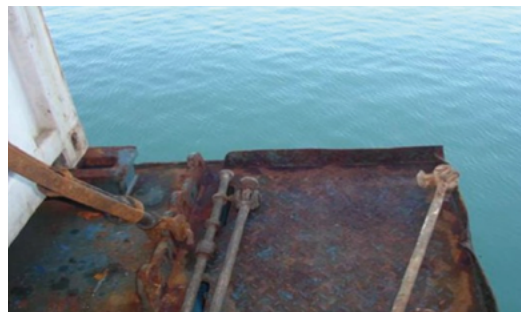
- 선원이 직접 현장에서 수행하는 고박과 해체작업에 대한 위험성 평가가 이루어지지 않았다.
- 조사결과 확인된 안전관리조치가 이행되지 않았기에 해체작업을 위한 위험평가 검토는 효과적이지 않은 것으로 나타났다. 게다가, 선사의 SMS에서도 선측 가까이에서 작업 시 부유장비 착용을 의무화하지 않았다.

Figure 14.2 14.3 Container lashing · Platform 출처 Investigation Report (Portuguese Maritime Accident Investigation and Aeronautical Meteorology Authority Office(GAMA))

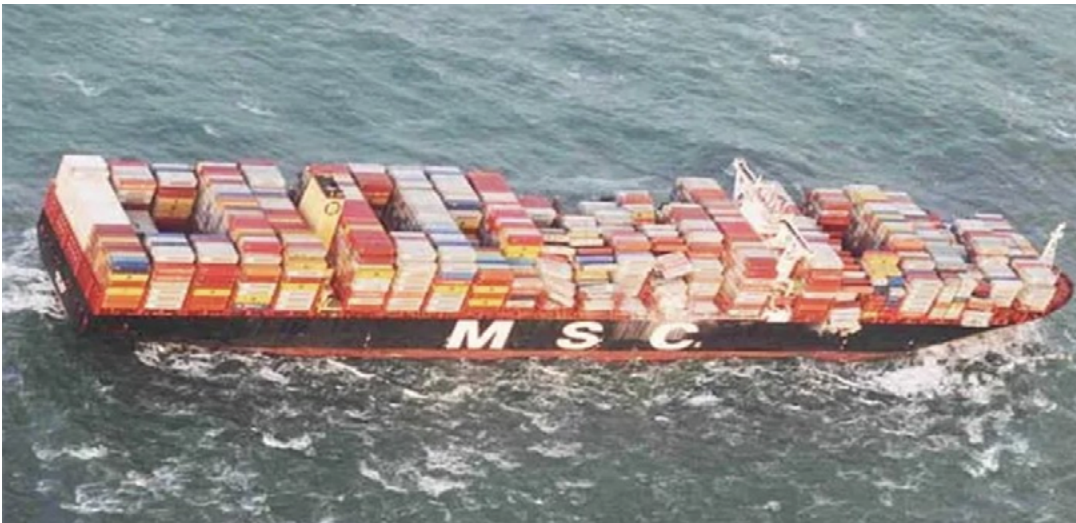
190,000GT 컨테이너선이 통항분리수역(TTS)인 테르스헬링섬(Terschelling) - 저먼 바이트(German Bight)를 통과하던 중 342개의 컨테이너가 유실되었다.

Figure 15 Loss of 342 container in storm 출처 <http://maritimepost.com>

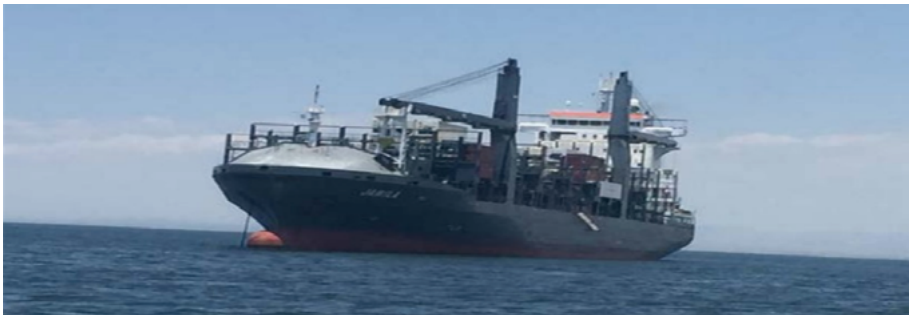
A container ship collided with two fishing vessels that were fishing in parallel, connected by wires, pulling one set of fishing gear. Both fishing vessels foundered causing the drowning of two crew members. The container ship sustained only superficially hull damage. The container ship collided with the paired fishing vessels while passing through multiple groups of other vessels engaged in fishing when it failed to take action to avoid collision.

Figure 1.1 Container ship SOURCES Investigation Report (LIBERIA MARITIME AUTHORITY)

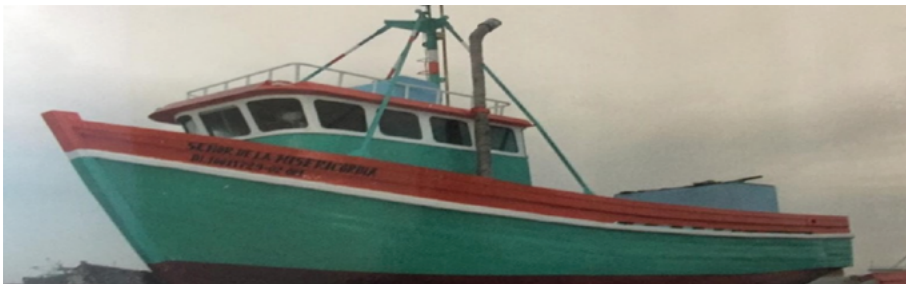
Figure 1.2 Fishing boat SOURCES Investigation Report (LIBERIA MARITIME AUTHORITY)

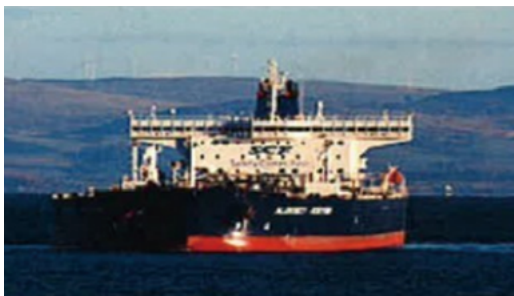
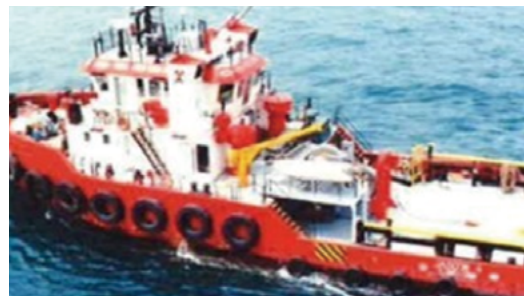
Due to the combination of severe weather condition and the pulling by the tug, the bow chain connecting the tanker to the SBM parted and the tanker began drifting away from the SBM, risking damage to the cargo hoses.

Then the tug declared via VHF that it had an emergency on board. The tug was seen shipping seas on deck and rolling heavily when it took two successive large swells on her beam. The tug then capsized and quickly began to sink. The other mooring master (MM1) sent out Mayday, requesting immediate assistance. Another tug arrived shortly and immediately commenced search operation for any survivors.

Figure 2.1 Oil tanker · Tug boat SOURCES Investigation Report (LIBERIA MARITIME AUTHORITY)

The bow chain connecting the tanker to the SBM parted due to the combined effects of the severe environmental condition and pull-back by the tug to prevent the tanker from contacting the SBM.

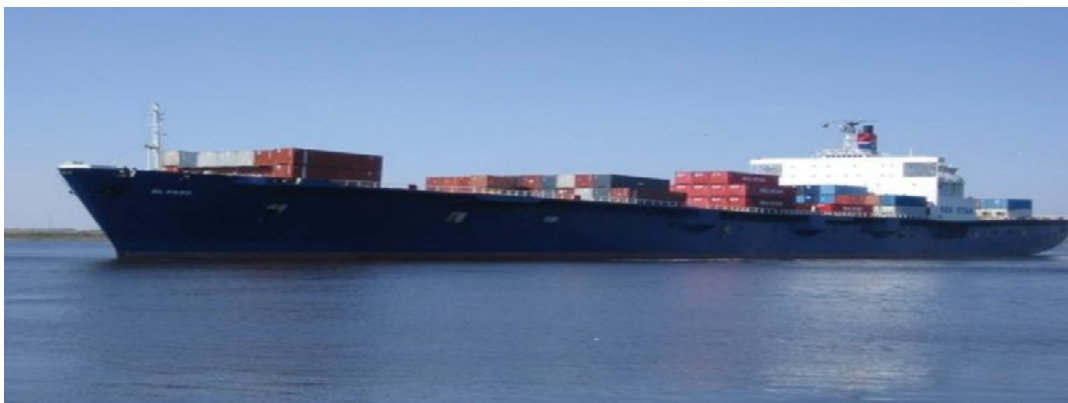
Seawater started to enter the cargo hold through an open scuttle which caused the vessel to develop a prolonged starboard list. Due to the trim and list, the low lube oil sump tank levels could not maintain the propulsion causing the vessel to drift with its beam to the hurricane force winds and seas.

The vessel subsequently experienced progressive flooding and sank. Although a distress alert was sent 10 minutes prior to the sinking, the search and rescue efforts did not locate any survivors.

Figure 3.1 Container Ship **SOURCES** Investigation Report (UNITED STATES COAST GUARD)

- Lack of oversight of the stevedores and longshoremen resulted in the ro-ro cargo not being secured in accordance with the cargo securing manual, causing the cargo to break free and cause damage below the waterline.

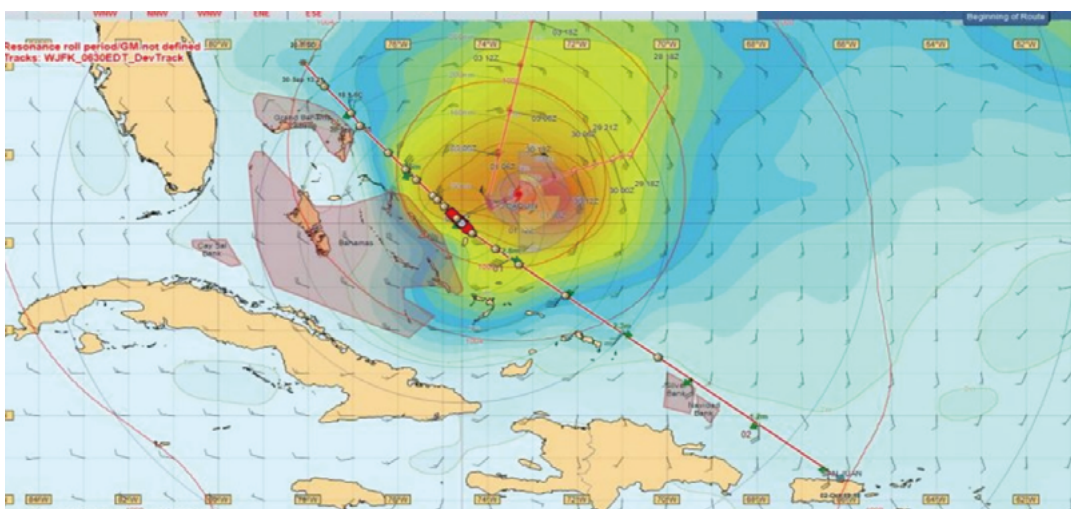
Figure 3.3 Course line SOURCES Investigation Report (UNITED STATES COAST GUARD)

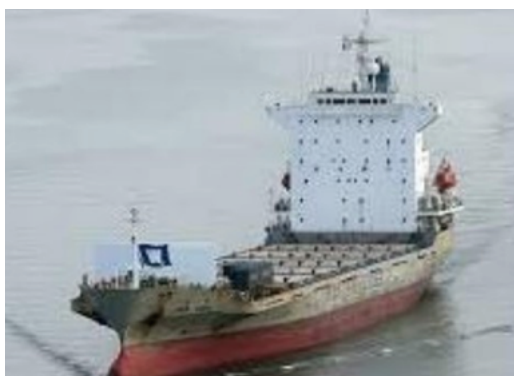
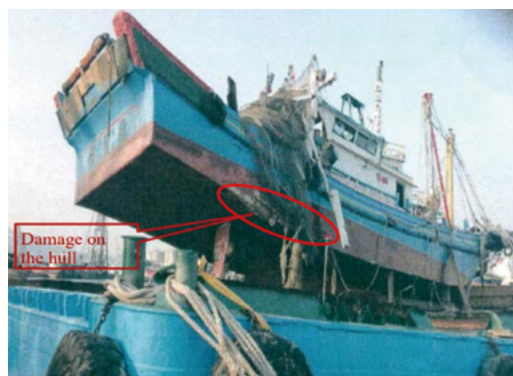
Figure 4.1 4.2 Container ship · Fishing boat SOURCES Investigation Report(HONGKONG Special Administrative Region Marine Department)

En route to that position, while at a speed of 15.3 knots, the container ship collided with a fishing vessel, causing the latter to capsize. The coxswain of the fishing vessel was trapped inside the wheelhouse where he subsequently drowned. The other fisherman fell into the sea and was lost.

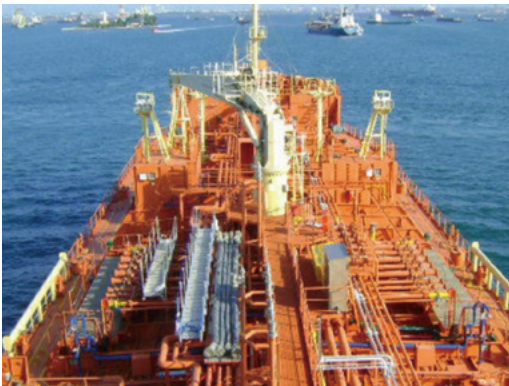
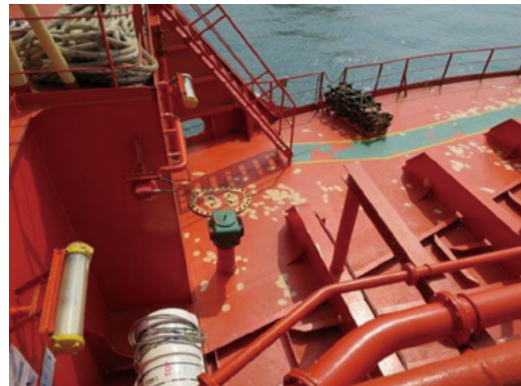
Figure 5.1 5.2 Tanker · Foreward deck **SOURCES** Investigation Report (Republic of the Marshall Islands Maritime Administrator)

After the master had reduced the ship's speed and altered course to decrease any waves coming on deck, the four-man team went forward. They identified other issues, including parted anchor wire lashings, so it was decided to address the store issues and inspect the forecastle store. While attending these tasks, one of them exited the store to check the starboard windlass while the other three remained inside. As the man was returning to the store, a large wave washed across the forecastle from port to starboard and washed him overboard. The master initiated a search in which two other ships and a rescue helicopter also joined. However, the man was not located and was presumed dead.

- The crewmember was in a very exposed location when the large wave washed across the forecastle.
- The risk assessment was inadequate for the weather conditions and resulted in the master and crew on deck developing a false sense of security.
- Identified precautions were not properly taken, including not making a sufficiently large course alteration and not using safety harnesses and lifelines.
- There was no contingency plan in case the inspection identified additional problems.
- Heavy weather precautions for encountering the tropical storm were inadequate.

- It is critically important to ensure that a ship is properly secured for sea and that additional precautions are taken before encountering heavy weather.
- It is very hazardous to work on deck in heavy weather and should be avoided unless not doing so will expose the crew and ship to greater risk.
- If it is necessary to work on deck in heavy weather, a complete and realistic risk assessment must first be done followed by taking all necessary precautions.
- Appropriate alterations of course and/or speed are very important precautions before working on deck in heavy weather.
- Safety harnesses and lifelines must always be used in addition to other personal protective equipment identified for working on deck in heavy weather.

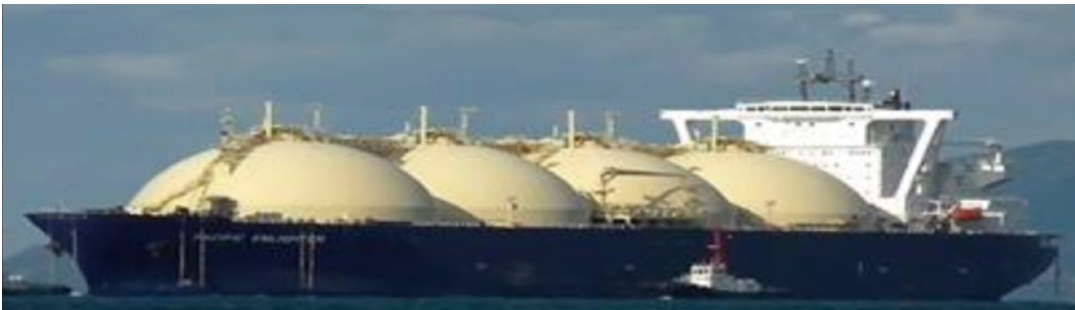
Figure 6.1 LNG Carrier SOURCES Investigation Report (Transport Safety Investigation Bureau (TSIB) Ministry of Transport Singapore)

During unmooring operation in a shipyard, two shipyard workers were struck by the opened bight from a mooring line tail rope, which was used for the mooring of a liquefied natural gas tanker. One worker was fatally injured.

- The set of tail ropes used was recorded to be in good condition prior to being stored for 2 months. This could possibly have affected their condition.
- Shipyard personnel involved with mooring operations was not required to undergo a structured training programme as per competency standards for mooring/unmooring of ships.
- The inspection and appraisal criteria for mooring ropes did not specially include the inspection of the seizing twine, which like the main rope are subjected to similar operational and environmental conditions

- The shipyard reviewed its risk assessment and formulated new procedures (safe work procedures) for mooring/unmooring operations.
- When inspecting and appraising the condition of the tail rope, the condition of the seizing twine should be taken into account.

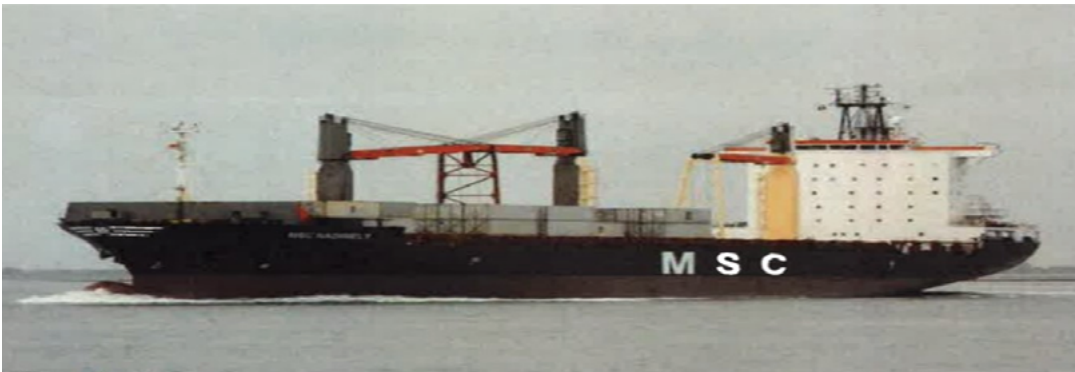
Figure 7.1 Container ship **SOURCES** Investigation Report (LIBERIA MARITIME AUTHORITY)

While preparing the pilot ladder the bosun sent his co-workers for more materials. On their return the bosun and the pilot ladder were missing. Having searched they raised the alarm. The bosun's body was recovered from the water sometime later and he died in hospital. His safety harness was found at the scene. When recovered he was not wearing a lifejacket though he had been seen "wearing" one earlier.

- Bosun was not secured to the vessel when working close to the side.
- PPE (lifejacket and safety harness) was not worn.
- Lack of formal procedures in vessel's SMS for this operation though it was established practice to wear a safety harness on this occasion the bosun did not.
- Solo working at the time of the accident.

- Just because an operation is routine does not mean it is of low risk (and thus not being considered in the SMS). It is important to regularly review the SMS to ensure that all operations are correctly considered and appropriate risk mitigation is put in place.
- It is the responsibility of all crew members to look after their own and co-workers' safety.
- In this instance correct wearing and used of provided PPE may have prevented the fatality.
- When solo working, the risks are heightened.

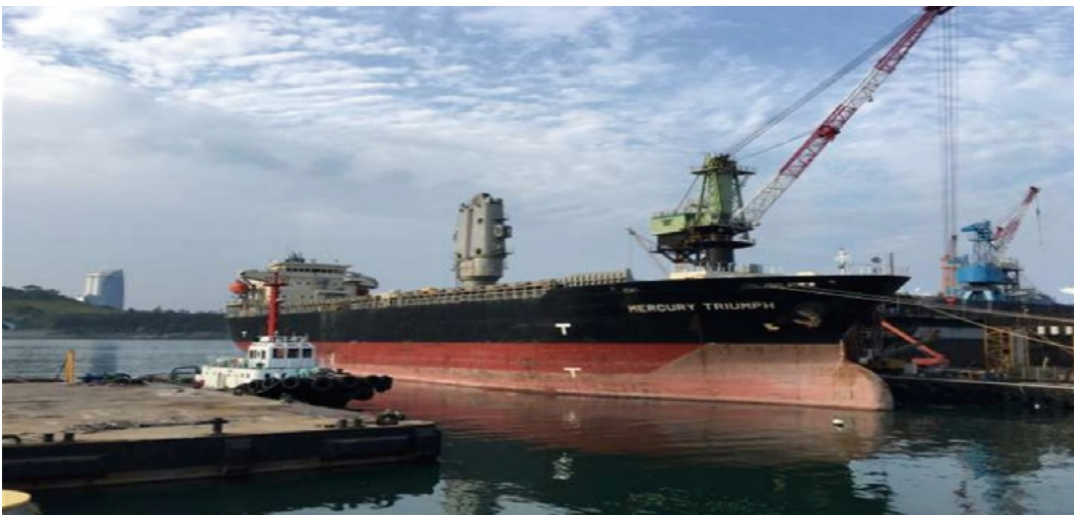
Figure 9.1 General cargo ship SOURCES Investigation Report (PANAMA MARITIME AUTHORITY)

A cargo vessel was navigating heading 240 degrees when the master noticed a target on radar approaching on the aft port quarter with a course of 270 degrees and a distance about 6 nautical miles. About half an hour later, the second officer noticed that the closest point of approach (CPA) had closed to 0.8 nm indicating that the vessel had changed course. The other vessel was turning to starboard toward own vessel which prevailed the second officer to immediately call the other vessel via VHF. As no answer was received, the second officer gave the command to alter the course to hard starboard but a collision between the two vessels could not be avoided.

- Both vessels' bridge teams did not maintain a proper or effective lookout to determine if a risk of collision exists.
- Safe speed was not kept related to the traffic situation.
- Not all available means to prevent risk of collision were used.

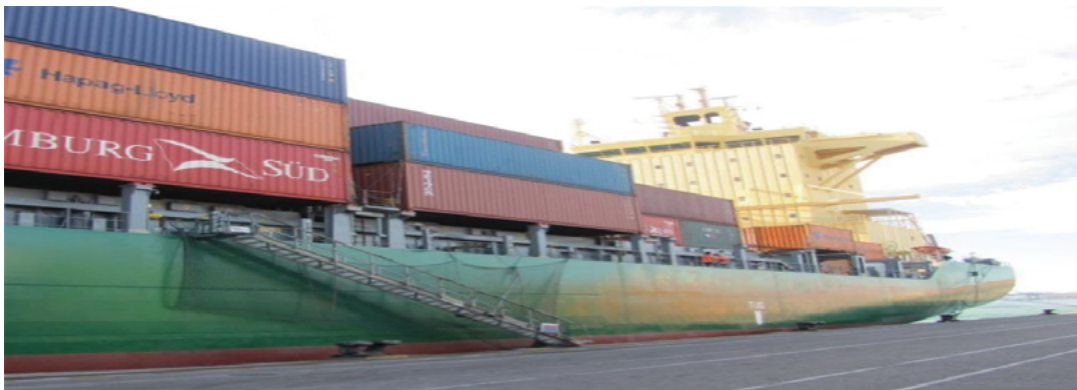
Figure 11.1 Container ship SOURCES Investigation Report (Republic of the Marshall Islands Maritime Administrator)

The 210 metre-long, 28,000 GT container ship was underway in heavy weather when it was noted that the port anchor was loose. Preparations were made to secure the anchor and the ship was turned to create a lee. Three crewmembers, including the chief officer, were on the forecastle attempting to secure the anchor when a large wave swamped the forecastle. The chief officer was washed overboard and an able seaman was seriously injured. Emergency procedures were conducted and shore authorities notified. About 2.5 hours later the chief officer was sighted by ship's crew and then retrieved by a rescue helicopter. The two injured persons were evacuated ashore for further treatment. Unfortunately, the chief officer did not survive the injuries sustained during being washed overboard and from more than three hours in the water.

The task planning, including a risk assessment, did not adequately assess the hazards posed by the deck work in heavy weather. Furthermore, the planning did not ensure that the crewmembers involved used the personal protective equipment prescribed in the safety management system for work on deck during heavy weather. Lifejackets, safety harnesses and lifelines were not used.

Subsequently, the lee created by manoeuvring the ship, did not effectively shield the crewmembers on the forecastle from the heavy seas.

In addition to these factors, revised safety procedures resulting from a similar incident the previous year had not been effectively implemented.

- All risks involved with any task being undertaken during heavy weather and/or on deck must be carefully and fully assessed and addressed. This includes the need to provide a lee for sufficient protection against the weather.
- Seafarer training should include regular emphasis on risk management, relevant techniques and emphasising the need to account for changing conditions and the importance of fully implementing risk controls. This should include strictly following guidance on the use of personal protective equipment.
- It is important that lessons learned from previous incidents result in full, effective and verified implementation of safety actions such as revised procedures

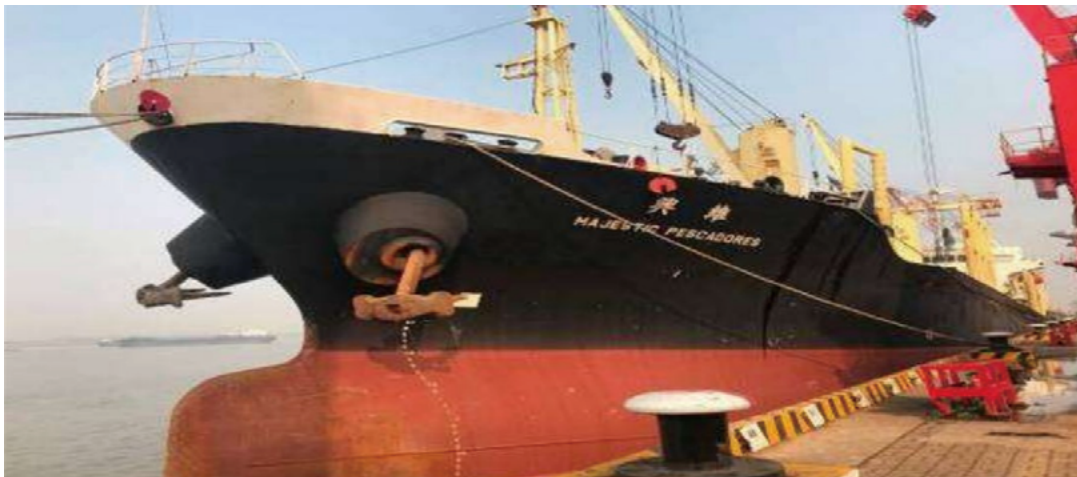
Figure 12.1 General cargo ship SOURCES Investigation Report (PANAMA MARITIME AUTHORITY)

A 120 metre-long, 7,000 GT geared general cargo ship was loading timber logs from barges at a remote anchorage. During the stay, the opportunity was taken to complete the scheduled overhaul of a main engine cylinder and piston. During reassembly, the piston and rod assembly was being lowered into the engine while suspended from the engine room crane. The first engineer entered the crankcase and climbed on top of the crosshead in an attempt to clear an obstruction.

At this time, a cargo barge made heavy contact with the ship causing severe vibrations throughout. The sudden movement caused the securing bolt of the piston lifting tool to fail and the piston and rod to fall. The first engineer was trapped and crushed between the piston rod foot and the crosshead assembly.

Task planning and identification of potential hazards did not fully consider the effects of vessel movement while conducting maintenance in the engine room. Furthermore, the lifting appliances and tools being used were not fully understood or adequately maintained. As a consequence, when contact between the cargo barge and the ship caused sudden movement, the lifting tool was stressed to failure. This allowed the piston and rod assembly to fall, trapping and fatally injuring the engineer.

- All vessel operations, including deck and cargo work, should be considered as part of risk assessments for any engine room maintenance tasks.
- The condition of all tools, equipment and fittings available for and used during maintenance tasks, especially for lifting, should be regularly checked and verified. Records of inspection and equipment histories should be maintained and referred to.
- Access to medical assistance should be considered when assessing and planning for any work done on board ship.
- Personnel should not, for any reason, pass or position themselves under a suspended load.

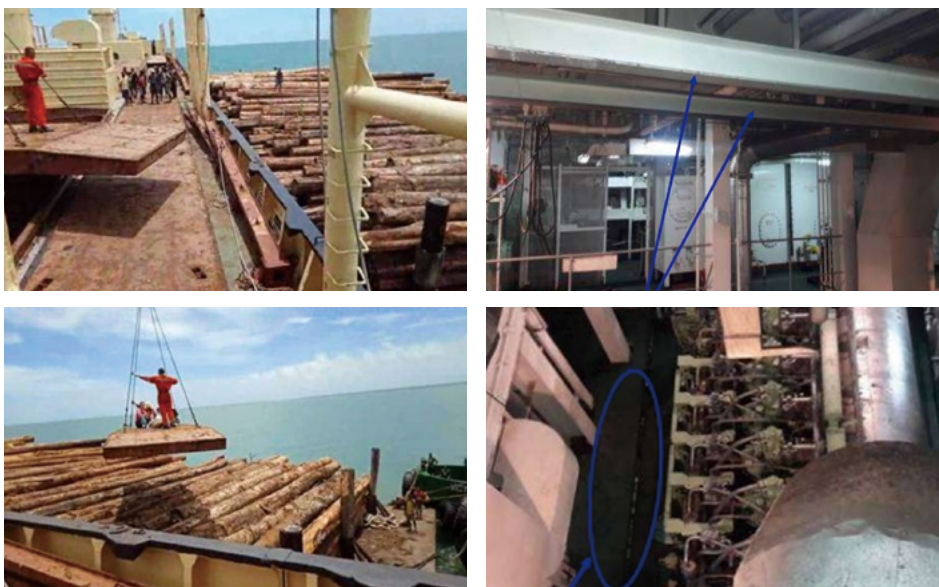
Figure 12.2 갑판작업 중 · 기관실 추락현장 SOURCES Investigation Report (PANAMA MARITIME AUTHORITY)

The remote location of the anchorage then limited access to timely medical assistance. This was inadequately considered when the decision was made to undertake this work. As a result, it was many hours before the severely injured person reached a hospital and professional medical assistance.

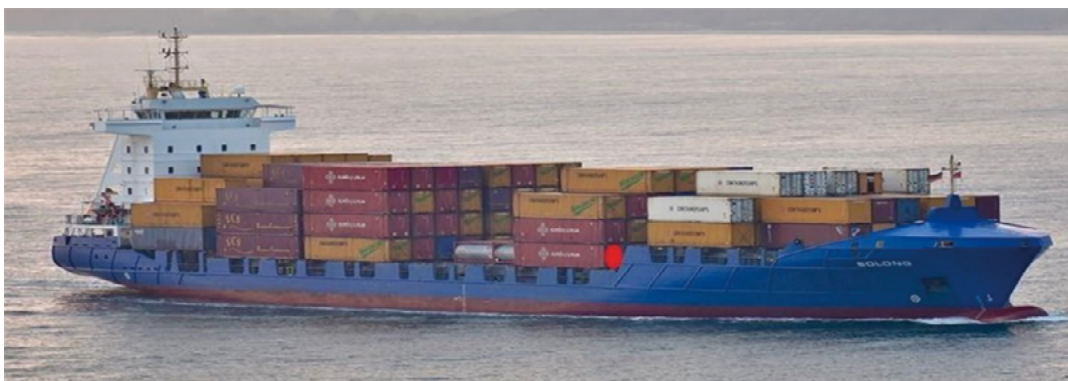
Figure 14.1 Container ship **SOURCES** Investigation Report (Portuguese Maritime Accident Investigation and Aeronautical Meteorology Authority Office(GAMA))

Due to the possibility that stevedores were not available at arrival of the 30,000 GT fully cellular container vessel, the crew started to prepare by un-lashing the cargo while still at sea. A crew member, who did not wear a fall arrestor, nor a floatation device while unlashing the outboard container, could not balance himself after removing the long and heavy lashing rod and fell overboard into the sea.

- The risk assessment was not updated for lashing and unlashing tasks to be done on site.
- Personal floatation device when performing unlashing task at outboard rows near ship side where there was a potential risk of drowning for a person falling in the water was not included in the vessels procedures.
- The investigation revealed that the review of the risk assessment for the unlashing task was ineffective as the safety control measures identified were not implemented. In addition, the Company's SMS did not require the wearing of floatation device when working near the ship side.

- A review of the SMS procedures to clearly identify risks involved in different tasks and provide clear guidance what type of PPE should be worn accordingly could have prevented the accident.
- An effective risk assessment prior to a task is commencing would have identified the safety precautions necessary.
