2023년도 주요 해외 해양사고 교훈사례집

중앙해양안전심판원

**2023
LESSONS LEARNED
FROM MARINE SAFETY
INVESTIGATION
REPORTS**

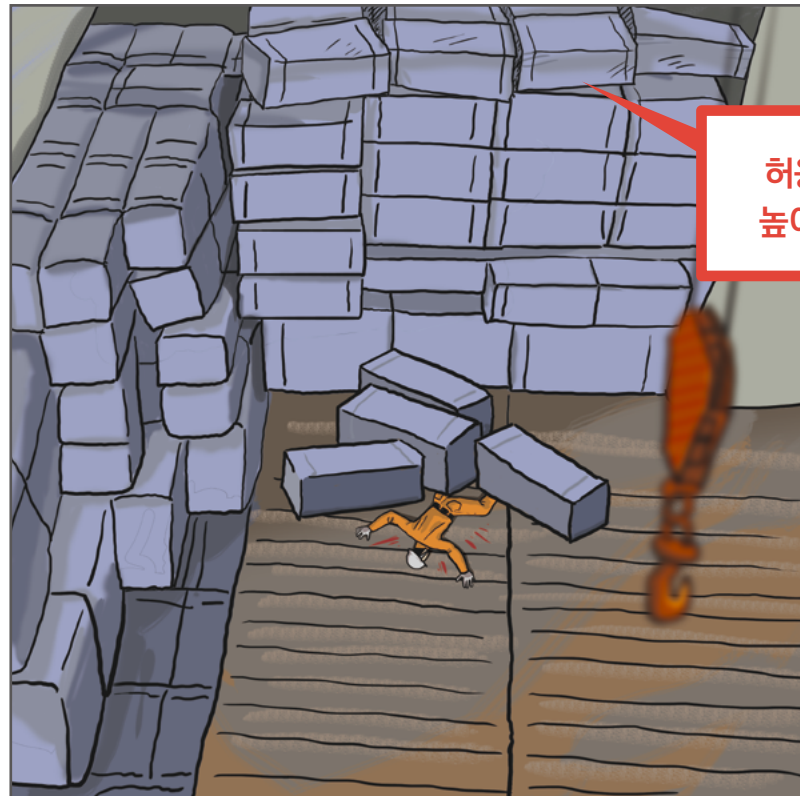
허용적재
높이 초과

선박이 접안하여 탄소음극(carbon anode) 화물을 하역하던 중 화물창에 있던 화물 1열이 무너졌고 당시 강판 하역고리(sling)를 풀고 있던 하역근로자는 무너지던 화물에 깔려 사망하였다.

조사 결과 해당화물이 비표준 단위화물임에도 불구하고 하역 작업 중 허용 가능한 화물적재 높이를 초과하도록 내버려 둔 점과, 효과적인 모니터링 및 의사결정 메커니즘 없이 진행된 작업방식이 이번 사고발생의 원인으로 드러났다.

- 해운회사는 여러 업무에 포함된 위험요소를 분명하게 파악하기 위해 안전관리체계(Safety Management System, SMS) 절차를 검토하고 선대에 그에 따른 분명한 지침을 제공해야 한다.
- 선내 선적/하역작업에 참여한 터미널 운영사/하역회사는 작업에 앞서 위험평가를 효과적으로 수행해야 한다.

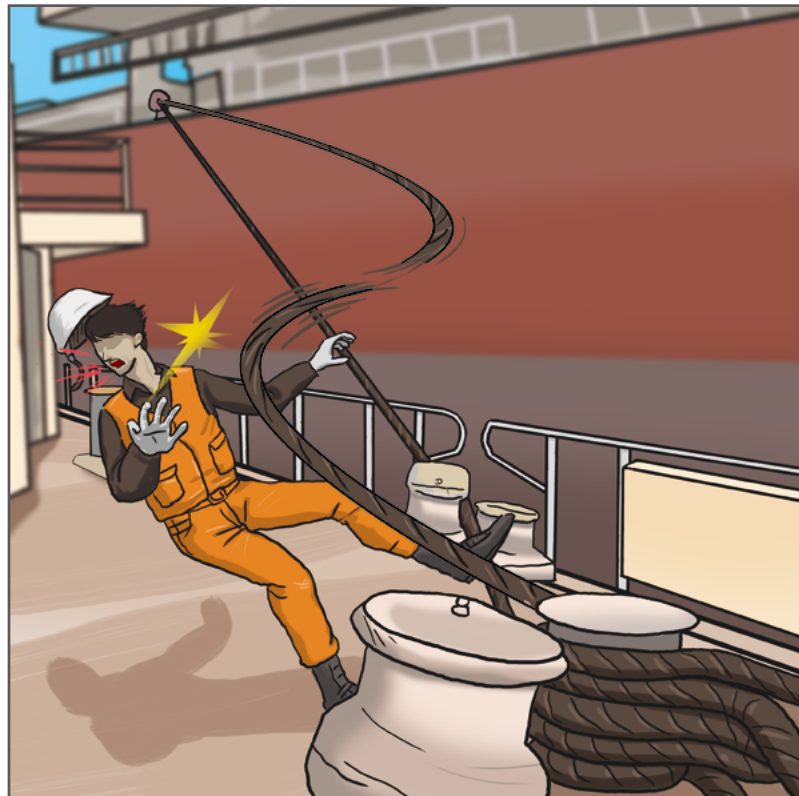
일반화물선(A)이 산적화물선(B)의 크레인을 사용하여 선박 대 선박(ship-to-ship, STS) 곡물 이송을 위해 정박 중인 B 선박에 나란히 접안하였다. 선적이 끝나갈 무렵 두 선박 중 크기가 더 작았던 A 선박은 B 선박의 크레인으로 하역작업을 계속하기 위해 전방으로 2~3미터 이동해야 했다. A 선박의 선장은 계선줄을 이용해 선박을 전방으로 움직이기로 결정하고 당직선원과 일등항해사에게 작업을 지시하였다. 일등항해사가 피로하다는 사실을 선장이 인지하고 있었음에도 당직이 끝난 선원들은 휴식중이었기 때문에 당직 중인 선원만이 계류작업에 참여했다. 갑판수(AB) 한 명과 일등항해사는 선미 계류설비장소, 갑판장과 삼등항해사는 선수 계류설비장소에 배치되었다. 해당 선박의 선박안전관리매뉴얼(Safety Management Manual, SMS)에 따르면 계류작업이 진행되는 동안 선원들은 3명이 한 팀을 구성하여 각 계류설비장소에 위치해야 하며 일항사는 이를 감독해야 한다.

- 페어리드가 개방형이었기 때문에 계류작업 중 계선줄이 튀어 올랐고 두 선박의 높이 차이가 증가하여 계선줄이 화물작업을 하는 동안 위험하게 위쪽으로 향하였다.
- 두 개의 계선줄을 하나의 페어리드로 연결하여 공간이 부족해졌고, 이것이 계선줄을 페어리드로 부터 튀어 오르게 한 원인 중 하나로 추정된다.
- 계류작업을 시작했을 때 일등항해사는 팽팽해진 계류줄에 가까운 위험구역에 위치하던 중 심각하게 부상을 당했다.
- 당직이 끝난 선원들은 휴식중이었고, 선장은 그들의 휴식시간을 방해하지 않으려 계선작업에 불충분한 인원이 배치되었다.
- 시간적인 여유가 없고 선원이 STS 작업에 익숙하지 않았기 때문에 계류작업에 대한 계획이 불충분했다.
- 선원이 STS 작업에 익숙하지 않았고 SMS에 해당 작업에 대한 가이드가 없었다.

- 선내 작업에 충분한 수의 인원을 배치하는 것이 중요하다. 이 사고에서 선미 계류설비장소에 두명의 선원만 배치된 것은 안전하게 계류작업을 수행하는 데 불충분했고, 결국 일등항해사가 위험구역에 위치하게 되었다.
- 액체화물의 STS 작업에 대해서는 산업계에서 활용되는 문서화된 지침서가 충분하나, 산적 고체화물에 대해서는 제한적이다. 사고선박의 SMS에는 고체화물의 STS 작업에 대한 절차 또는 계선줄을 이용한 계류작업의 절차서가 없었다. SMS는 선박에서 발생할 수 있는 작업의 적절한 수행에 관한 지침을 포괄적으로 정하고 있어야 한다.
- 작업과 관련된 모든 위험을 식별하고 해당 위험의 통제 방안을 마련할 수 있도록 선내 작업은 적절한 계획에 따라 진행되어야 하고, 작업 전에 위험도 평가와 안전 정보 제공이 이루어져야 한다.
- 적절한 장비가 작업에 사용되어야 하고 선원은 해당 장비의 제약에 대해 충분히 이해하고 있어야 한다.

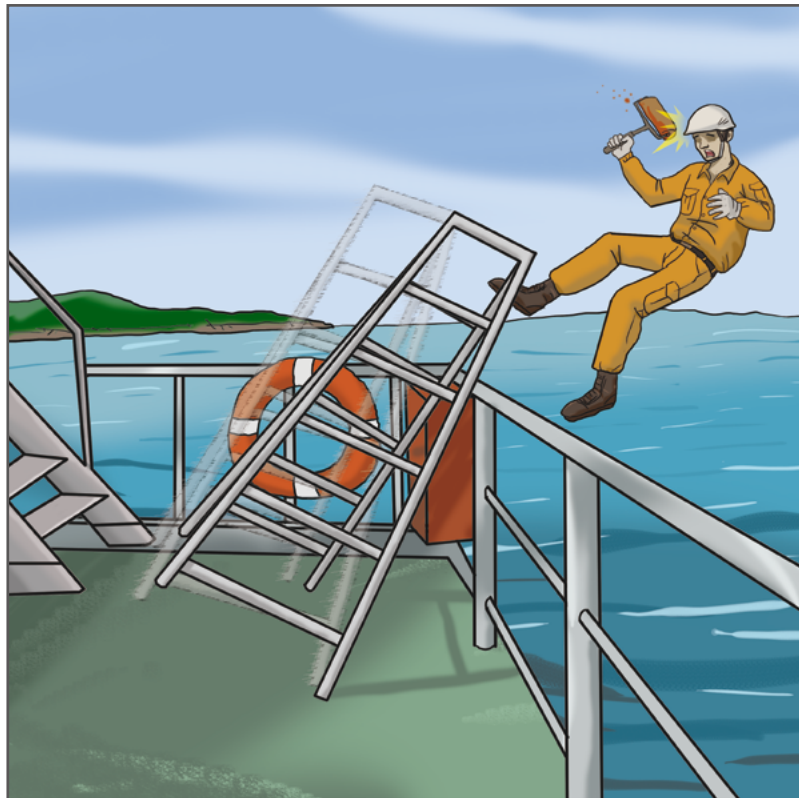
가스운반선이 6월에 남대서양을 통과하여 브라질항만으로 항해하고 있었다. 일등항해사는 삼등항해사에게 아침에 항해당직을 인계한 후 선원 2명에게 단정갑판에서 분리된 2개의 총계참 바닥면을 도색하도록 했다.

조사에서는 선원들이 도색작업 임무를 받고 선교에서 작업에 대한 설명을 들었을 때에는 이동식 사다리의 사용을 고려하지 않은 것으로 밝혀졌다. SMS에 기재된 바와 같이 이동식 사다리를 사용하기 위해서는 위험평가와 작업허가 후 선장의 승인이 필요하다.

사고를 당한 선원은 누구와도 상의하지 않은 채 이동식 사다리를 사용하였다. 작업을 함께 한 다른 선원에게 작업중지권 카드(stop-work authority card)가 있었으나 이 카드를 사용하지 않아 이동식 사다리 사용을 막을 기회를 놓쳤다.

- 작업안전회의(Toolbox Meeting) 실시의 중요성과 함께, 선원들이 수행할 선내 작업의 정보를 당직사관이 숙지하고 있어야 하며, 특히 당직선원이 해당작업에 참여할 때에는 더욱 유의해야 한다.
- 위험한 상황 또는 안전하지 못한 행동을 발견했을 때 선원이 “작업중지” 권한을 행사하는 것이 중요하다.

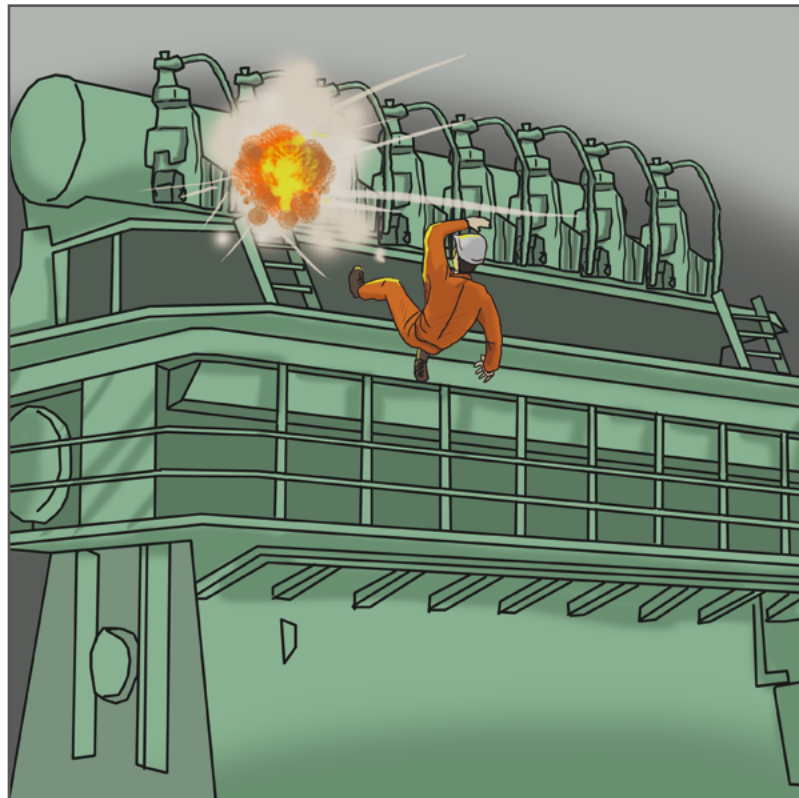
9월 이른 아침, 광석운반선이 브라질항만을 향해 남서방향으로 인도양을 통과하던 중 주기관에서 배기온도에 이상이 생겼다. 이후 기관부원들은 기관실에 모였고 연료유분사밸브(fuel oil injection valve, FOIV)를 비상교체하기 시작했다.

조사에 따르면 기관 분당 회전수(RPM)가 0이 되지 않았을 때 삼등기관사가 FOIV 고정나사를 제거한 것으로 밝혀졌다. FOIV는 실린더 커버에서 떨어져 삼등기관사 안면을 강타하였다.

사고조사팀은 삼등기관사가 RPM이 0에 도달하기 전에 FOIV를 제거한 이유를 확인할 수는 없었으나 조사를 통해 기관부원들이 FOIV가 과거 어떻게 제거되었는지 기억과 관찰에 의존하였으며 기관 매뉴얼에 기재된 안전수칙을 서로 다르게 이해했다는 것을 알 수 있었다.

- 이번 사고는 안전수칙 준수의 중요성을 강조한다. 특히 선박의 기관과 관련된 안전수칙은 어떤 단계라도 생략된다면 엔진과 선원 모두에게 예상치 못한 결과를 초래할 수 있다.
- 각 안전수칙의 목적을 잘 이해해야 하며 안전을 확보하는 검증절차 이후에 작업이 시작되어야 한다.
- 안전수칙을 포괄할 수 있는 폭넓은 훈련을 실시하고 체크리스트 등 “작업허가(Permit-To-Work)” 체계를 수립, 이행해야 한다.

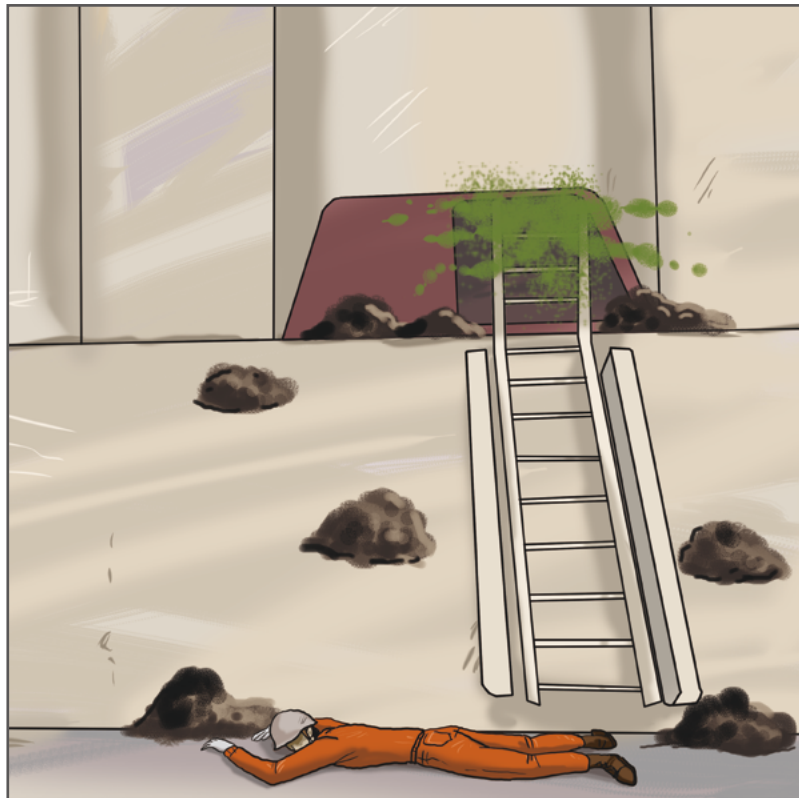
접안 중인 산적화물선 내에서 석탄을 하역하던 하역근로자들은 산적화물선에 조명을 더 제공해 달라고 요청하였다. 당직항해사는 선원 2명에게 해당 작업을 배정하였다. 1번 선원은 폐쇄식 사다리(Australian ladder)를 통해 화물창에 진입하는 동안 추락하여 사다리 바닥에 떨어졌다. 2번 선원은 이를 목격하고 그를 돕기 위해 사다리 트렁킹(Trunking)으로 진입하였으나 그 역시 추락하여 사다리 바닥으로 떨어졌다. 구조작업을 시작하였고 선원 2명을 구조하였으며 이들은 약간의 지연 후 병원으로 이송되었다. 2번 선원은 잠시 후 회복되었으나 1번 선원은 치명상을 입었다. 부검을 통해 그가 황화수소에 노출된 것이 사망원인으로 밝혀졌다.

선원들이 작업을 시작했을 때 화물창이 열린 채 거의 비어있었기 때문에 유해 또는 독성가스에 노출되는 위험은 고려되지 않았다. 당직항해사는 위험구역 진입을 예상하지 못했고 현장에 없었기 때문에 회사의 폐위구역 진입절차에 따라 화물창의 실내공기를 검사하지 않았다. 비록 화물창은 열려 있었지만 폐쇄식 사다리(Australian ladder)의 구조 상 화물이 하부출구를 막고 있었기 때문에 해당 공간에는 자연통풍이 불가하였다.

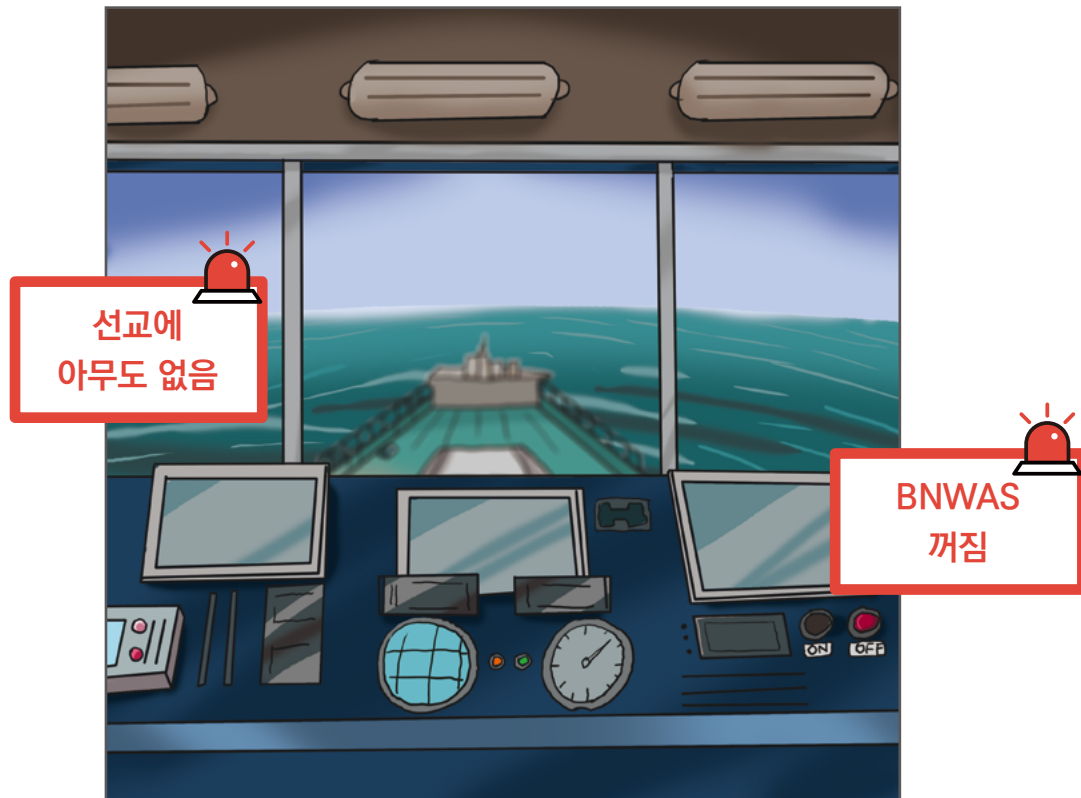
컨테이너선박이 9월에 멕시코를 향해 북태평양에 있는 항만에서 항해를 시작하였다. 이른 아침 갑판장은 04시 00분부터 08시 00분까지 항해당직 중이던 일등항해사로부터 업무지시를 받고자 선교로 왔다. 그러나 갑판장은 일등항해사를 찾을 수 없었고 선장에게 이를 알렸으며, 선장은 일등항해사를 수색하기 위해 선박을 선회하였다. 수색 및 구조를 위해 인근 해경에게 이를 알렸고 다음 날까지 작업이 이어졌으나 구조하지 못했다.

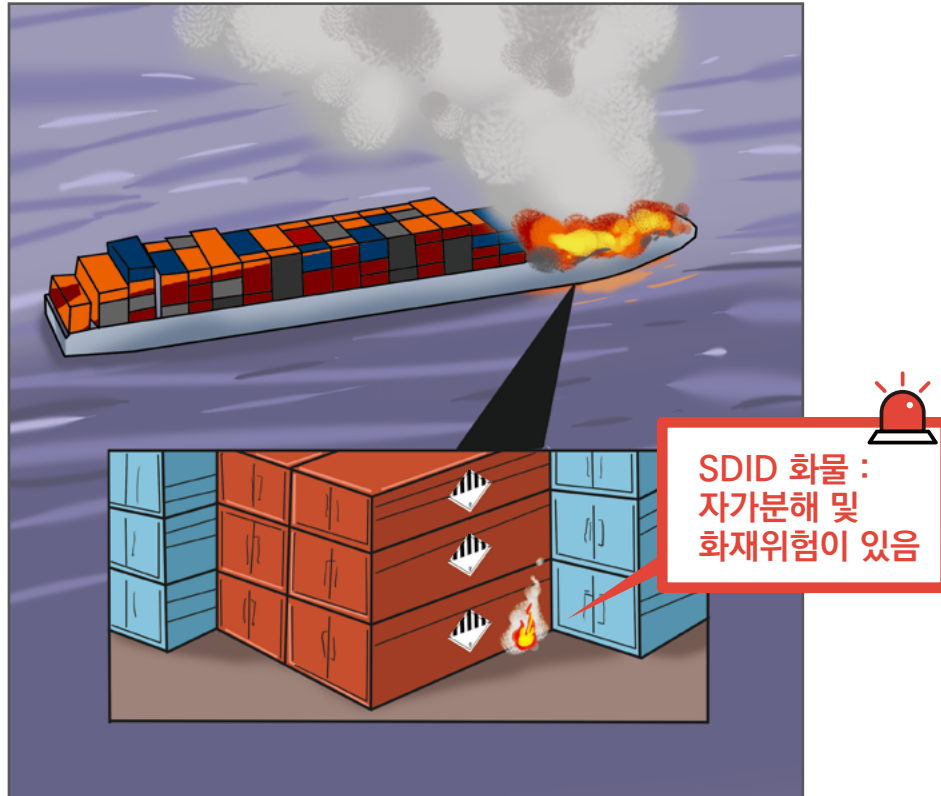
항해하고 있던 총톤수 150,000톤 컨테이너선박의 화물창 중 하나에서 심각한 화재가 발생하였다. 제9급 화물(유해성 물질)의 자가분해로 인해 연기와 불씨는 화물창으로 확산되었다. 화물은 블록 적재 방식(동일한 위험등급을 가지는 위험물이 적재된 컨테이너를 특정한 구역에 함께 적재하는 방식)으로 운반되어 분해과정을 악화시키고 가속화했다. 선원들은 냉각 및 이산화탄소 분사를 통해 화재에 대응하였으나 성공하지 못했고 결국 퇴선하였다. 선원 4명은 행방불명되어 실종된 것으로 신고되었으며 나머지 한 명은 육상으로 이송되던 중 사망하였다.

증거자료 대부분은 화재로 손상되어 사고원인을 판단할 수 없다. 화물창에는 나트륨디클로이소시아 누레이트 이수화물(Sodium Dichloroisocyanurate Dihydrate, SDID)이 포함된 컨테이너가 한 개 이상이었고 이는 SDID의 자가분해로 손상되었다. SDID의 블록적재 방식이 이후 반응물과 열발생물을 악화시켰으며 그로 인해 화재가 통제할 수 없을 정도로 확산되었다. 발열성 분해가 시작되는 실제 온도는 화주가 신고하는 통상적인 온도값보다 훨씬 더 낮으며 화물창이나 SDID의 대량포장 내에 자유수(free water)가 존재하는 경우 그 온도가 더 크게 하락한다.

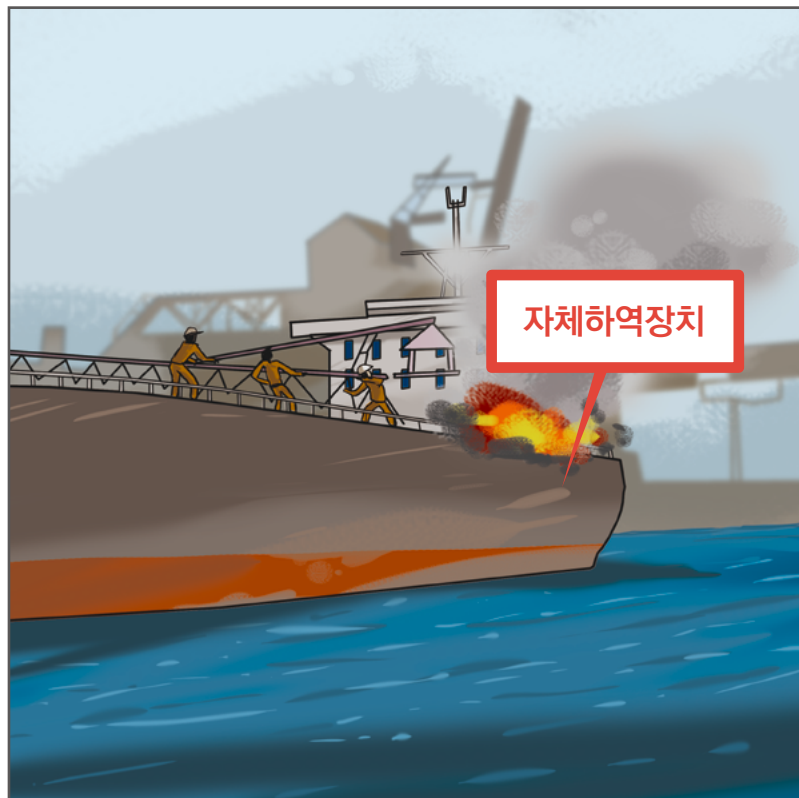
자체하역(self-unloading, SUL) 산적화물선이 6월에 접안중 화물을 양하하던 중 내부 화물처리 공간에서 화재가 발생하였다.

선박은 2개 연료유 탱크 파공을 포함, 상당한 구조적 손상을 입었고 SUL장치의 핵심 부품이 크게 손상되었다. 선박은 추정전손을 선고 받았으며 이후 재활용되도록 보내졌다. 중대한 부상이나 해상오염은 보고된 바 없었다.

조사에 따르면 화재는 선내 C-Loop 공간에서 시작되었고 선박의 컨베이어 장치에 있는 손상된 베어링으로 인한 발열로 고무 컨베이어 벨트에 발화되어 발생되었을 가능성이 있다. 또한, 선박에는 선내 SUL 공간에서 발생한 화재에 대한 비상대응계획이 없었으며 비상대응을 하는 동안 선박의 경보장치에 기술적 결함이 있었다는 점이 조사를 통해 밝혀졌다. 게다가 선박의 화재대응은 일부 화재의 확산에 기여하였고 또 다른 측면에서는 선내 화재진압 역량을 제거하여 화재위험을 높였다.

조사에서는 선박 C-Loop 공간에서 화재위험이 확인되었고 화재발생 약 5년 전 선사가 이를 허용불가한 수준인 것으로 기록했다는 사실이 밝혀졌다. 이 위험등급을 받은 것은 주로 SUL 공간에 화재탐지 및 화재진압을 위한 효과적인 수단이 없었기 때문이었다. 그러나 이를 해결하기 위해 취한 조치는 부적절하거나 비효과적이었다. 특히 SUL 선박의 화재 안전성과 관련된 적절한 규제요건이나 표준이 불충분한 점은 해당 선박을 포함하여 일부 화재발생 건의 요인이었다. 또한 선박의 안전관리체계는 이 조사에서 확인된 안전요소, 또는 선박에 내재된 높은 화재 위험성 및 해당 위험성 관리와 관련된 결함들을 확인하지 못한 것으로 이번 조사를 통해 밝혀졌다. 추가적으로, 조사에서는 육상 소방관의 해상화재 진압 역량과 관련된 안전사항뿐 아니라 선상 훈련 및 항만의 비상대응계획의 불규칙한 실시와 관련된 기타 안전사항이 확인되었다.

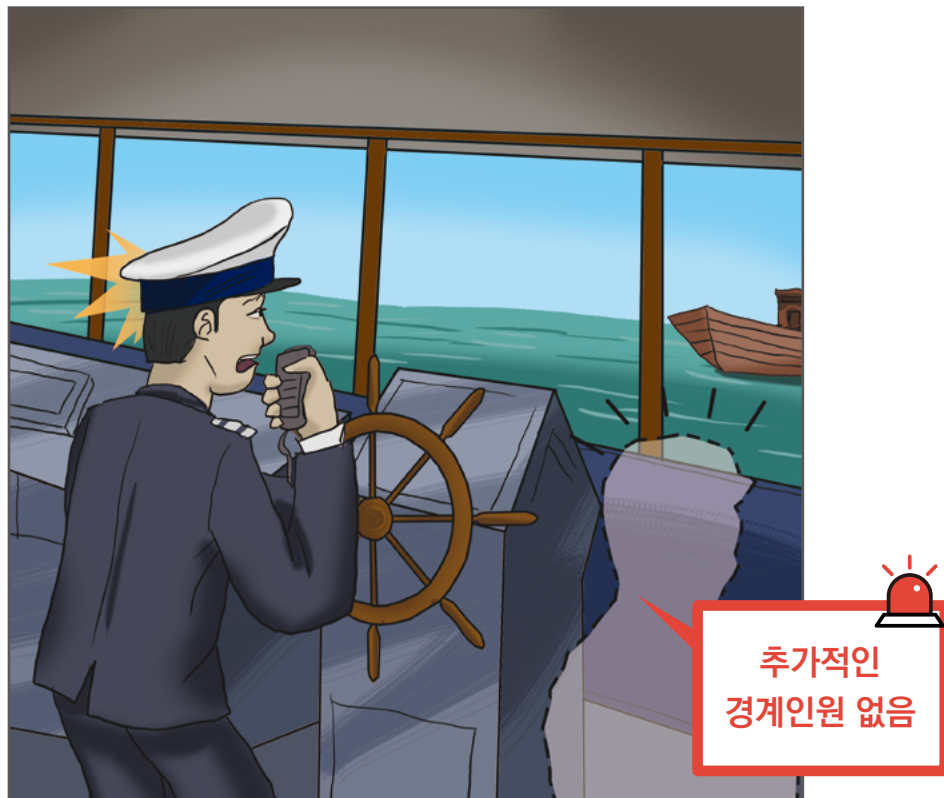
병커탱커가 밤에 급유작업을 완료한 후 항계 내에서 항해 중이었다. 항해하던 중 병커탱커의 선장은 등화를 켜지 않은 목재 연안선박이 자선의 우현측 선수로 접근하는 것을 목격했다. 두 선박이 충돌하기 직전 탱커의 선장은 선박의 휘슬로 음향신호를 울렸다. 두 선박 모두 충돌방지를 위한 행동을 취하지 않았다. 사고 당시 탱커선박의 선장이 항해와 통신을 담당하고 있었으며, 조타도 직접 담당했다. 그 선박의 일등항해사는 선교에서 항해일지를 기록 중이었고, 경계인원은 배치되지 않았다. 목재 어선은 선장이 혼자 선교에 있었다. 탱커의 선장은 충돌 즉시 항만당국에 신고하고 정박지로 계속 항해했다. 목재 어선의 선체는 심각하게 손상되었고, 잠시 후 파선되어 침몰하였다. 목선의 전체 선원 9명은 모두 인근을 지나가던 예인선에 의해 구조되었다. 병커탱커에는 약간의 스크래치만 발생했고 부상자는 발생하지 않았다. 이 사고가 발생했던 당시 기후는 온화하였으며 부분적으로 구름이 끼고 시계가 양호했다. 해상은 고요했고 속력 5노트 미만의 동풍이 약하게 불었다.

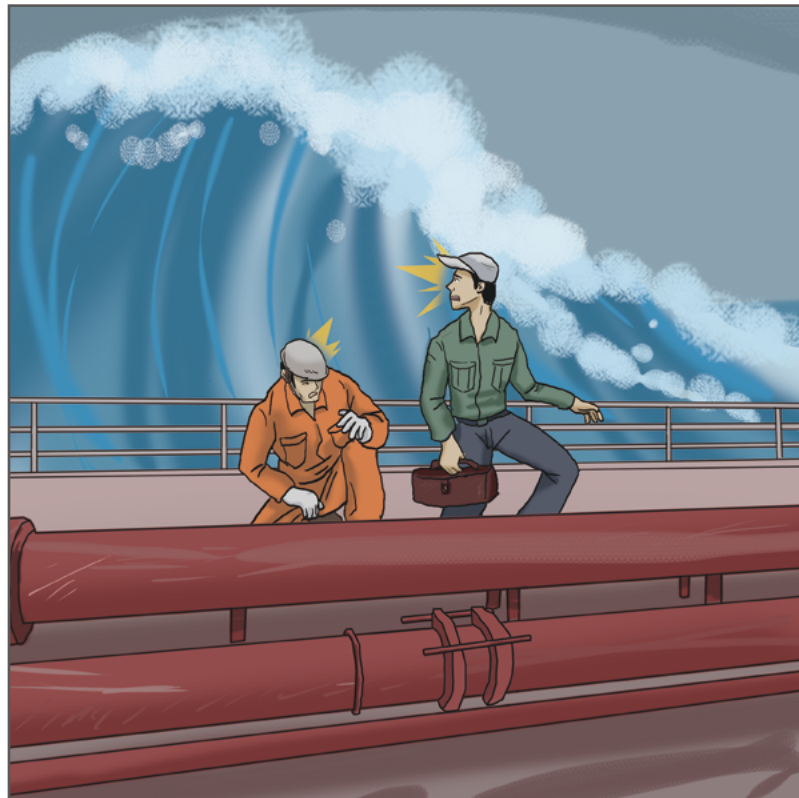
하기흘수선까지 선적한 케이프사이즈 산적화물선이 5월에 아프리카 남단 인근에서 항해하고 있었다. 갑판장과 이등항해사는 갑판 소화주관의 누수를 수리하고 있었다. 작업을 마친 두 선원은 커피를 마시러 갔다. 곧이어 높은 파도와 파고로 인해 갑판작업은 중단되었다. 갑판장과 이항사가 휴식을 마치고 갑판으로 돌아와 도구를 담을 때 전에 없던 높은 파도가 선박의 우현 정형을 강타하였고 갑판장은 선외로 휩쓸렸다. 수색 및 구조작업이 시작되었으나 갑판장을 구조하지 못했다.

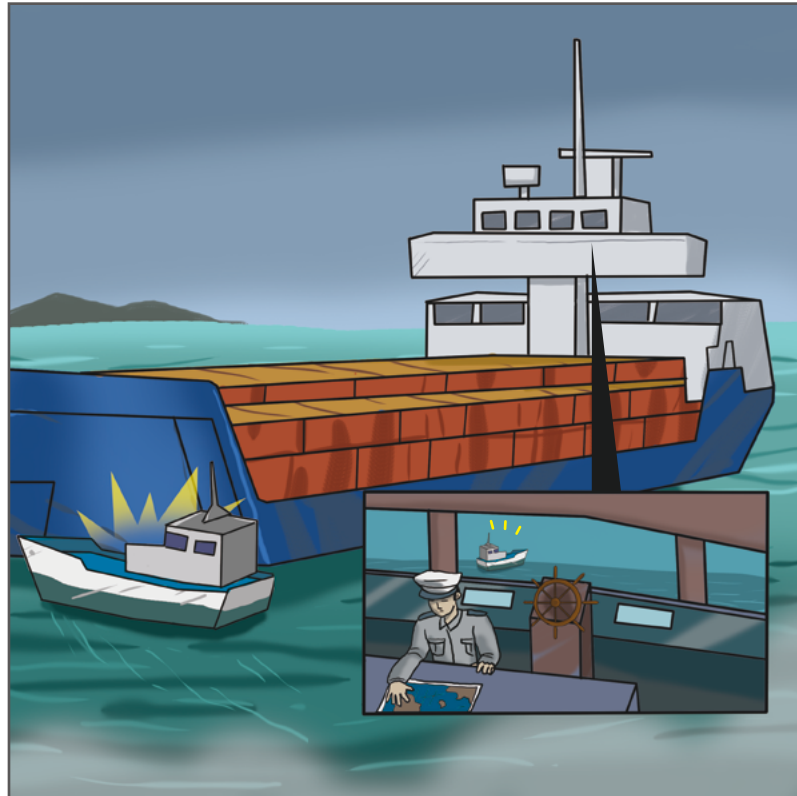
연안 인근에서 항해하던 연안 일반화물선이 제한된 시계 속에서 선체가 목재로 된 어선과 충돌하였다. 어선은 중대한 손상을 입었고 좌현으로 예인되는 동안 침몰하였다. 화물선은 경미한 손상을 입었다. 부상자는 없었다.

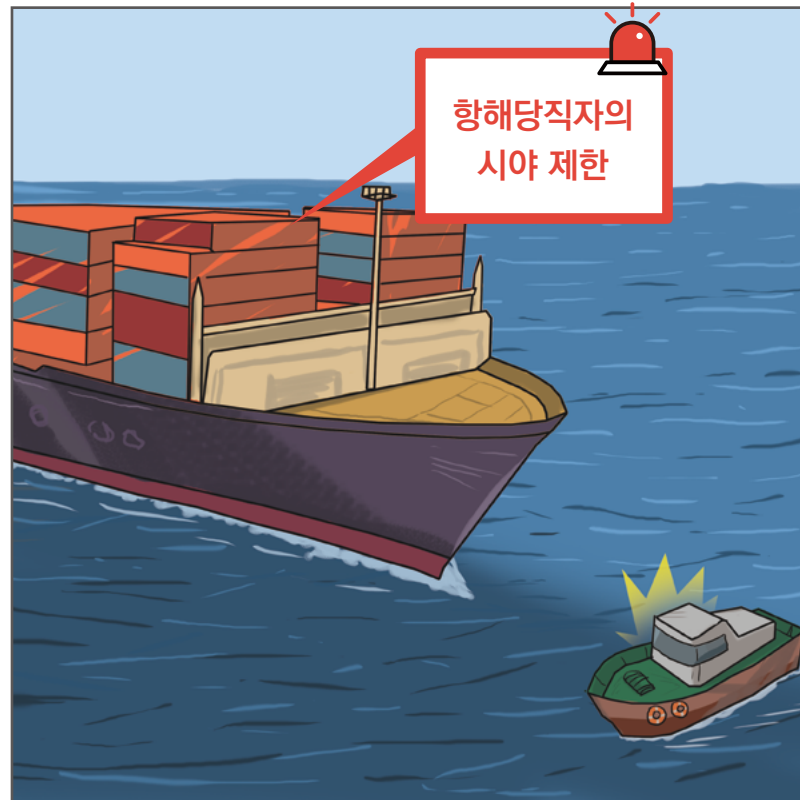
약 2,000 TEU(20피트 규격 크기)인 컨테이너선박이 길이 31미터 어선과 공해에서 충돌하였다. 충돌사고는 시계가 5해리 이상으로 양호한 시계에서 주간일조시간에 발생하였다. 당시 컨테이너선박은 표류하고 있던 어선 무리를 통과하고 있었다. 이들 어선 중 어업을 하는 선박은 없었다. 컨테이너선과 충돌한 어선은 전복되어 침몰하였고 어선원 2명이 실종되었다. 컨테이너선박은 경미한 손상을 입었다. 충돌 당시 컨테이너선박 선교에는 OOW만 있었고 어선에는 당직 중인 선원이 없었다.

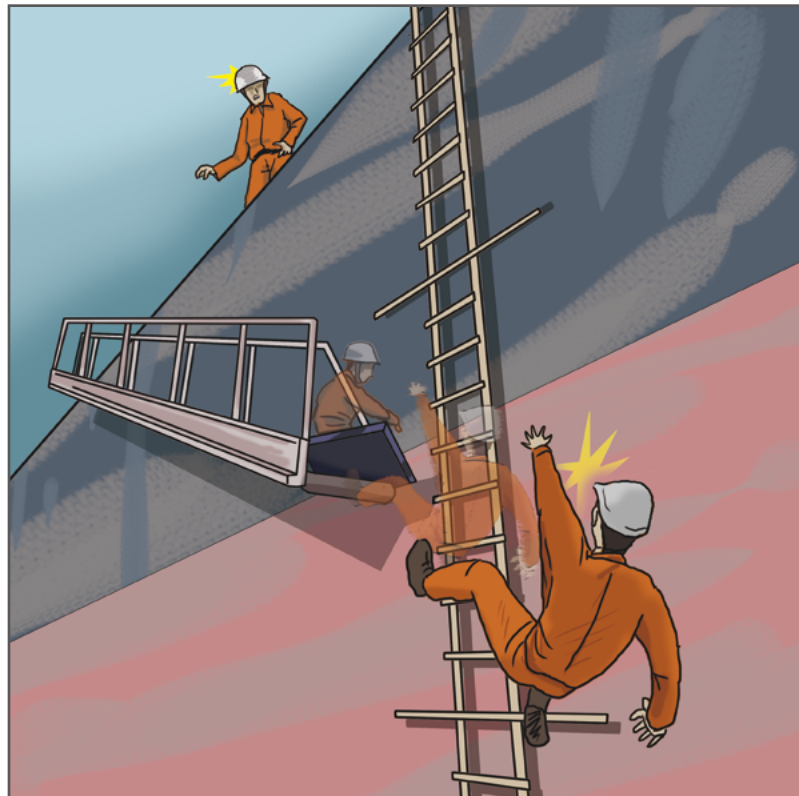
총톤수 51,500 GT의 유류/화학제품운반선이 일출 전 출항준비를 하고 있었다. 약 05시 15분경 갑판장과 갑판수는 도선사 승선을 위해 선박 좌현으로 컴비네이션 사다리를 설치하기 시작했다. 이들은 선측으로 사다리를 내렸고 하부 플랫폼이 해수면과 평행하지 않아 조정해야 한다는 점을 발견하였다. 갑판수는 선박의 SMS에 정하는 요건과 달리, 선박에 구멍줄을 부착한 안전벨트와 구멍조끼를 착용하지 않고 사다리를 내려갔다. 갑판장은 갑판수가 현측사다리를 내려가기 시작하는 것을 보았으나 갑판으로 돌아오라고 지시하지 않았다. 게다가 갑판장은 선장이나 OOW에게 갑판수가 사다리를 내려가고 있다고 알리지 않았다. 갑판수는 현측사다리 하부 플랫폼을 조정하다가 선외로 추락하였다.
