# 2018년도 주요 해외 해양사고 교훈사례집

해양수산부  
중앙해양안전심판원

IMO 협약이행 전문위원회  
5차, 2018년

# LESSONS LEARNED FROM MARINE SAFETY INVESTIGATION REPORTS

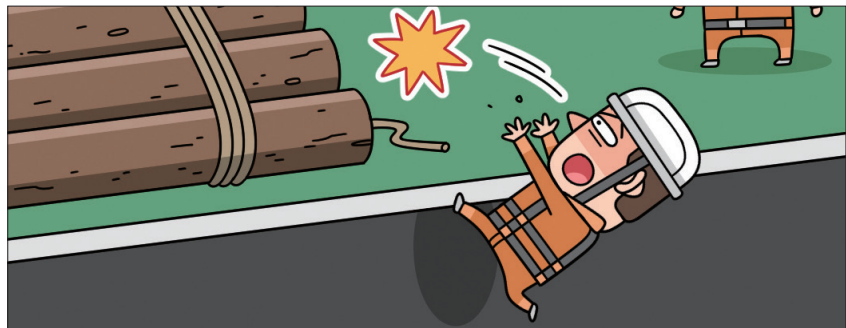
A bulk and log carrier was loading logs at an anchorage. Loading logs on deck above number one hold were complete. The ship's crew were lashing the logs above number one hold while loading continued at other holds. While lashing, one of the ordinary seamen fell overboard into the sea. Another member of the deck crew jumped into the water to search for the ordinary seaman. Despite an extensive search over several days, involving several other vessels, the ordinary seaman was never found.

- What caused the ordinary seaman to fall overboard was not established. He was wearing coveralls, gloves, a safety helmet and studded overshoes.
- The ordinary seaman was not an experienced seaman and, not only was he not experienced in log lashing operations, he had received no training or briefing from senior crew members as to the risks involved in working on log stacks.
- No guard lines or rails had been erected and nor was the ordinary seamen wearing a safety harness attached to an appropriate fall arrestor, so there was nothing to prevent or arrest his fall when he fell from the log stack.
- The ordinary seaman was not wearing a lifejacket or buoyancy aid to aid his survival when he fell into the sea.
- Nothing in the ship's SMS manual required the crew to rig safety lines or wear safety harnesses when working on top of log stacks.

- Working on top of log stacks is a potentially hazardous operation that involves working at height. Crew need to take all necessary precautions to mitigate the risks involved.
- When working at height on top of log stacks, crew should be protected at all times by either guard lines or safety harnesses attached to an appropriate fall arrester system.
- When working near the side of the vessel on top of a log stack, crew should be wearing an appropriate buoyancy aid to improve their chances of survival should they fall overboard.
- The company should identify and assess all risks to its ships and personnel, and establish appropriate safeguards based on robust hazard identification and risk assessment. All necessary safeguards should be addressed through procedures in the ship's SMS.

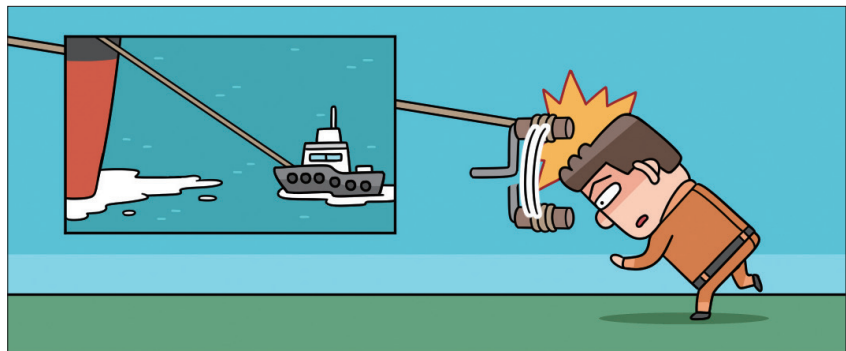
A 16,000 GT bulk carrier was waiting at the anchorage for berthing when the ship's crew were involved in a routine abandon ship drill. The enclosed davit-launched lifeboat was being recovered when it failed to operate. The ship's electrician was summoned to the boat deck to identify the reason for the winch controller's failure. In the interim, the master instructed the bosun, ordinary seaman (OS) and another crew member to recover the boat manually. The crew inserted the manual crank handle to hoist the boat. The electrician, on being told by the bosun about the motor, went to the switch board location to restore the power. At the lifeboat deck, the motor started to turn. Along with it, the manual crank handle, which was still inserted into the hoisting slot, turned a few rounds and hit the bosun and the OS who were standing in close proximity to the handle. The bosun received injuries to his skull as the rotating handle struck his head while the OS sustained minor bruising to his hip. The bosun succumbed to his injuries on board.

- The lifeboat's electrical system was found to have been bypassed to overcome an inoperable or malfunctioning limit switch so as to facilitate the winch motor to operate. In order to restore the power, the electrician had to bypass the existing jumper or short circuit, thereby compromising the safety interlock which was designed to prevent accidents. During this process the lever for hoisting remained engaged in the stowed position while the bosun and the crew continued to hoist the boat manually using the manual crank handle. This condition allowed for the winch to operate when the electrician restored power to the breaker.

- The crew on board the vessel were not well versed with the interlocking system of the lifeboat. Although the manual and drawings of the lifeboat system contained instructions and warnings, there were no warnings at the operation area to warn the users of hazards that may occur during launching / recovery of the lifeboat.

- There was inadequate supervision of the boat deck when the officer in-charge left the station to look for the electrician. A routine drill recovery process was not upgraded to a high-risk operation when the hoisting mechanism failed to operate.

- Crew must fully understand the operating mechanism of the equipment on board the ship and ensure that safety interlocks are not bypassed under any circumstances.
- Work performed by shore contractors should be supervised by the ship's staff and verified.
- Procedures in the SMS for the operation and maintenance of ship's systems and equipment should take into account the recommendations and hazard warnings provided by the manufacturer.
- Alternative modes for recovery of survival craft should be regularly incorporated into mandatory drills.
- The benefits of pre-briefings and debriefing of the crew in relation to mandatory drills should not be underestimated for crew training and familiarization.

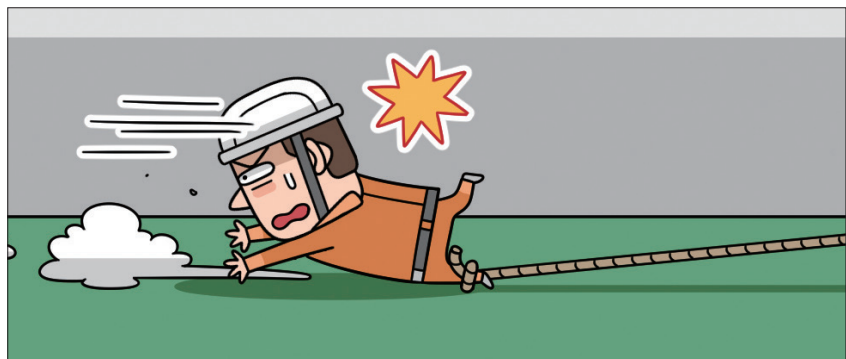
A 21,000 GT chemical/products tanker was approaching the berth under pilotage with the assistance of tugs. The forward tug was to be released from the tanker's bow as the vessel was required to turn to starboard. The tug line's eye had been secured to the bollard on the forecastle. The eye had a messenger rope attached to it. The tug's line was slackened to facilitate its release. The ordinary seaman (OS) eased the rope out through the closed chock (Panama Lead) and had taken a turn of the messenger rope around the bitts. As the tanker's turn to starboard for berthing continued, and the tug's line was in the water, the messenger rope's exit speed from the closed lead started to increase. The officer in charge of the mooring operation warned the OS to step clear from the messenger rope. The OS moved between the bitts from port side to the starboard side, as rope's speed around the bitt quickened. He fell on the deck and was dragged with the rope entangled around his leg. His body hit a structure near the single point mooring chain stopper before he was dragged overboard through the Panama Chock. The OS was recovered from the water by the tug boat, and received first aid and CPR. Emergency services subsequently transported the OS to hospital, but the OS died the next day.

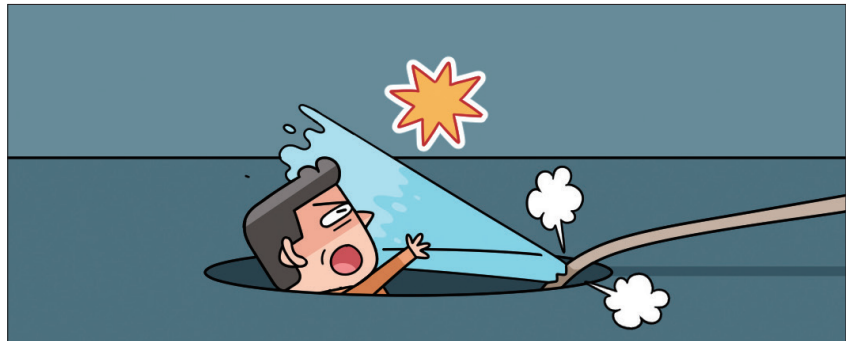
Upon the vessel's early morning arrival, a water leak was detected by an engineering watch officer coming from the main engine turbo charger drain. Suspecting a water leak in the boiler/economizer, the chief engineer ordered it be shut down so that it could be inspected for leaks and repaired later that morning during normal working hours. About 5 hours later the second engineer, along with a fitter, entered the boiler space from the bottom manhole door after they were satisfied with all safety precautions having been taken for man entry. They identified a leaky boiler tube and plugged it from the bottom. Next, their plan was to plug the same tube from the top of the boiler and then restart the boiler. While the second engineer was exiting the bottom manhole door with the fitter right behind him, the inserted boiler tube plug fell off along with a small broken section of the water tube causing hot water from the boiler water drum, steam and smoke to leak out upon the fitter, killing him instantly.

- Lack of SMS boiler work risk assessment process. Failure of the engine-room team to identify all hazards involved for the intended procedure. Failure of the engine-room team to adequately and effectively check that the boiler was drained of water and depressurized. Likely fatigue of the second engineer.

- The dangers of working around, with, and on pressurized boiler systems.
- The value of having SMS procedures for working on pressurized systems such as boilers, as well as following those procedures.
- The dangers of relying on and making assumptions based on gauges.
- Risk assessment forms for this repair evolution were generic in nature and do not identify specific hazards associated with individual tasks.
- Boilers should only be depressurized when boiler water blow down commences to ensure all water from the drum is emptied overboard.
- Engineers should not solely rely on steam being emitted from the stack as the only indicator that a steam drum is empty. The boiler vent on top of the boiler should also be opened to check that a boiler is depressurized.

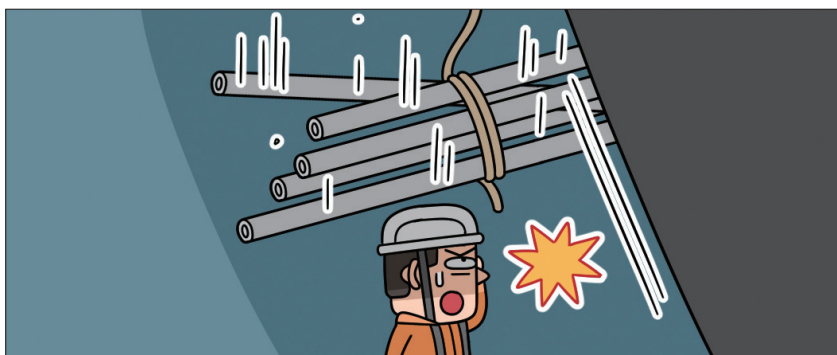
While alongside a wharf, the vessel was loading a cargo of heavy stainless steel pipe bundles. Suddenly, and without warning, the vessel lurched, the suspended pipe load swung uncontrollably in the vessel's cargo hold, crushing three longshoreman between the suspended load and side wall; two died and one was seriously injured.

- The underside of the vessel's fenders on the starboard shoreside amidships hull caught and hung up upon the top of the wharf's fenders. As the tide fell and the vessel's draft increased due to loading of the cargo, the vessel's list increased to a point where the ship's fenders suddenly released from the wharf causing the vessel to quickly and heavily roll. This caused the hoisted pipe bundles to swing in the cargo hold, striking the stevedores who were trapped between the swinging cargo hoist and the vessel's side wall.

- The dangers of working in, on or around a vessel subject to ever-changing and dynamic forces.
- Hazards of working with suspended cargo in a confined cargo space.
- The value of critically evaluating a vessel's condition while alongside a dock, paying particular attention to identifying and eliminating snag hazards and tending mooring lines.
- The value of establishing cargo work plans to consider the possibility of sudden hull rolling and identifying worker refuge areas.

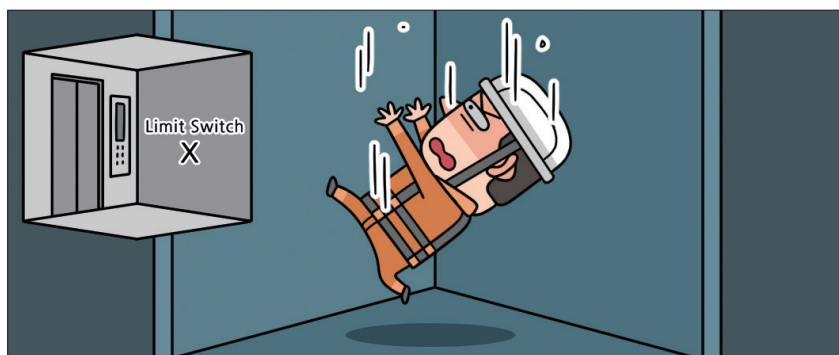
A messman was found entrapped in the shaft of a provisions lift on board a bulk carrier. The lift was found off the guard rails with the lift motor still running. Following the recovery of the trapped messman from the lift shaft, it was confirmed he was deceased. How the messman came to become trapped in the lift shaft is unclear.

- The lift doors were not fitted with limit switches to prevent operation of the lift when the doors were open, although they were shown in the original circuit diagram.
- The lift controls only required a single touch to operate; they were not required to be constantly pressed.
- Neither ship nor company staff had noticed that the door limit switches had been missing since the ship was built.
- The provisions lift was not included in the ship's maintenance system and was not routinely inspected.

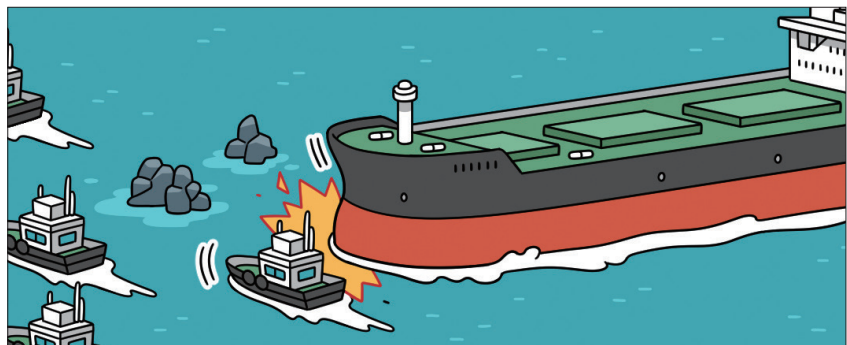
The 40,000 GT bulk carrier was on her way to the next loading port. Around midnight the bridge was manned with the officer of the watch (OOW) and one lookout. At the same time the 240 GT fishing vessel sailed from the fishing grounds to her home port with a crew of 15. In a distance of about 6 nm the fishing vessel appeared on the radar screen of the bulk carrier and it was optically visible on the starboard bow. There were about 25 fishing vessels in the vicinity. During this time the bulk carrier ran with a speed of about 14 knots, the fishing vessel with a speed of about 9 knots. The OOW of the bulk carrier detected that the fishing vessel would pass the bow from starboard to port side. Both vessels met in a crossing situation in which the bulk carrier was the give-way vessel. During the approach of both vessels the closest point of approach (CPA) decreased, although the bulk carrier had started a small course alteration to starboard. The bulk carrier continued with a bigger course alteration to starboard. Shortly afterwards the fishing vessel made a course alteration to port which led to the collision of both ships. The fishing vessel was struck by the bulbous bow of the bulk carrier on the starboard side amidships and suffered severe damage with a massive intake of sea water. This caused the foundering of the fishing vessel shortly thereafter. Only two crew members of this vessel survived. None of the bridge team was rescued. The bulk carrier continued her voyage without any activities as they thought nothing had happened.

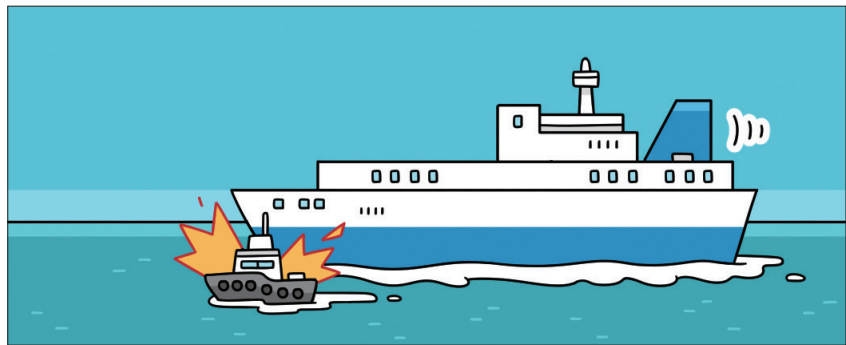
The tug had been engaged to assist the ro-ro passenger ferry to berth in high winds. There was no harbour pilot on board the ferry because the master held a pilot exemption for the port. The tug was manoeuvring close to the port bow of the ferry while attempting to establish the tow, when the stern of the tug collided with the ferry's bulbous bow. As a result of the collision the tug became broadside on in front of the ship, heeled dangerously to port and took on water. The tug capsized and two of its crew died.

- The pilot-exempt master of the ferry was not required to have undergone additional training for tug assistance, which was usually requested during adverse and difficult weather conditions.

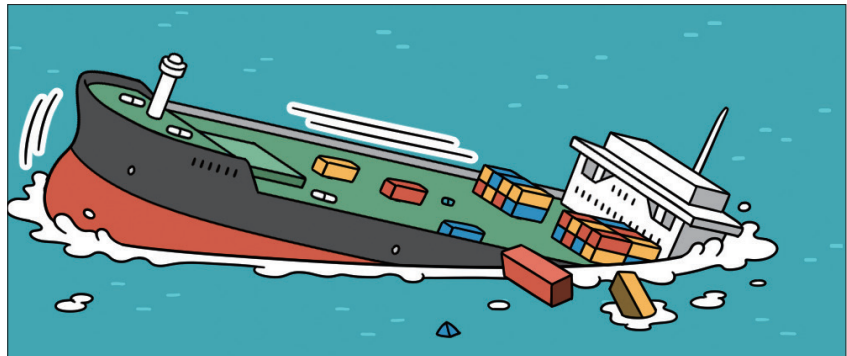
A dry cargo vessel was approaching port, and the vessel developed a severe port list due to cargo shifting and subsequently water entered the engine-room via a weathertight engine-room escape door being left open. This exacerbated the list and the crew abandoned ship. The main engines were left running and this caused the vessel to make circles and make boarding very difficult if not impossible. Eventually this led to the vessel's grounding on a shoal where she became a constructive total loss. It became evident during the accident investigation that the cargo was not stowed and secured as required by the vessel's cargo securing manual.
