Marine Safety Investigation Report

on Bulk Carrier *ENVY*

– Fatality of stevedores –

Accident Date : 2021.03.18.

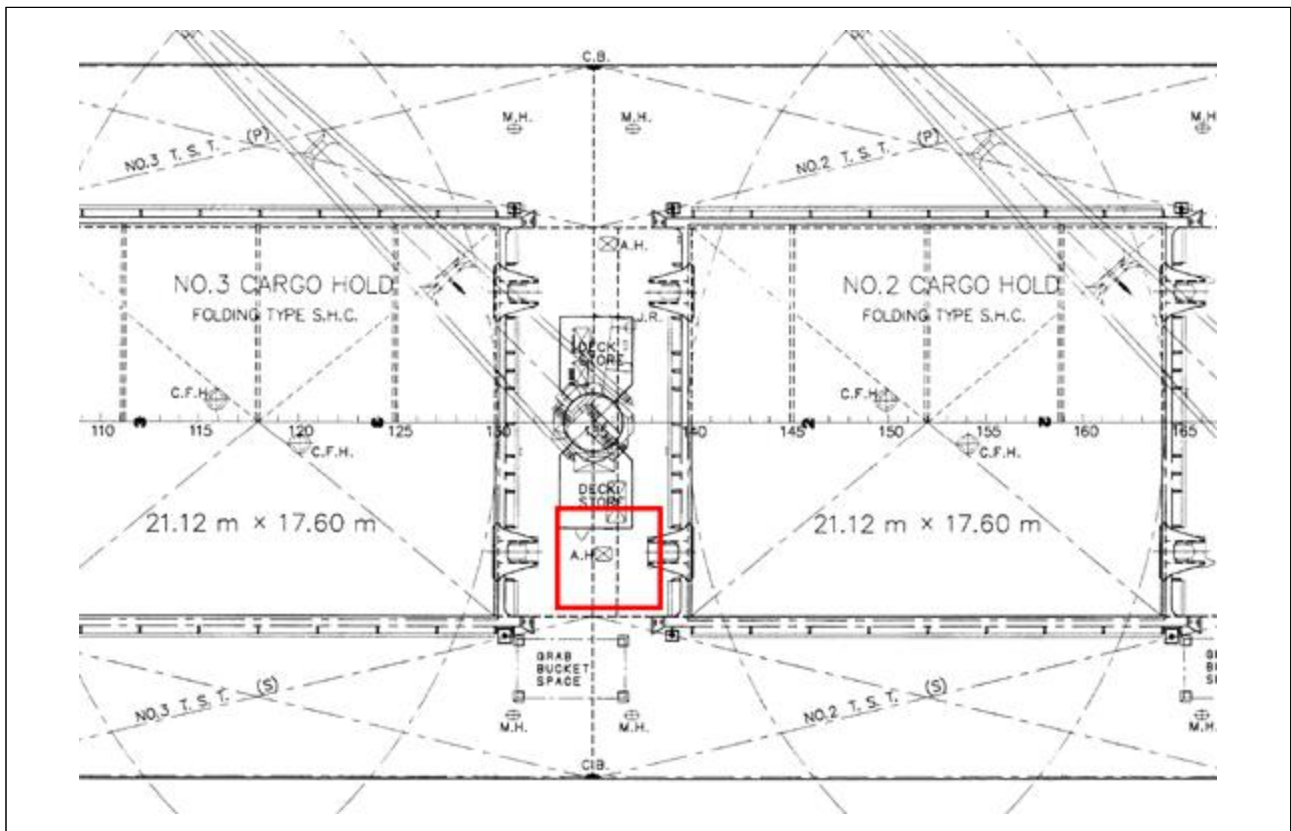
<Figure 2> Location of access hatch (A.H) to No. 2 cargo hold

by 17.60 meters each, located at the front of the engine room area, which is arranged below the upper deck. Each cargo hold has a hatch cover and access hatches. The access hatch to the No. 2 cargo hold, where the accident occurred, is located at the cross deck between the No. 2 and No. 3 cargo holds.

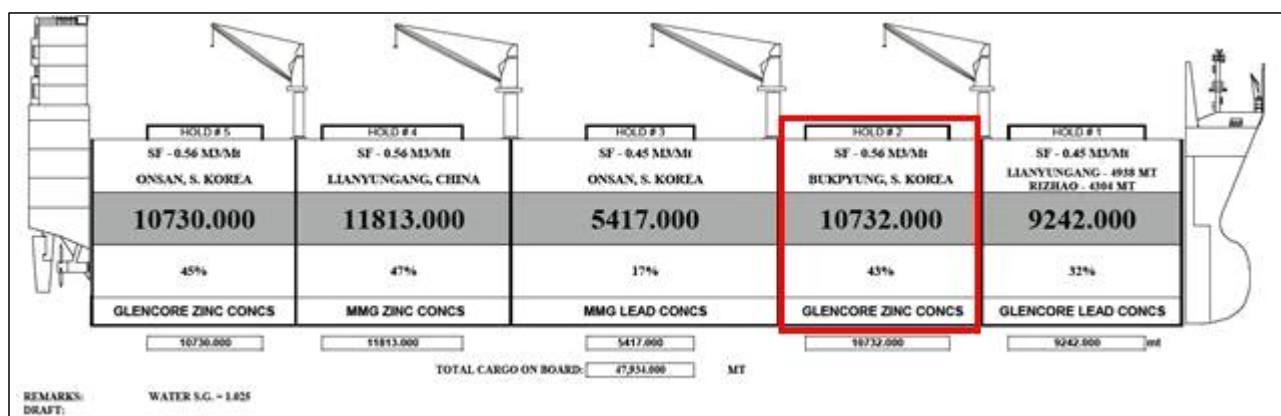
<Figure 7> Details of cargo loading by cargo hold

3.1.1 The *ENVY* loaded about 48,000 tons of cargoes, including zinc and lead concentrates, and departed from Townsville, located in the northeast of Australia, on February 15, 2021. Excluding the cargo in the No. 2 cargo hold, most of the cargoes were unloaded at the Lianyungang and Rizhao ports in China and Onsan Port in Korea, after which the vessel departed from Onsan Port on March 15, 2021. The cargo in the No. 2 cargo hold (10,732 tons of zinc concentrates) was going to be unloaded at the next port, Donghae Port²⁾.
