[MSI Report 2023-002]

Marine Safety Investigation Report

– Fatal Accident aboard Research Vessel Isabu –

Date of Accident: 5 July 2022

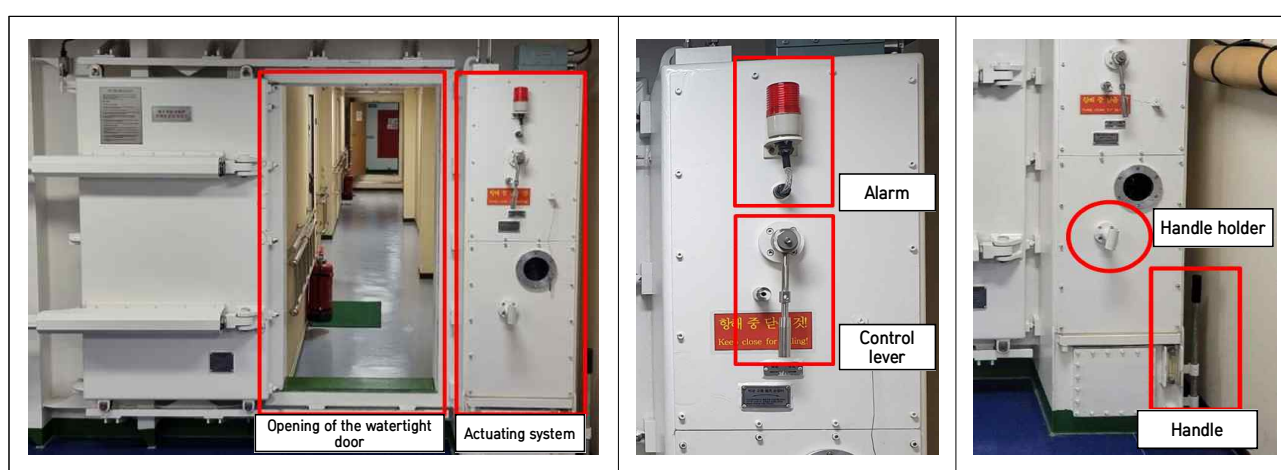
<Figure 4> Opening and actuating system (left); control lever and alarm (middle); and hand pump handle (right)

2.7.2 Isabu's watertight doors are operated by the hydraulic sliding system consisting of oil tanks, a hydraulic pump, an accumulator, control levers, hand pump handles, a pressure gauge, and an alarm. This system runs at a maximum pressure of 180kg/cm² with 440 volts, and the accumulator has a capacity of 32 liters. The alarm, connected to a 24-volt emergency power supply, gives off audible/visual signals.

2.7.3 The watertight door specifications say it takes 20 to 40 seconds to close the watertight door under normal conditions, and closing takes up to 90 seconds when the hand pump is used.

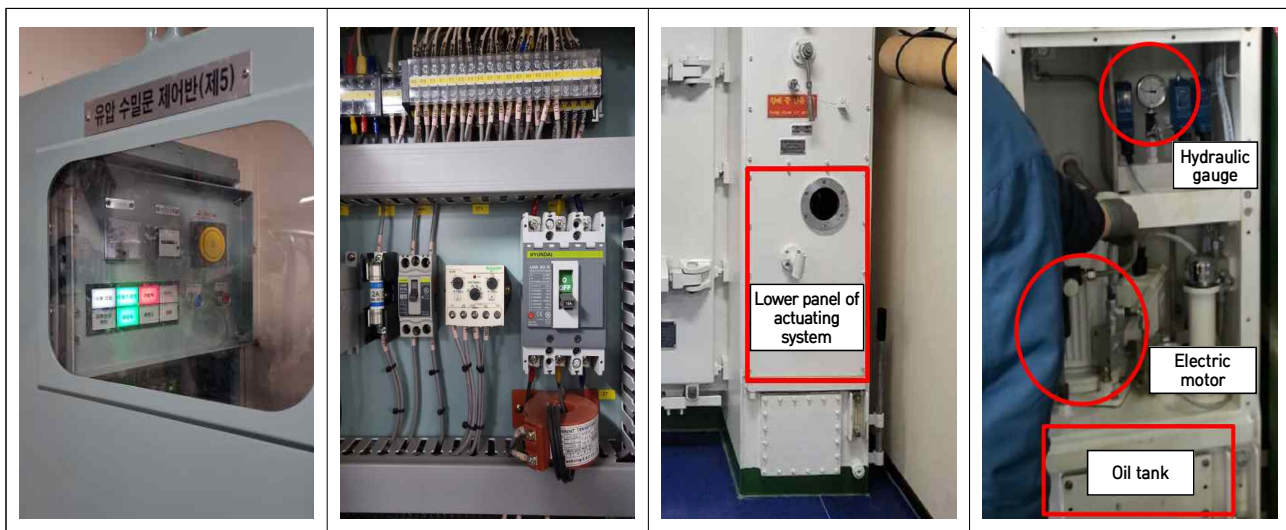
<Figure 7> Power switchboard, switchboard interior, lower panel of the actuating system, and inside the panel (from left)

3.1.7 From 14:15 to 15:05, the C/EE stayed at the fitness room.⁹⁾ The C/EE opened the cover of the power switchboard installed on the wall and checked its condition. The switchboard was closed with the power off. There are two power switches inside: one is a 440-volt power switch that operates the watertight door's hydraulic system; and the other one is a 24-volt emergency power switch for ringing an alarm and displaying a control console.

3.1.8 Then, the C/EE opened the lower panel of the actuating system where the watertight door's control lever was installed, checked the hydraulic gauges, electric motors, and other equipment, and cleaned the inside with cleaning cloths. While doing so, the watertight door remained closed.¹⁰⁾

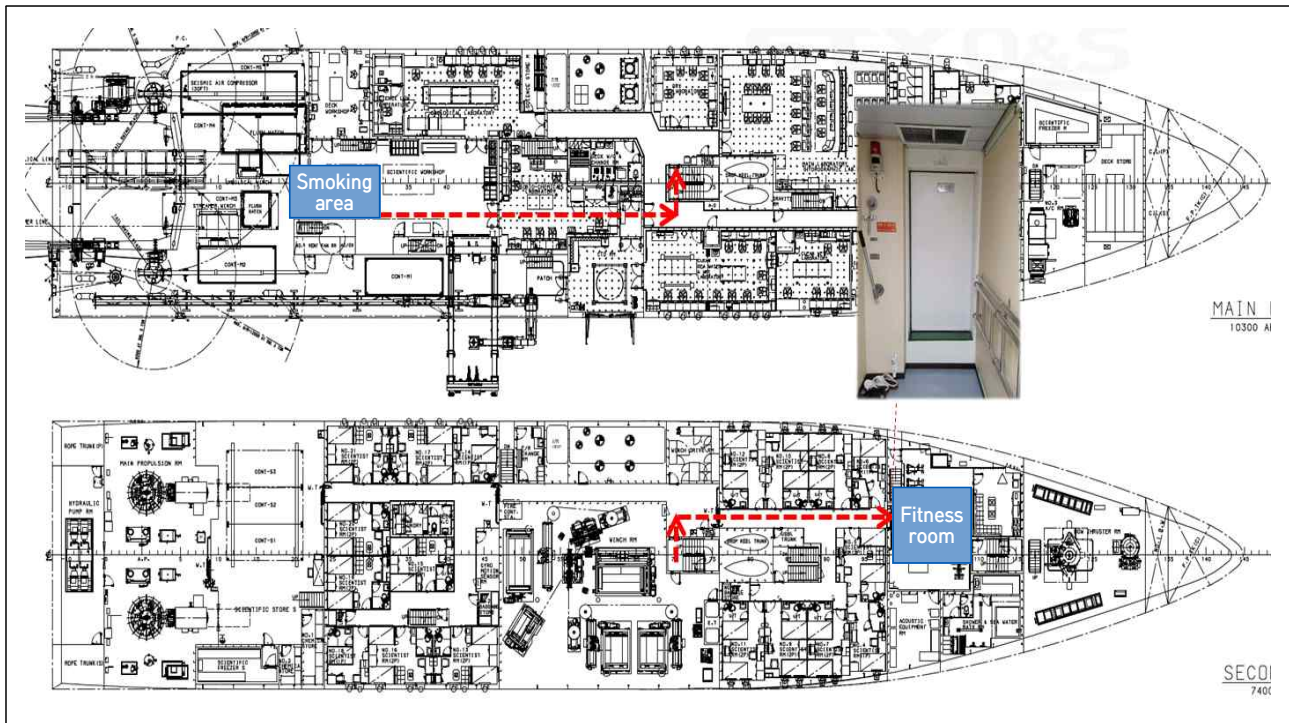
<Figure 9> Route taken by the C/EE (Smoking area → Fitness room)

- 3.1.10 From 15:08 to 15:12¹¹⁾, the C/EE took a short break in the smoking area. The C/EE joined four or five crewmates there, smoking and chatting amongst themselves.
- 3.1.11 At 15:13, the C/EE left the smoking area and returned to the accommodation area. On the way back, the C/EE went down to the second deck along the stairs in the middle of the accommodation area on the main deck.
- 3.1.12 At 15:15 when coming down to the second deck, the C/EE walked along the corridor where the cabins for researchers and crew are located and arrived at watertight door no. 5. At that time, the door was kept closed.

- 3.2.1 The C/EE tried to open watertight door no. 5. It is uncertain why the C/EE tried to open the door which is normally closed. Since the C/EE was maintaining the watertight door, the C/EE probably intended to check the door's condition, or to simply save time to go back to the fitness room from the smoking area. When the door was closed, a stopper was always put into the hole of its control lever in the corridor.
- 3.2.2 At 15:15, the C/EE took out the inserted stopper from the lever and opened the watertight door by turning the lever to the right. Since the power switchboard of watertight door no. 5 was turned off¹²⁾ at that time, the door was operated by the accumulator's residual hydraulic pressure. While opening the door, the C/EE was holding the control lever in the opening direction.¹³⁾

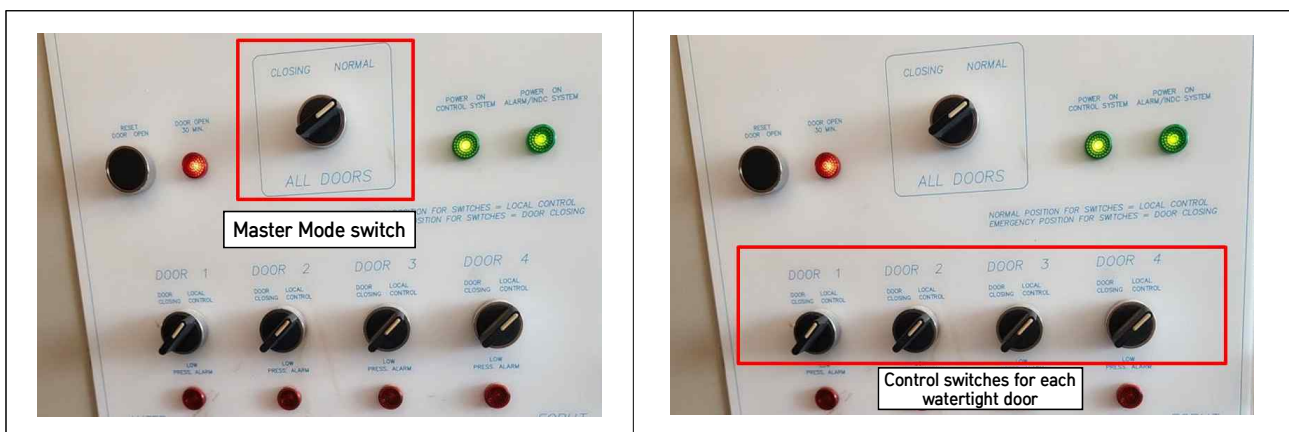
<Figure 18> Control console for watertight doors onboard Onnuri

4.6.4 Another research vessel of the KIOST, "Onnuri," has the "master mode" switch with "control" switches for each watertight door below it on the central control console at the bridge, showing that the console has different functions and arrangement from that of Isabu.

4.6.5 It seems that the various functions of the control console on Isabu are likely to confuse the crew when they fail to understand their differences and functions. Therefore, it is considered important to provide sufficient training for the crew and

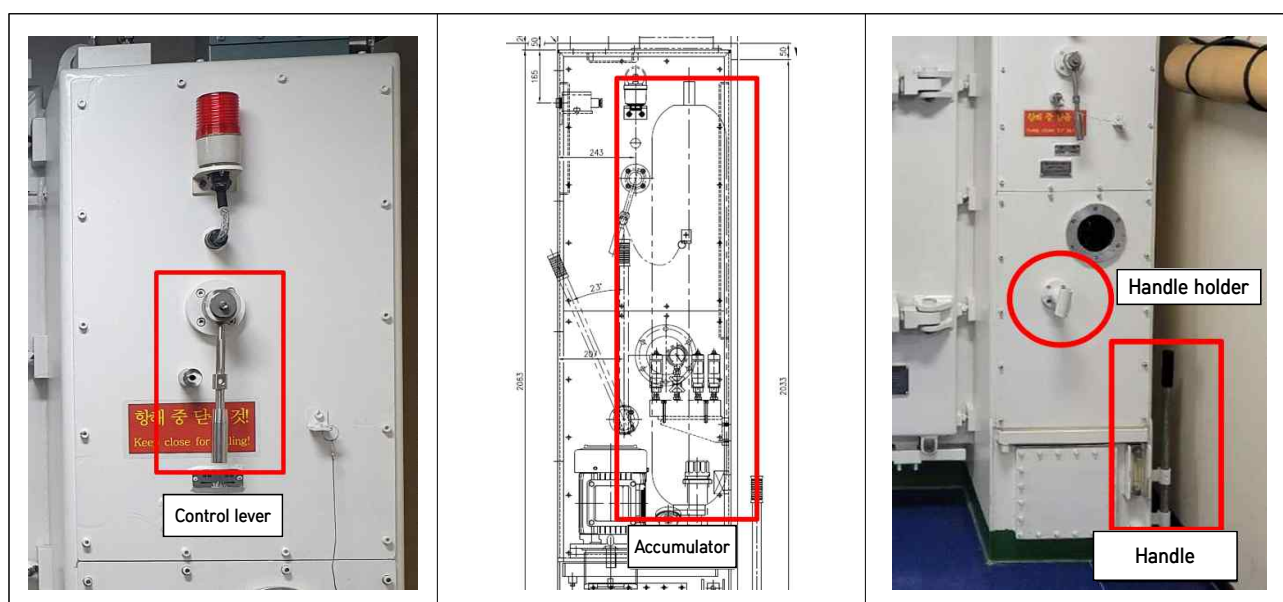
<Figure 19> Control lever (left); accumulator in the diagram (middle); and hand pump handle (right)

4.6.7 Meanwhile, the watertight doors onboard Isabu may be operated locally, at each door itself, in one of three ways: First, a person can use a control lever by running the hydraulic pumps; second, when the power is off, the door can be operated by the residual pressure of the accumulator; and third, if the oil pressure is not sufficient to operate the door, a person can use a handle for emergency operation to manually operate it.
