Marine Safety Investigation Report

on Chemical Tanker *Golden Bridge Hana*

– Fatality of a crew member –

Date of Accident: 29 August 2019

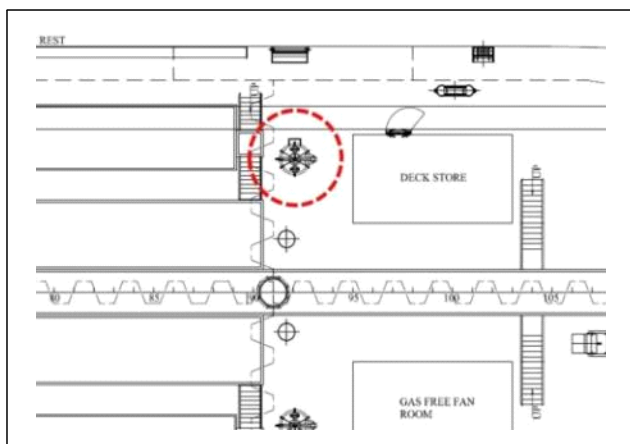
<Figure 3> Position of the hatch manhole of No. 2 COT (P)

- 2.4.3 Each cargo tank has one hatch cover on its aft part. The hatch covers are in the mode of turning the steering wheel to open and close. In case of entering to a cargo tank, this hatch cover must be opened.

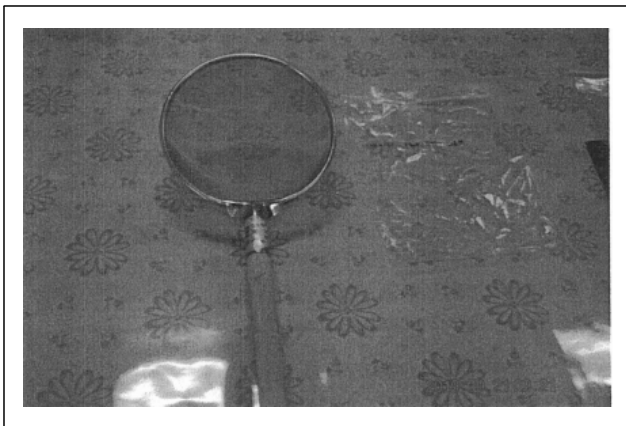
<Figure 7> The type of the scoop net used by the bosun

- 3.2.8 At around 16:30, the bosun brought a scoop net from the mess room after being informed that the sampling device had dropped into the cargo tank. While carrying it to the deck, he said to the C/O, who was writing a report in the cargo control room, "The cargo pump can be damaged when we discharge cargo at the port of discharge. I will get into the cargo tank and remove the bottle."

- 3.2.10 Later, the master came across the bosun carrying the scoop net at the entrance of the accommodation area. The master asked, "What are you going to do?" The bosun answered, "I will scoop up something." Then, the master just said "Ah, is that right?" without asking what was to be scooped.

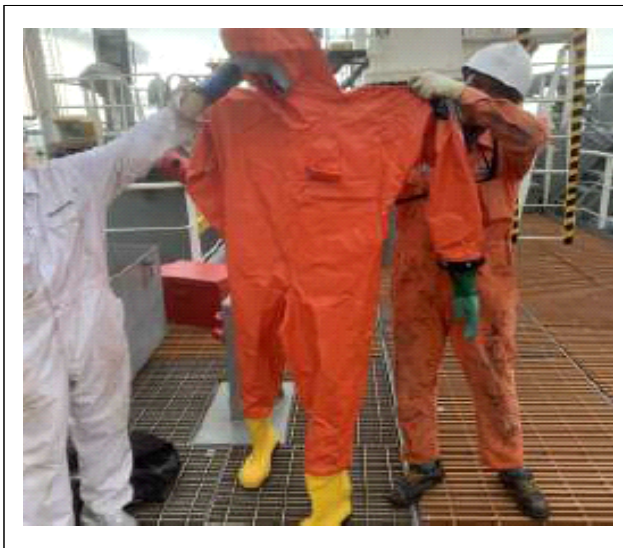
<Figure 9> The chemical protection suit worn by the bosun

- 3.3.1 At around 16:45, the bosun wore a chemical protection suit and a self-contained breathing apparatus (SCBA) and entered No. 2 COT (P) through the open hatch cover, without notifying his superiors.
- 3.3.2 At the time, the C/O was discussing with the cargo surveyor how to remove the device and the glass bottle that had fallen to the tank bottom⁵⁾.

- 4.1.2 His fall inside the cargo tank may have been due to sudden confusion or fainting after inhaling toxic gas through gaps between his face and a loosened facepiece.

- 4.1.6 These circumstances collectively suggest that the facepiece of the SCBA lost its firm seal on the bosun's face as he fell forward onto the floor, which had 50cm of VAM on it. Lethal gas and liquid VAM appear to have leaked into the facepiece, and the bosun inhaled them.
