Marine Safety Investigation Report

on Chemical Tanker *Onsan Chemi*

- Fatality of a crew -

Date of Accident: 23 November 2020

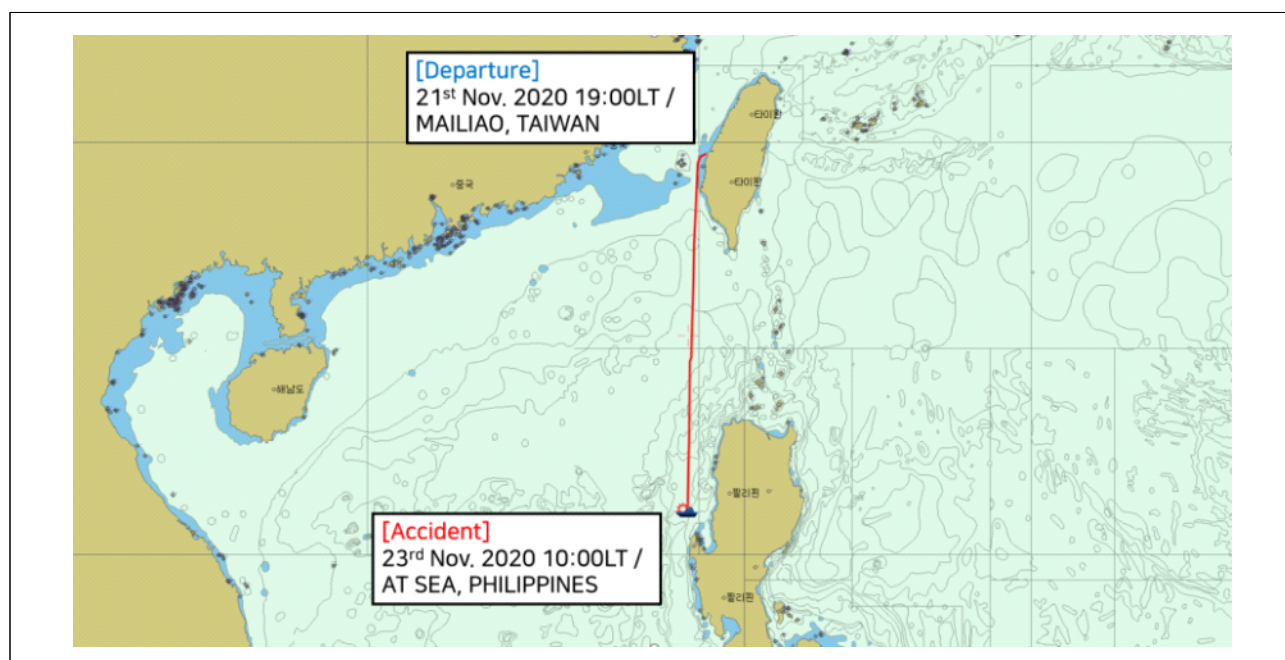
[Figure 5] Track of *Onsan Chemi* and the accident location

- 2.9.1 Prior to this accident, *Onsan Chemi* departed from Mailiao Port in Taiwan for Manila Port in the Philippines. The vessel was sailing off the coast of the Philippines when the accident occurred.
- 2.9.2 The weather conditions were recorded in the logbook as in [Table 2], and the wind and waves were mostly in fair condition.
