[MSI Report 2021-001]

Marine Safety Investigation Report on *M/V MILANO BRIDGE* - Contact with gantry cranes -

Date of Accident: 6 April 2020

Korea Maritime Safety Tribunal
Marine Safety Investigation Team

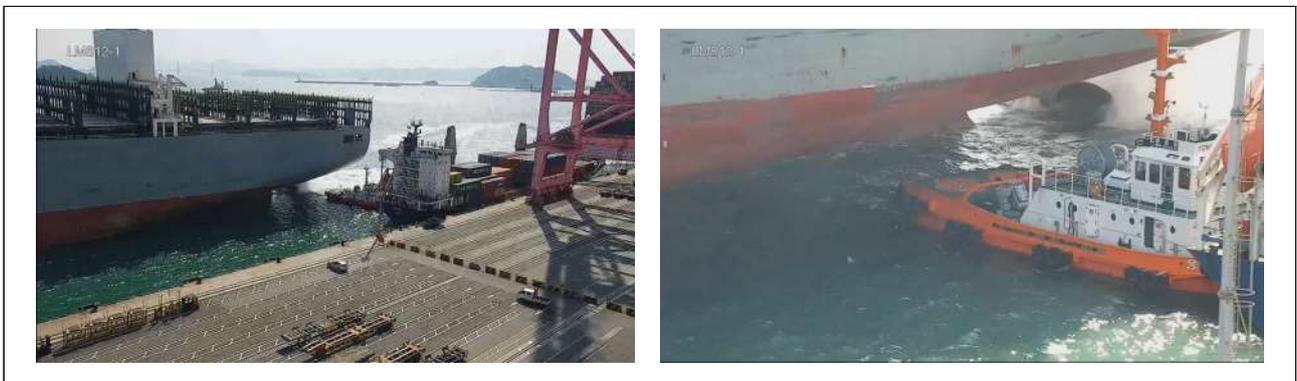
<Figure 21> Space between *Milano Bridge* and M/V *Proteus* (CCTV)

3.5.2 At around 14:47, Pilot A ordered the aft tug to stop pulling and the rudder hard to starboard as the heading became about 087°. He then issued a series of urgent steering orders, including hard to port and hard to starboard to turn the vessel to starboard while preventing the stern from drifting toward the pier. At that time, the speed of *Milano Bridge* was about 6.2 knots, and her stern moved to within ten meters of M/V *Proteus*, a containership standing by for departure at Berth No.1 of Pier No.3.

3.5.3 At around 14:38, with the bow turning to starboard, *Milano Bridge* barely passed M/V *Proteus*. However, at around 14:49, when *Milano Bridge* was on a heading of 104° at about 5.6 knots, the port bow of the vessel contacted Gantry Cranes No.84 and No.83 in succession, after a crash into a Gantry Crane No.85 at Berth No.8 of Pier No.2. As for Gantry Crane No.81, its boom, a horizontally lowered beam, made a hard contact

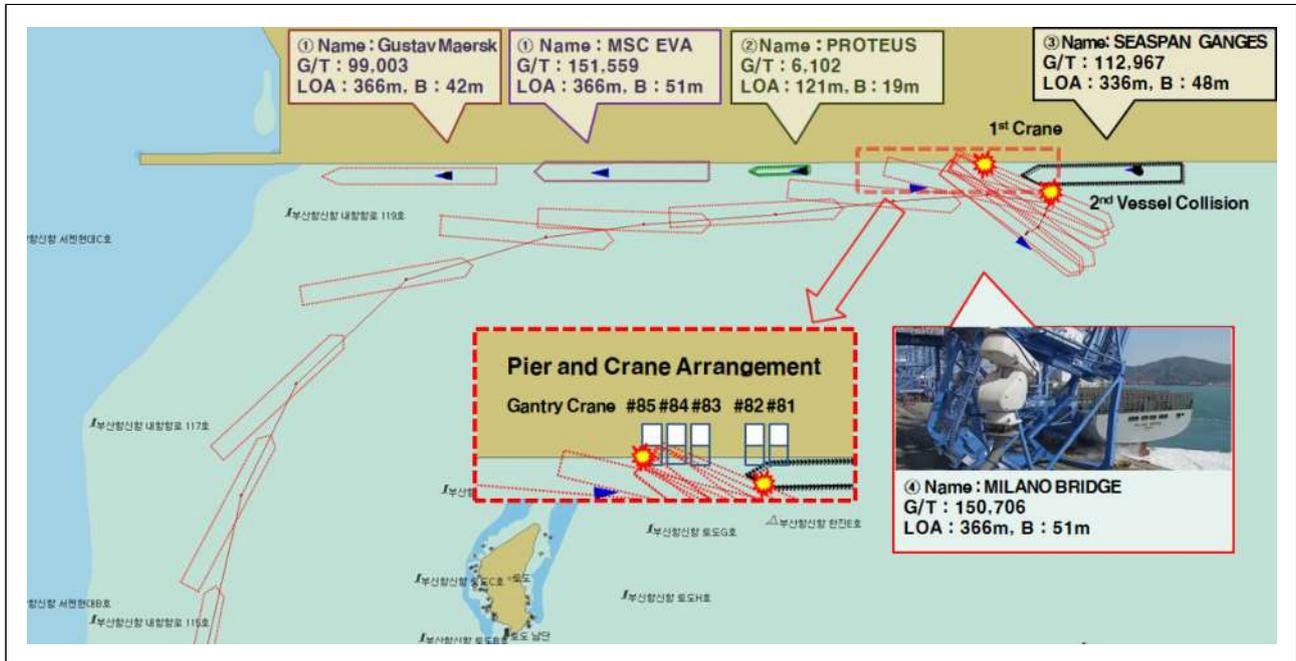
<Figure 22> Berthing arrangement and collision when the accident occurred

with the port wing bridge of *Milano Bridge*, cutting the support frame of the crane and collapsing its lower part.

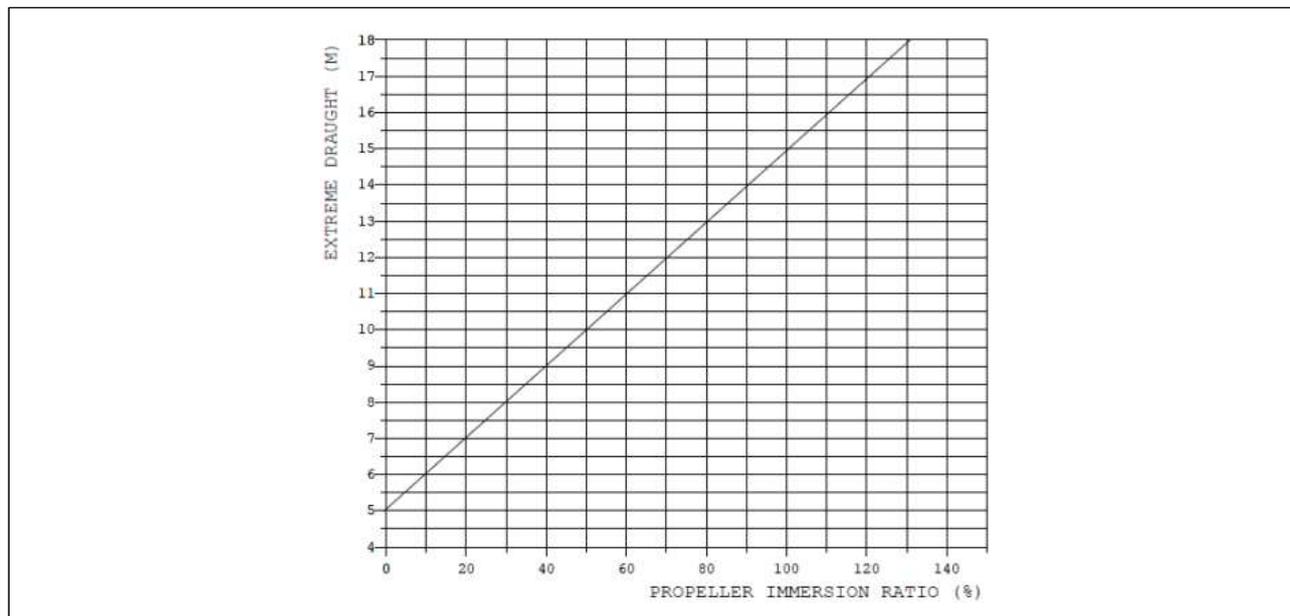
<Figure 25> Propeller Immersion Ratio Curve of *Milano Bridge*

4.3.3 Figure 25 shows the propeller immersion ratio of *Milano Bridge*, as presented in the Stability Booklet with Loading Guidance, approved by the Classification Society when building the vessel.

- 4.3.8 Analysis on a six-minute track of *Milano Bridge*, recorded in the VDR right before the accident, showed that despite consistent efforts to increase rpm (35 to 44)³²⁾ the vessel had advanced about 0.6 miles in 6 minutes, equal to about 6 knots (over 12.2 knots according to the vessel information). Given that, such analysis is considered to demonstrate deterioration of propulsive efficiency when the propeller rpm was increased, as described in Paragraph 4.3.7.

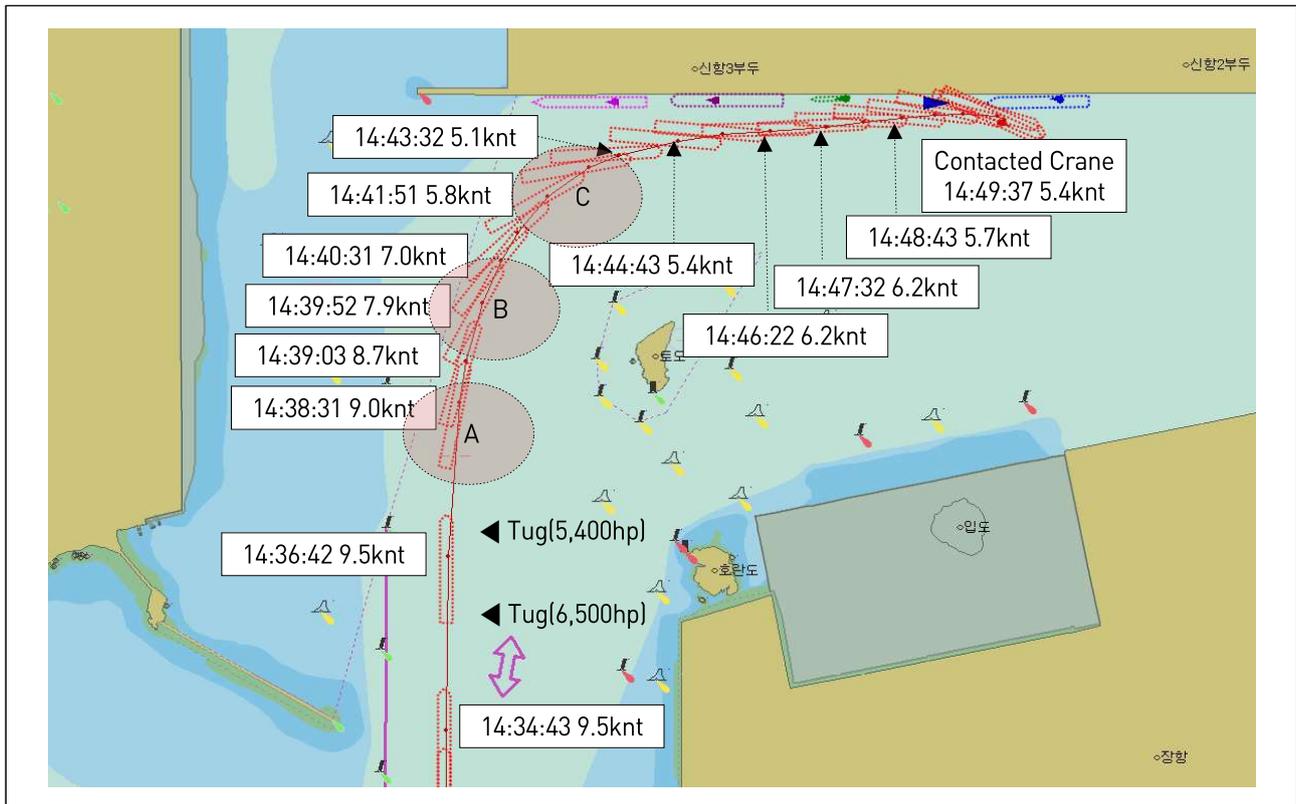
<Figure 27> Track of *Milano Bridge* at the time of the accident

4.4.1.1 Pilot A boarded *Milano Bridge* in the vicinity of Racon B, a buoy located off the southernmost tip of Gadeok Island, at around 13:54 on 6 April 2020. At around 14:34, he piloted the vessel past the west breakwater of Busan New Port on a course of about 000° at about 9.5 knots, as illustrated in Figure 27.

4.4.1.2 Around 14:36, Pilot A first ordered starboard 10° to turn the vessel to make a 90° change in heading to starboard and proceeded to the waters off Pier No.2 at the position with a straight-line distance of 0.84 miles (1,556 meters) from the quay of the North Container Terminal before arriving Point A, marked in Figure 27.

4.4.1.3 At around 14:39, Pilot A ordered the main engine stopped to lower the speed when passing Point B. He, however, feeling that the vessel turned much slower than expected due to a low rate of turn, sought to increase the rate of turn further by ordering hard to starboard and setting the main engine to dead slow ahead. Also, at around 14:40, the pilot ordered the aft tug on the starboard quarter to push the stern and the bow thruster full to starboard to increase her turning rate to starboard.

- 4.4.1.4 Despite this, the starboard turn was further delayed while the vessel proceeded even closer to the pier. Thus, Pilot A, who was worried that the vessel might collide with the other vessels berthed at Pier 3, at around 14:41 ordered to increase the turning rate at Point C so that the speed can increase and he can avoid collision.

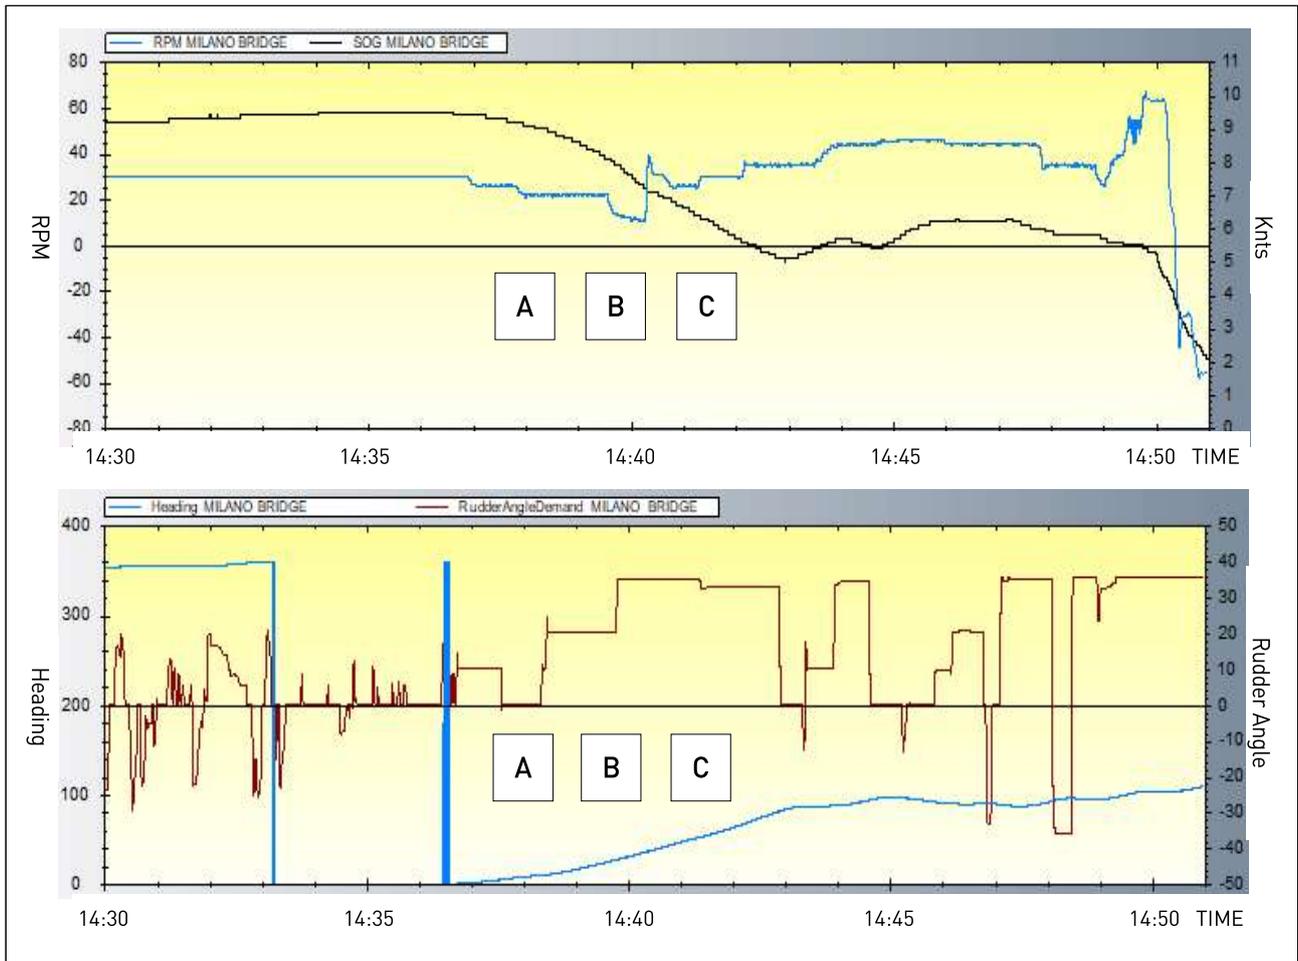
<Figure 28> VDR Record

- 4.4.1.6 Figure 28 illustrates rpm, vessel speeds, headings, and change of rudder angle, recorded in the VDR from around 14:30 right before *Milano Bridge* approached the west breakwater of Busan New Port to around 14:50 when the collisions took place.

4.4.1.7 The vessel put To Islet on the starboard side and made a large course change of 90° to turn starboard from 14:36 to 14:43 (approximately 7 minutes and 45 seconds on a per second basis). In the following table, such a track (from Point A to C) was compared with the track of *Milano Bridge* during the sea trials,³⁴⁾ when she was in ballast at half ahead (10.6 knots), like the conditions at the time of the accident.

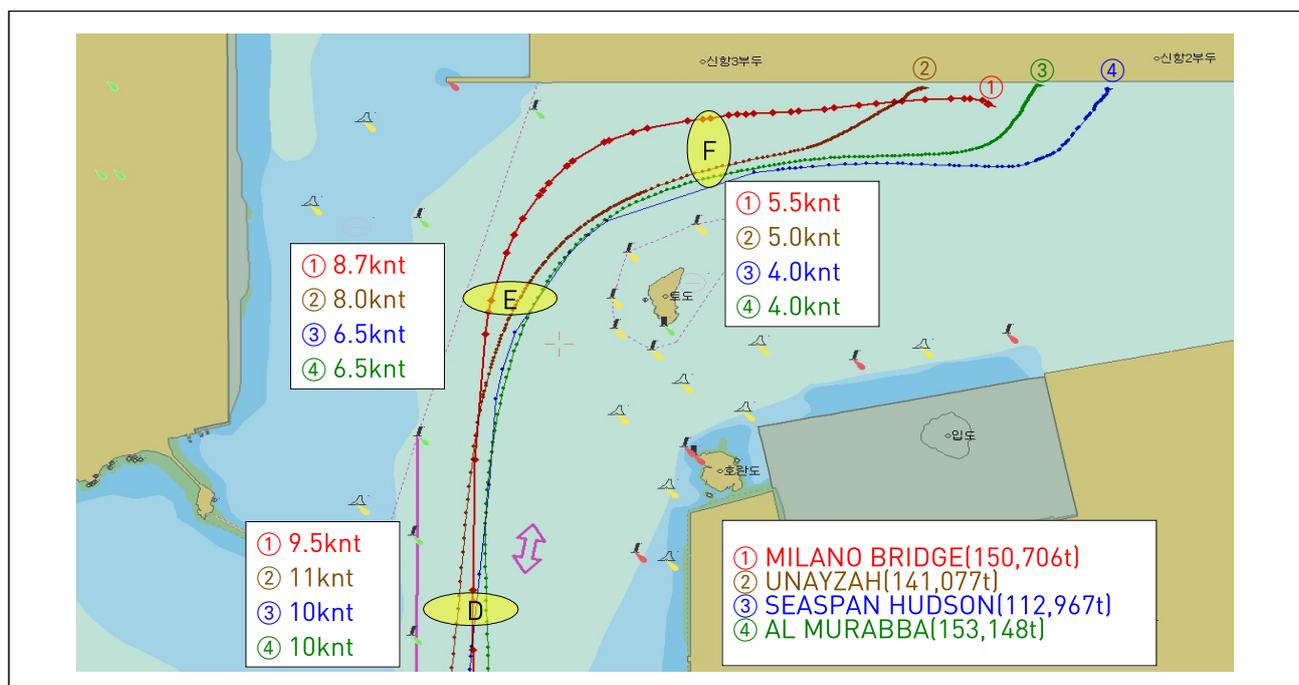
<Figure 30> Tracks of vessels at the time of the accident

4.4.2.1 Pilot A had piloted four vessels in total (including *Milano Bridge*) into berthing at Pier No.2, putting To Islet on starboard side, among vessels over 100,000 tons that had entered Busan New Port since 2019 until the day of the accident. Figure 30 illustrates their tracks.

4.4.2.2 *Milano Bridge* proceeded into the port 0.8 knots slower than the other three vessels' average speed of 10.3 knots at Point D, passing the west breakwater of Busan New Port. At Point E, passing To Islet, however, Pilot A started to turn *Milano Bridge* at speed 0.7 to 2.2 knots faster than the other vessels he had piloted. Her speed at Point F in front of Pier No.3 remained 0.5 to 1.5 knots faster than that of the other vessels as the speed of *Milano Bridge* was slowly reduced.

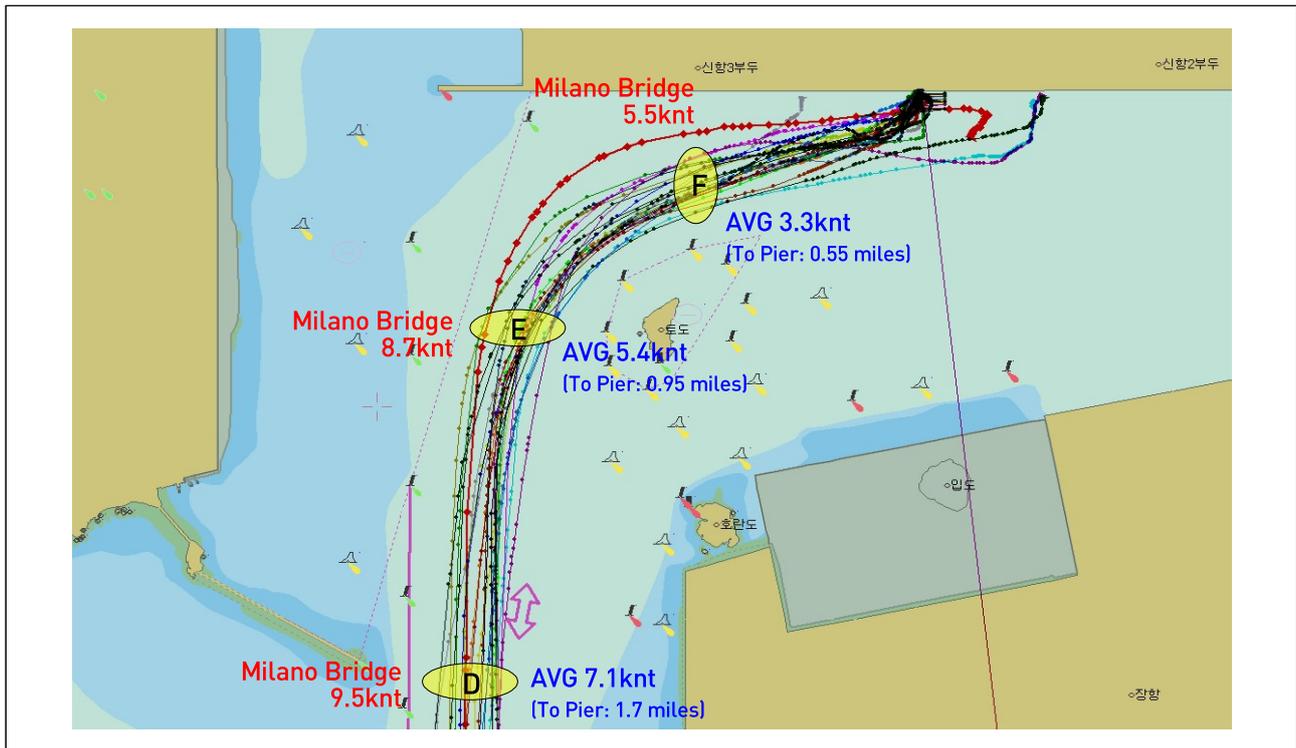
<Figure 31> Berthing tracks of 23 vessels

4.4.3.1 Among the large vessels (over 140,000 tons) that had entered Busan New Port from January to April 2020, a total of 23 had berthed at Piers No.2 or 3, putting To Islet on the starboard. Figure 31 compares the tracks of these vessels with that of *Milano Bridge* during the accident.

- 4.4.3.2 Figure 31 shows that *Milano Bridge* was at 9.5 knots, 2.4 knots faster than the other vessels, whose average speed was 7.1 knots at Point D, passing the west breakwater. Even at Point E, passing To Islet, *Milano Bridge* was at 8.7 knots, 3.3 knots faster than the other vessels' average speed of 5.4 knots.

- 4.4.3.4 A simple comparison would be difficult as operation conditions at the time, such as weather, vessel drafts, or maneuverability, varied. However, when comparing the process of *Milano Bridge* passing the islet and making a large course change, with those of the other 23 vessels, it turns out that *Milano Bridge* approached at a

relatively fast speed, made a late turn, and increased the tactical diameter.

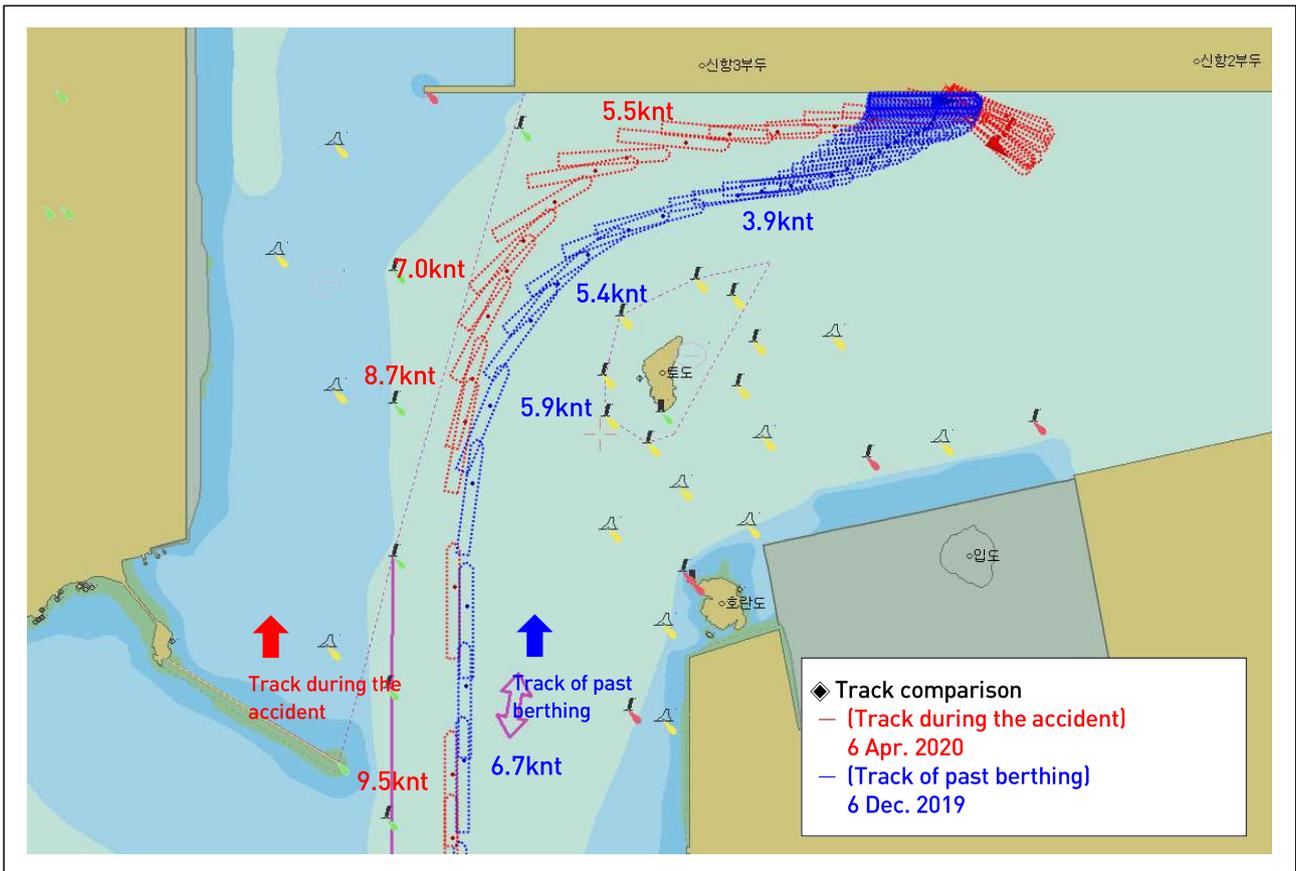
<Figure 32> Comparison between the past track of *Milano Bridge* and the track during the accident

4.4.3.5 Figure 32 compares the track of *Milano Bridge* being normally berthed at Pier No.2 of Busan New Port by a different pilot on 6 December 2019 with the track of this accident on 6 April 2020.

4.4.3.6 The track of *Milano Bridge* on 6 December 2019 when berthing at Busan New Port was like the average track of the other large vessels illustrated in Figure 32. Operating conditions, such as maneuverability or weather, in addition to the draft of 12.7 meters at the time, meaning that her propeller was fully immersed, were different from the conditions during the accident. Still, speeds at the points passing the west breakwater and To Islet at the time were relatively faster than those in the past track and reduced slowly, which increased the tactical diameter according to the analysis.

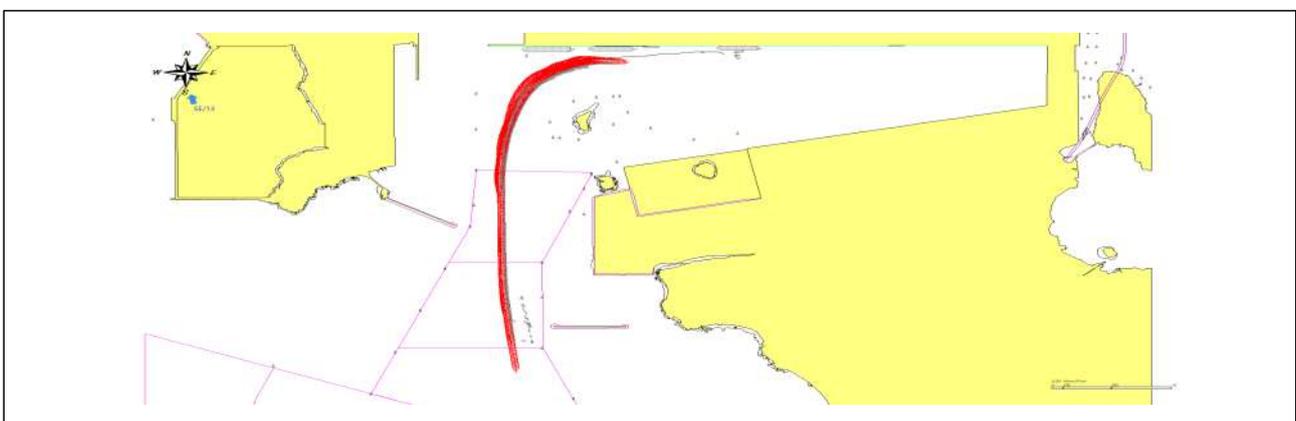
<Figure 33> Track of the simulation

CASE 1. Simulation to represent the accident situation

- This simulation was applied with the same rudder and engine orders, as recorded in the VDR, under the same weather conditions (wind and waves) and draft levels as during the accident. Also, the causal factors, which weakened the propulsion forces and rudder effectiveness of *Milano Bridge* due to her propeller exposure, were reflected in the simulation. The result represented a vessel track almost identical to the one during the accident³⁷⁾ (a solid line marked in the figure above).
- While reproducing the trial performance in ballast and the actual track during the accident, ship maneuverability was proven to have been significantly degraded compared with the trial performance after shipbuilding, as the propeller's propulsive efficiency had been weakened due to its excessive exposure.

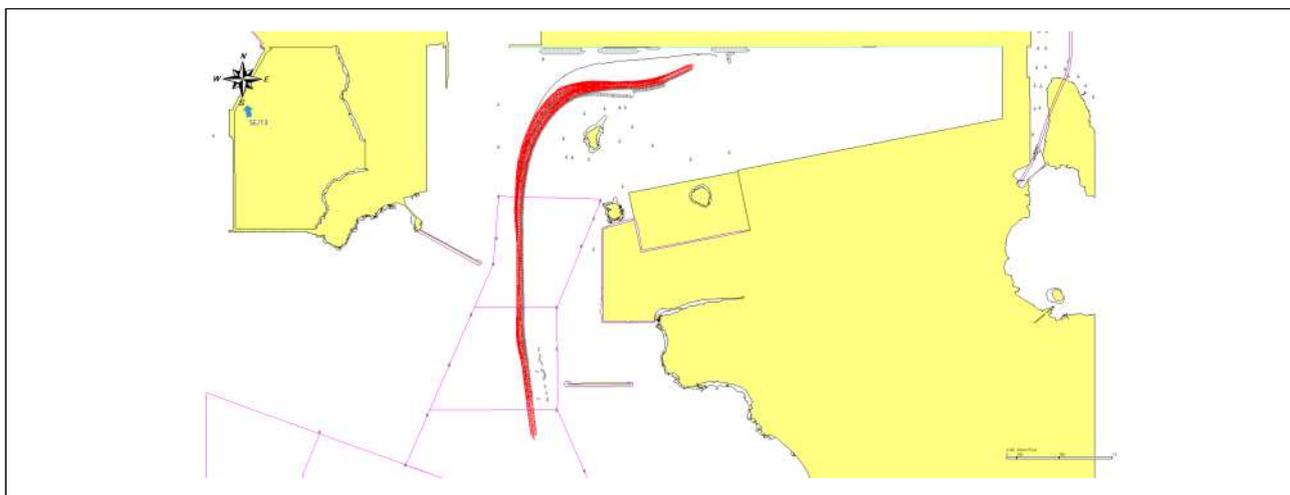
<Figure 34> Track of the simulation

CASE 2. Simulation with changed draft levels

- Under the same conditions as in Case 1, only the draft was changed, setting the vessel in full ballast where the propeller was 100% immersed. The same rudder and engine orders were used just as recorded in the VDR, while no decrease was made in propulsion forces and rudder effectiveness. As a result, the vessel turned out to be able to secure a safe distance from the pier as her tactical diameter was smaller than that it had been during the accident.

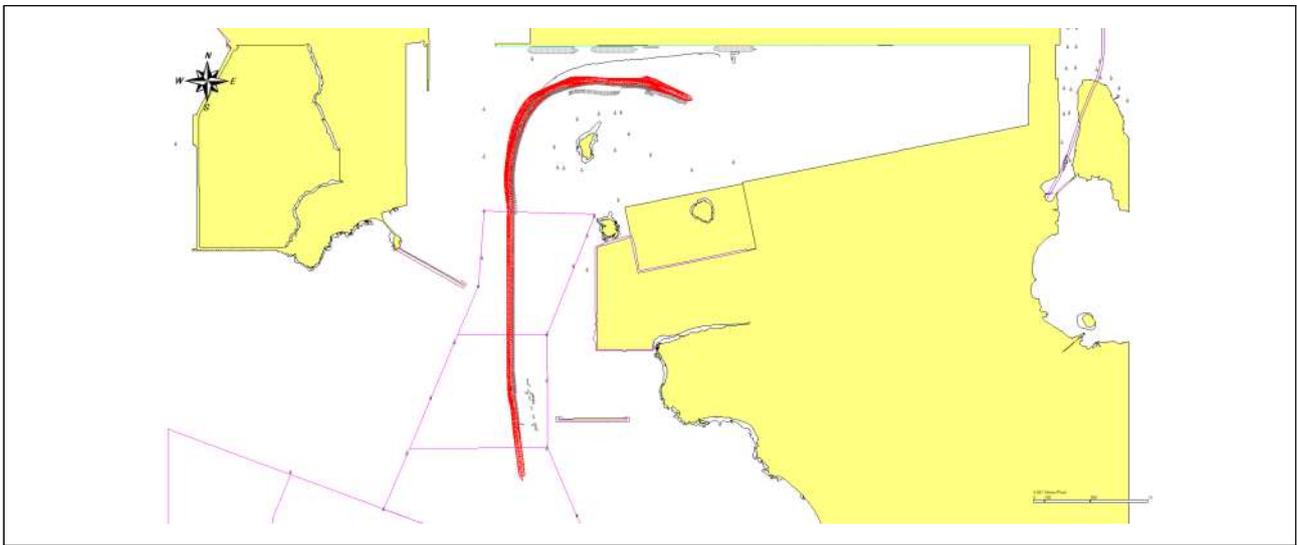
<Figure 35> Track of the simulation

CASE 3. Simulation with no wind

- In this simulation, the wind factor was removed under the same conditions as in Case 1 (wind speed, reduced from 13 knots to 0). As a result, the track in this simulation presented the vessel getting farther away from Pier No.3, at a distance of 100-150m, two or three times the beam, compared with the track during the accident. In general, a vessel is more affected by external forces, such as wind or current, if she reduces her speed so that she can maintain her maneuverability to the minimum level required for berthing. The result from this simulation was not much different from the facts above.

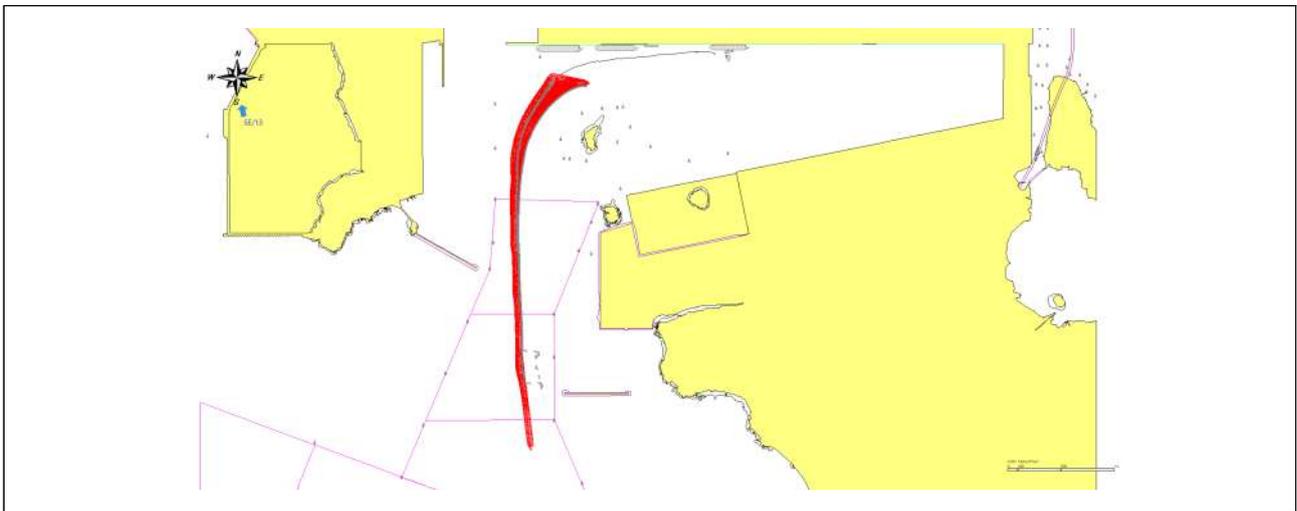
<Figure 36> Track of the simulation

CASE 4. Simulation of port entry at low speed

- In this simulation, when passing To Islet, the vessel reduced her speed to about 5 knots and made a turn to starboard as recorded in the VDR under the same weather and draft conditions as in Case 1. As a result, the vessel made a 90° change in heading at the mid-point between the quay and the islet.
- That means if *Milano Bridge* had reduced her speed to about 5 knots while passing the islet, she is presumed to have secured a safe distance from the quay as the vessel would make a 90° change in heading at the mid-point between the quay and the islet, just as the track of the other similar vessels described in Paragraph 4.4.3.
