사고를 통해 배우는 해양안전

—
2019년 주요 해외 해양사고 교훈사례집

LESSONS
LEARNED FROM
MARINE SAFETY
INVESTIGATION
REPORTS

해양수산부
중앙해양안전심판원

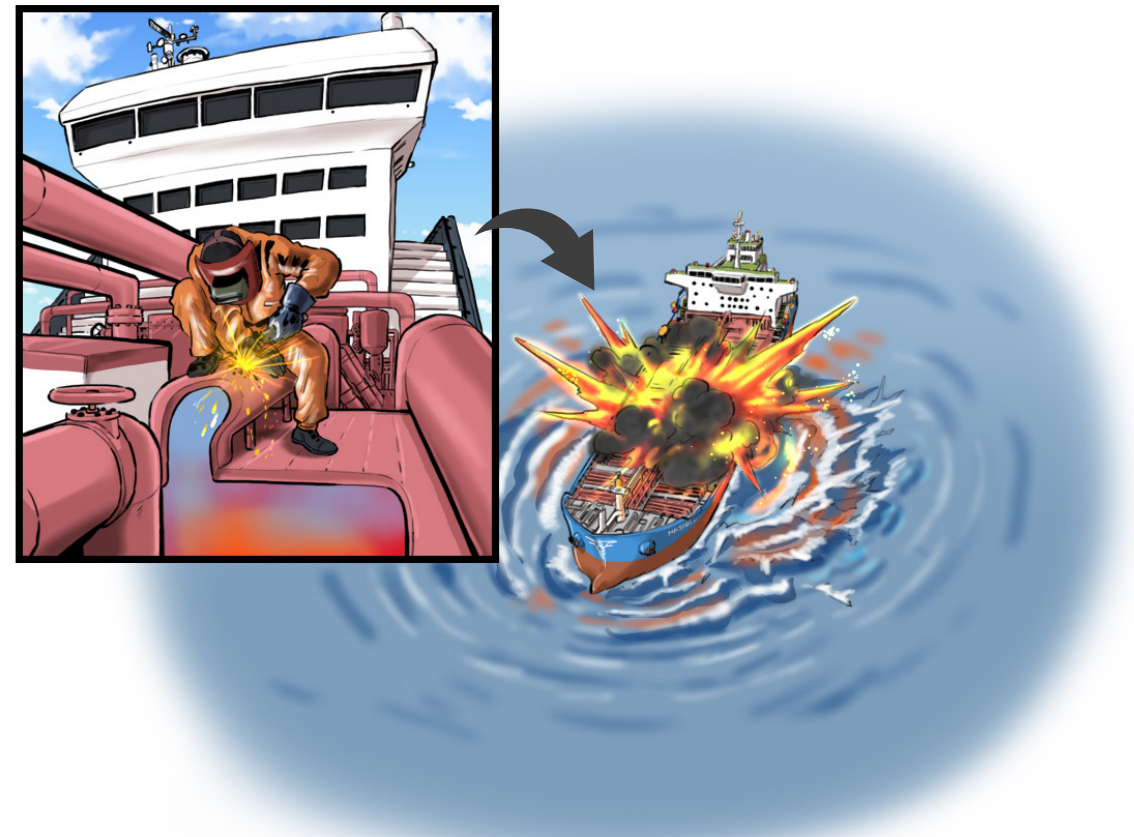
[1. 폭발]

화학제품운반선 용접 작업 중
폭발로 선원 사상

700GT급 화학제품운반선이 기유 화물을 하역했다. 선박은 다음 항구로 이동 중 탱크 청소 작업을 하고 있었다. 탱크 청소 전 화물 탱크와 펌프에 대해 플러싱(flushing) 작업을 실시하지 않았고, 기관장은 탱크 청소와 동시에 화물 탱크 중 하나의 송풍관을 용접했다. 용접으로 인해 송풍관의 화물 증기에서 발화가 일어났고 화물 탱크에서는 폭발이 발생했다. 기관장을 포함해 근처에서 작업 중이던 선원 세 명이 부상을 입었고, 기관장은 폭발로 인해 사망했다.

A 700 GT chemical tanker had discharged a cargo of base oil. En route to the next port, the vessel was performing tank cleaning operations. Prior to tank cleaning, there was no flushing of cargo tanks and pumps carried out by the crew. Concurrently with the tank cleaning, the Chief Engineer performed a welding operation on the ventilation duct of one of the cargo tanks. The welding caused ignition of the cargo vapours in the ventilation duct, which caused an explosion in the cargo tank. Three crew members working in the vicinity suffered injuries, including the Chief Engineer. The Chief Engineer succumbed to his injuries as a result of the explosion.

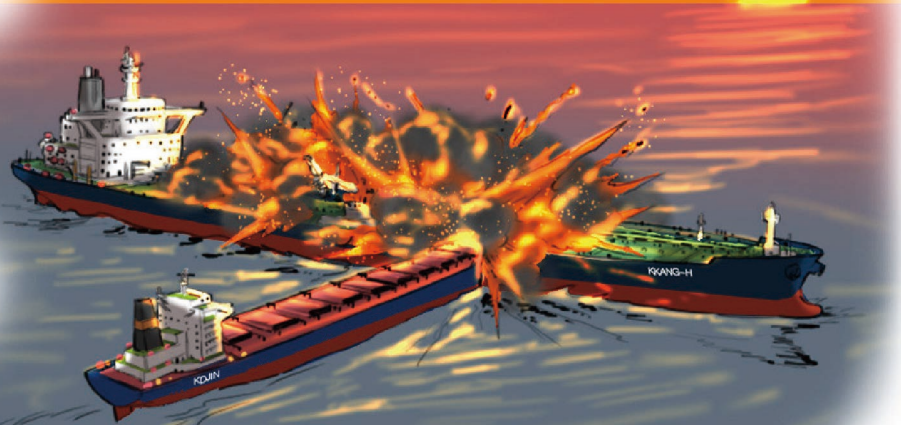
[2. 충돌]

유조선과 벌크선 충돌로 유조선 화재 · 침몰 및 전원 사망

85,000GT급 유조선과 40,000GT급 벌크선이 늦은 저녁 시간 충돌했다. 유조선은 100,000MT 콘덴세이트를 싣고 북쪽으로 항해 중이었고, 벌크선은 유조선 우현 선수 쪽에서 남서쪽 항로로 항해하고 있었다. 벌크선에 선수 부분이 유조선 2번과 3번 밸러스트 탱크 우현 선체와 충돌해 화물탱크가 파손됐다. 그로 인해 콘덴세이트에 불이 붙어 선상에서 폭발이 생겼다. 유조선은 침몰하고 선원 32명 전원 사망했다. 불타는 유조선에 끼어 벌크선은 선실과 구조체가 광범위하게 손상됐다. 두 선박 모두 3등항해사가 숙련 갑판원의 도움을 받아 견시하며 항해 중이었다. 벌크선 3등항해사는 충돌 전 1등항해사에게 견시 역할을 막 인계 받았고, 유조선 항해사는 상황을 잘못 인식한 것으로 보인다.

An 85,000 GT oil tanker and a 40,000 GT bulk carrier were involved in a collision during the dark hours of the evening. The oil tanker was carrying 100,000 MT of condensate. The oil tanker was on a northerly course while the bulk carrier was on its starboard bow proceeding on a south-westerly course. Prior to the collision, each vessel was aware of the presence of the other. The bow of the bulk carrier collided with the starboard hull of No.2 and No.3 ballast tanks of the oil tanker, breaching the cargo tanks. The collision resulted in the cargo of condensate catching fire, which then led to explosions on board and subsequently resulted in the sinking of the oil tanker and the loss of all of its 32 crew. The bulk carrier suffered extensive damage to the bow as well as to the accommodation and structure as the result of being stuck to the burning oil tanker before it separated. Both vessels were being navigated under the charge of their respective Third Officers assisted by an able seafarer (deck) as the lookout. The Third Officer of the bulk carrier had just taken over the watch from the Chief Officer prior to the collision. The officer of the oil tanker seems to have influenced the lookout's knowledge with his own erroneous perception of the situation.

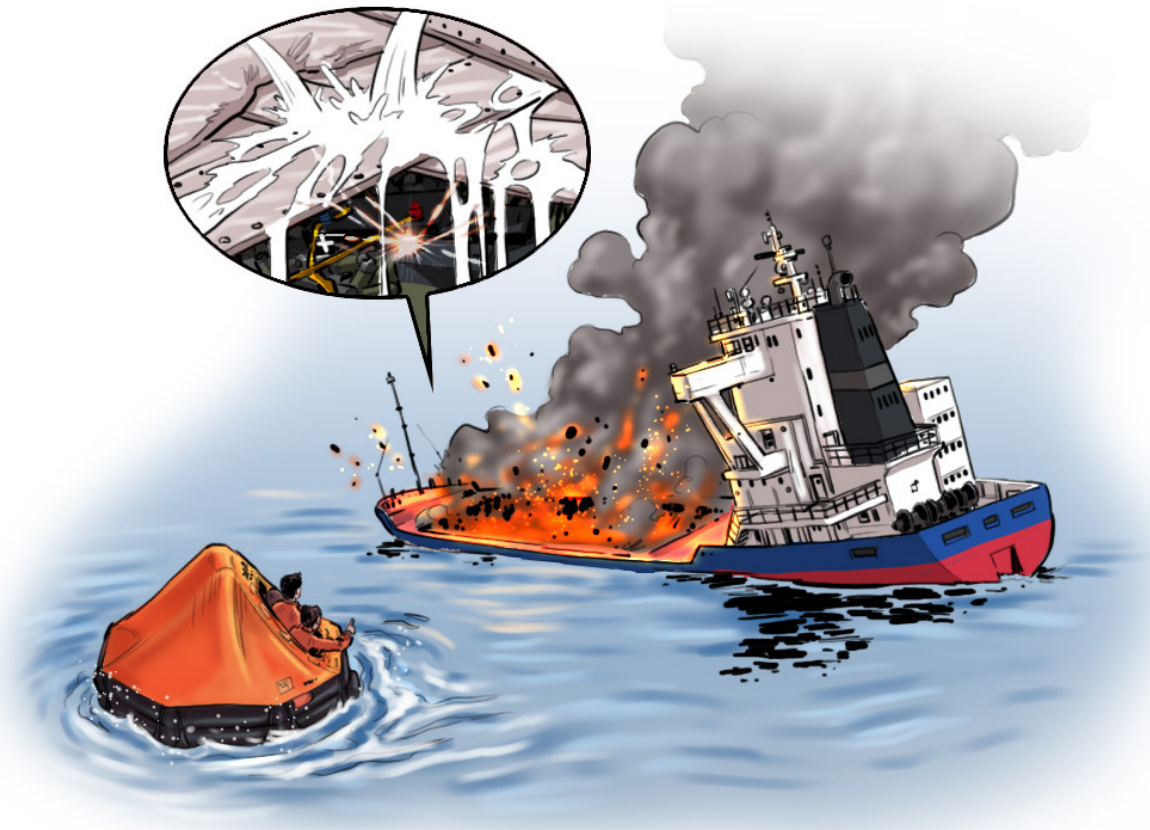
[3. 화재]

화물선 화물창에 화재 발생하여 선박 전손

선장과 10명의 선원이 타고 있는 2,000GT급 화물선이 폐금속과 기타 고철을 정박지에 하역하려고 기다리고 있는데 화물창에서 화재가 발생했다. 진화 작업 중 선박이 좌초해 전손되었다. 기름이 유출됐으나 사망자나 부상자는 없었다.

As the 2,000 GT cargo ship, with a master and ten other crew members aboard, was waiting to begin loading of waste metal and other miscellaneous scrap at a berth, a fire broke out in the aft cargo hold. The vessel foundered during fire-fighting operations and became a total loss. An oil spill occurred, but there were no fatalities or injuries.

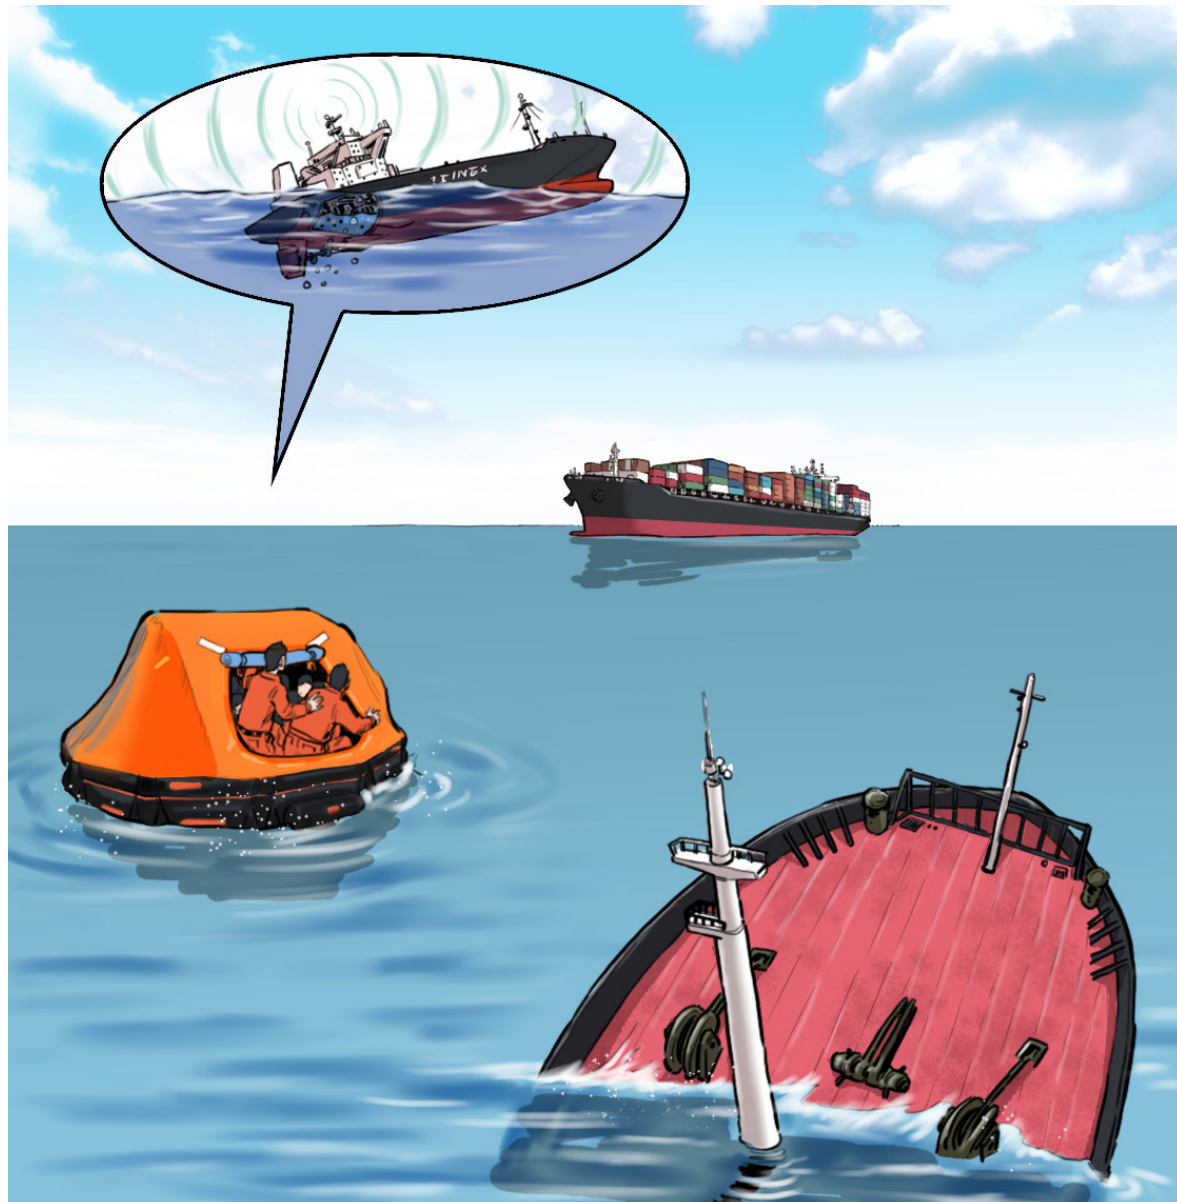
[5. 침수 및 좌초]

일반화물선 기관실 침수로 침몰

양호한 기상 상태에서 카보타지 항해로 고철을 운반하고 있던 1,200GT급 일반 화물선이 16번 채널로 국제조난신호를 보내 기관실이 침수되고 서서히 침몰하고 있다고 전했다. 이후 선장은 선원들에게 구명정을 출발하도록 하고 침몰하는 선박에서 퇴선하라고 지시했다. 부근 항해하던 컨테이너선이 조난 신호에 대응해 구명정에 타고 있던 선원 10명을 모두 안전하게 구조했다. 이후 선원들은 해안경비대 경비정으로 이동했다. 침수로 인해 화물선은 침몰했고 전손 선고를 받았다. 기름 유출이나 부상자 또는 사망자는 없었다.

A 1,200 GT general cargo ship, which was carrying iron slag on a cabotage voyage in good weather conditions, raised a Mayday call through VHF Channel 16, stating that its engine-room was flooding and that the ship gradually sinking. The Master then ordered his crew to launch the rescue boat to abandon the sinking ship. A containership navigating in the vicinity responded to the Mayday call and successfully rescued all 10 crew members from the rescue boat. The 10 crew members were later transferred to a Coast Guard boat. As a result of the flooding, the general cargo ship sank and was declared a total loss. There was no oil pollution, crew injury or death arising from the incident.

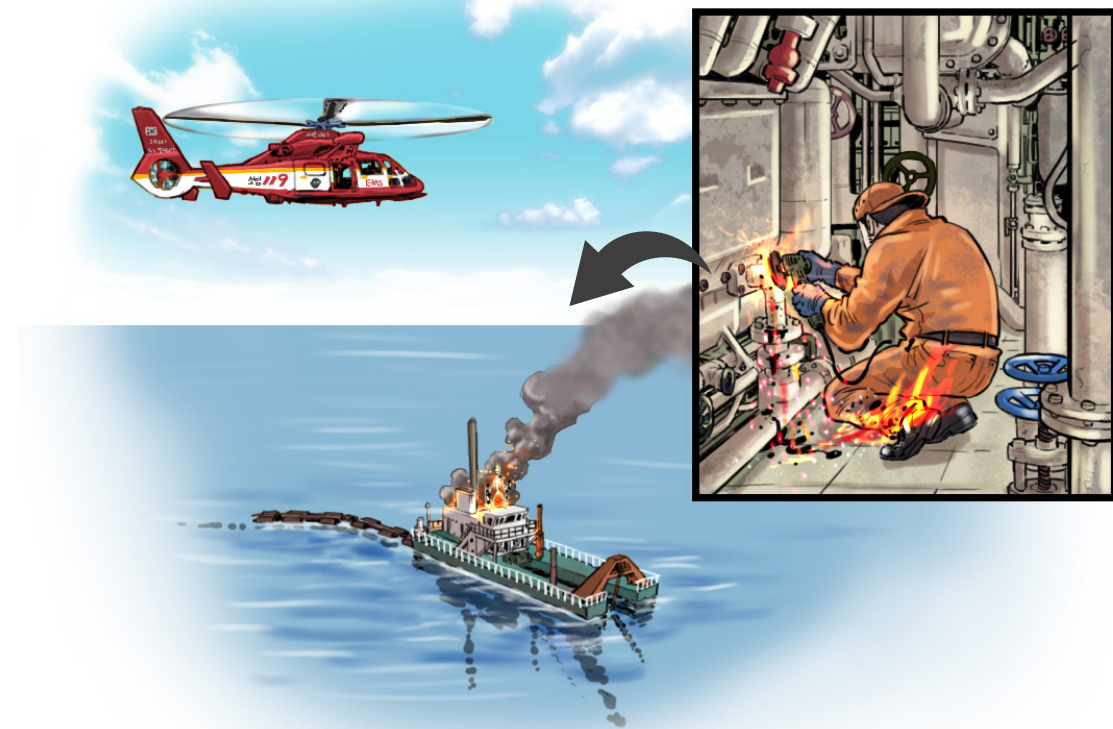
[7. 화재]

준설선 수리 작업 중 화재발생하여 선원 사망

펌프 준설선이 해안에서 약 12마일 떨어진 곳에서 모래 화물을 준설하고 있을 때 기관실에서 화재가 발생했다. 기관실에서 혼자 있던 견시 기관사는 엔진이 작동하고 있는 상태에서 주 기관 연료시스템의 저압 연료 Return Line의 누출을 수리하고자 앵글 그라인더를 사용하고 있었다. 앵글그라인더의 고에너지 불꽃으로 누출된 원자화 연료와 기관사가 입고 있던 디젤유에 젖은 작업복에 불이 붙으면서 화재가 발생했다. 기관사는 기관실에서 가까스로 대피했고 헬리콥터로 병원에 후송됐지만 중화상으로 결국 사망했다. 선원들이 기관실에 설치된 이산화탄소 소화 시스템을 작동시키고 Boundary Cooling을 실시해 화재는 진화했지만, 화재로 인한 강연 열기와 짙은 연기로 인해 진화 작업을 바로 실시하기는 어려웠다.

A suction dredger was dredging for a cargo of sand approximately 12 miles off the coast when a fire occurred in the engine-room. The watchkeeping engineer, who was the sole occupant in the engine-room, was using an angle grinder to attempt to repair a leak in a low-pressure fuel return line on the main engine fuel system while the engine was running. The fire started when high-energy sparks from the angle grinder ignited the atomised fuel from the leak and the diesel-soaked overalls he was wearing. The engineer managed to escape the engine-room and was evacuated by helicopter to a hospital, where he later died because of serious burn injuries. The intensity of heat and smoke prevented the crew from making a direct attack on the fire, so they activated the fixed CO2 fixed fire-fighting system in the engine-room and provided boundary cooling, which was successful in extinguishing the fire.

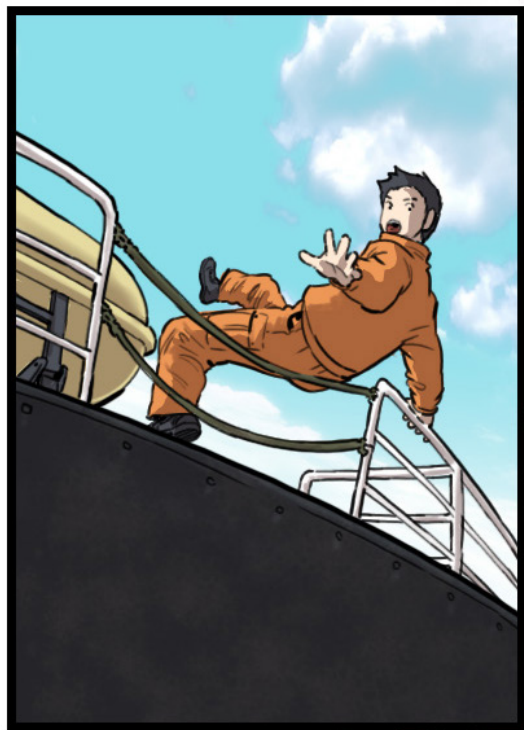
[10. 추락]

갑판원이 부두로 추락

길이 123m, 5,300GT급 화학제품/석유제품 운반선에서 숙련 갑판원이 선박의 2층 갑판에서 8m 아래 부두에 있는 컨테이너에 쓰레기를 버리던 중 치명상을 입었다. 숙련 갑판원이 구멍뚫목 보관 및 출발 구역에 있었는데, 이 곳의 보호 장치는 난간의 뚫린 곳을 가로질러 사슬 2개 뿐이었다. 갑판원은 균형을 잃었고, 체인은 그가 떨어지는 것을 막기에 충분하지 않아 아래 쪽 부두로 떨어졌다.
